AIRCRAFT ACCIDENT REPORT

EASTERN AIR LINES, INC.,
BOEING 727-225, N8838E
RALEIGH, NORTH CAROLINA
NOVEMBER 12, 1975

NTSB/AAR-83/06
(SUPERSEDES—NTSB-AAR-76-15)

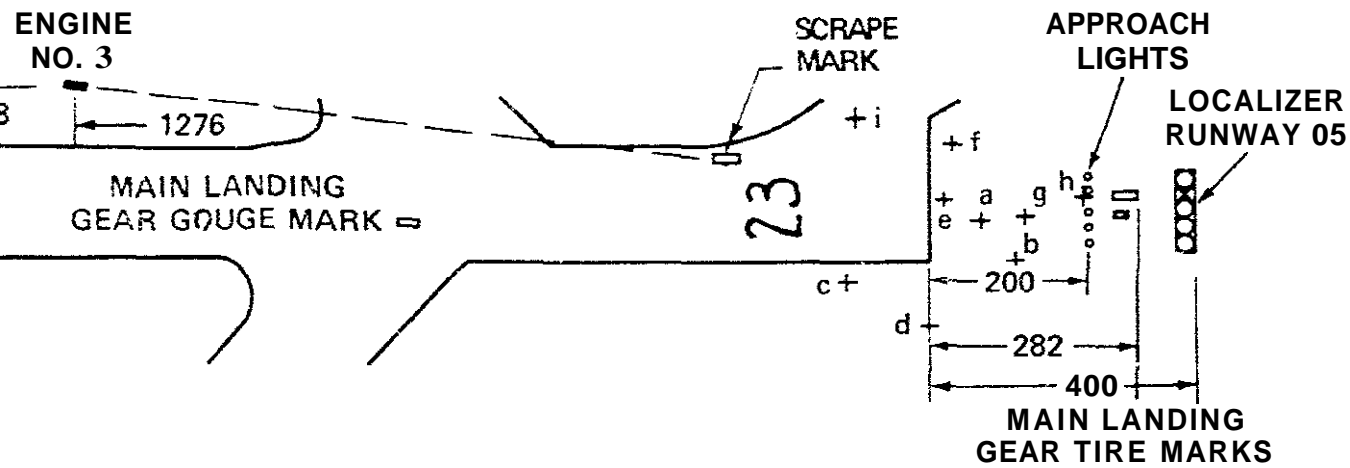
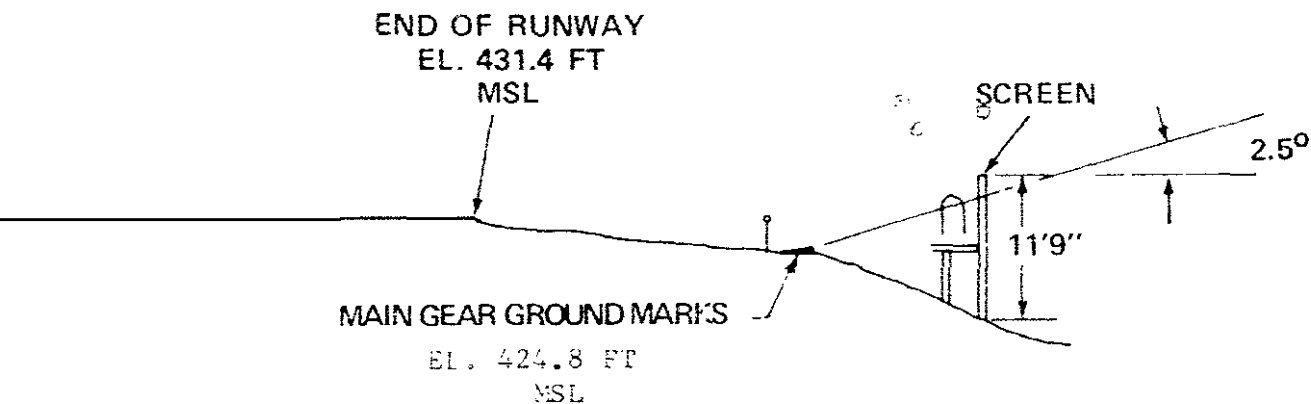
WRECKAGE DISTRIBUTION CHART
EASTERN AIRLINES FLIGHT 576

The airplane first struck the ILS localizer antenna screen for runway 05, which is located 400 feet before the threshold of runway **23**. The top 2 feet of the parallel antenna screen wires were severed. The elevation of the top wire was about **430** feet m.s.l., about 1.5 feet below the runway threshold elevation, and about 5 feet below the touchdown zone elevation. An antenna dome was also damaged. (See appendix E.)

The main landing gear tires hit the ground first—about **282** feet short of the runway **23** threshold. The elevation of the ground marks was about 425 feet m.s.l. about 3.5 feet below the elevation of the runway threshold, and about 6 feet below the elevation of the touchdown zone. The airplane's angle of descent between the broken ILS localizer antenna domes and the ground marks was about 2.5° .

The nose landing gear remained on the airplane; the tires were flat. Portions of both main landing gear support structures, the left inboard, mid-inboard, and the mid-trailing edge flaps; the airstair handrails; and airstair control access panel were found between the point of the first ground contact and the runway threshold.
