AIRCRAFT ACCIDENT REPORT

**LAS VEGAS AIRLINES FLIGHT 88
PIPER PA-31-350
GRAND CANYON, ARIZONA
AUGUST 17, 1983**

NTSB/AAR-84/05

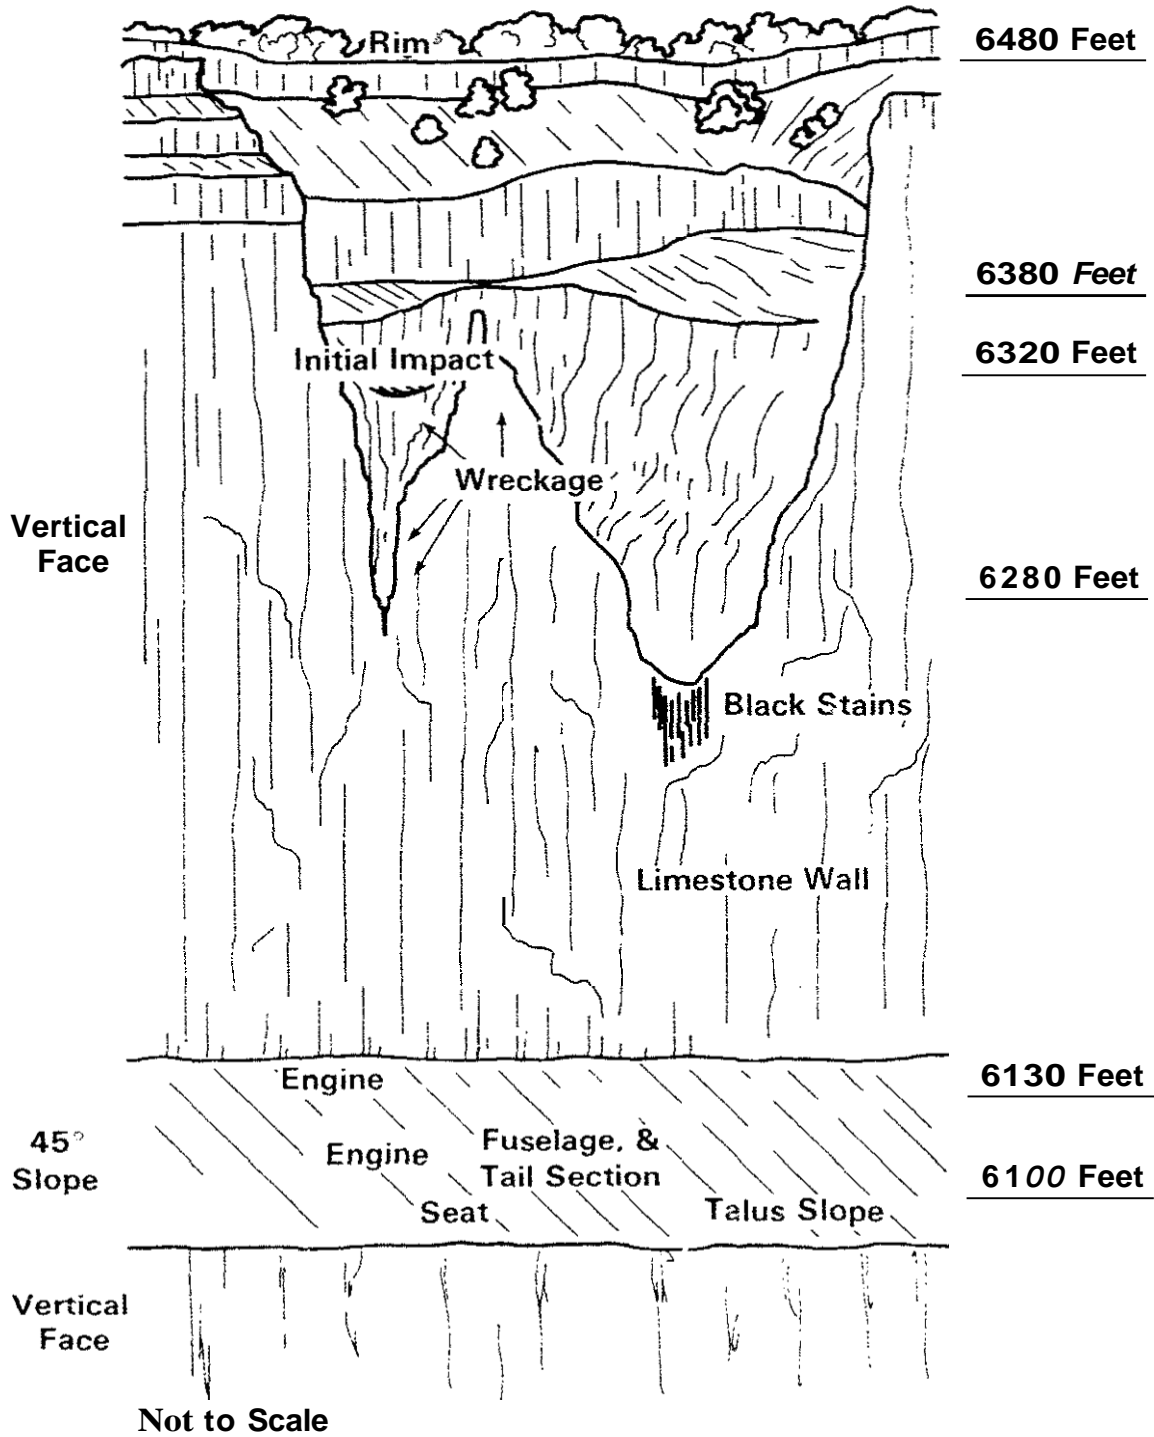
Figure 2.—Wreckage diagram.

Initial impact was in a crevasse in the vertical face of the mesa's wall about 160 feet below the rim. Portions of the forward cockpit/cabin were lodged in the crevasse. Circular marks on the face of the mesa wall corresponded to engine and propeller dimensions, and impact marks indicated that the aircraft struck in a near wings level attitude on a north-northeasterly heading.

Photographs of the area and the wreckage taken on August 20, 1983, from a helicopter chartered by the Safety Board showed that the main wreckage fell onto the talus slope about 200 feet below the initial impact point. Loose rocks and the steep grade precluded a landing by the helicopter on the talus slope, but three Safety Board investigation team members were able to observe the wreckage closely. Both wings had separated from the fuselage carry-through structure at or near the wing root area. The right wing was resting upside down on top of a pile of wreckage. The right main landing gear door appeared flush with the lower surface of the wing. The right wing trailing edge flaps were attached to the wing and appeared to be retracted. The left wing lay on a

bearing of about 315° about 75 feet from the large pile of wreckage. The left wing was broken and structurally deflected upward about 30° near the wing midspan. The rudder remained in place on the vertical fin. An airspeed indicator, found on a ledge about 75 feet below the talus slope, indicated about 170 knots indicated airspeed (KIAS). A vertical speed indicator, found near the airspeed indicator, indicated an ascending vertical speed of about 2,000 feet per minute.

One propeller blade was recovered; about 6 inches of the tip were missing, the end tip was curled rearward with respect to the forward plane of propeller rotation, the front face of the blade had heavy circular scratch marks, and the blade's leading edge exhibited deep cuts and gouges transverse to the longitudinal axis of the blade.
