NATIONAL TRANSPORTATION SAFETY BOARD

AIRCRAFT ACCIDENT REPORT

**LANDRY AVIATION
LOCKHEED LEARSTAR L-18, N116CA
SILVANA, WASHINGTON
AUGUST 21, 1983**

NTSB/AAR-84/06

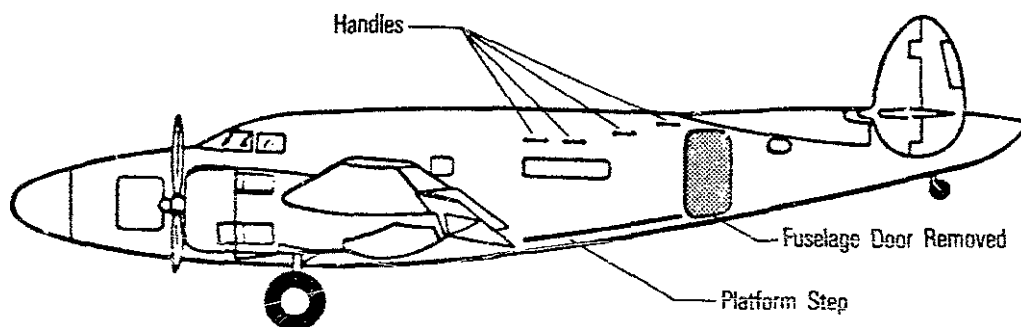
Figure 1.—Modifications to N116CA.

The owner of Landry Aviation, Inc., testified during deposition proceedings that some parachute jumpers had indicated that mass jump exits could be accomplished more easily if a step were installed adjacent to and forward of the door on the outside of the fuselage. In the week before the accident, four externally mounted handholds and a plywood step were installed on the fuselage forward of the cabin entryway. The step was made of 3/4-inch plywood, was 4 inches wide 7 feet long, and was attached by aluminum angle. (See figures 1 and 2.) He further testified that because similar installations had been made on other Lockheed L-18 airplanes used in jump operations, including a second airplane he had acquired, it was his opinion that the installation either was not a major alteration, and therefore did not require FAA approval, or that it had been approved previously by the FAA for other airplanes. The installation of the step was not inspected and approved by an authorized inspector nor did Landry Aviation request approval from the FAA. No flight testing was conducted to determine the effects on airplane handling and performance. The pilot who flew on the second and third flights on the day of the accident stated that he noticed no different or unusual effects on the airplane characteristics with the step and handholds installed or when the jumpers were standing on the steps.

After the accident, Landry Aviation contracted for an engineering study and analysis of the installation, and made the results available to the Safety Board. The study indicated that the installation had negligible effects on airplane stability and control. The report of the study and analysis was reviewed by the Safety Board's Aircraft Performance Engineering Staff and found to be correct regarding the effects of the installation.

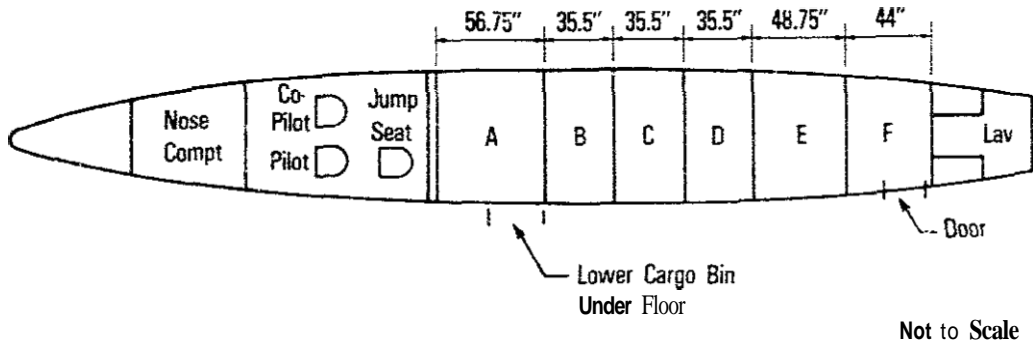
Figure 3.—Airplane configuration for weight and balance determination.

average front-to-back body depth of 10 inches ^{2/} and 10 inches for the thickness of the parachute pack, Safety Board investigators estimated weight and balance for the takeoff with 24 jumpers positioned. The estimate indicated the jumpers would have to occupy space back to compartment D. (See figure 4). That calculation provided an estimated center of gravity location at takeoff of 205.3 inches aft of the datum. The aft limit is 198.8 inches.

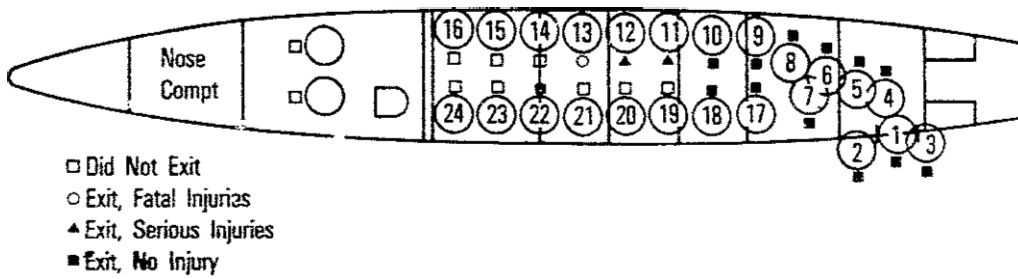
The pilot who performed the takeoff weight and balance calculations also stated that neither he nor the other pilots had made any weight and balance calculations for the load configuration of 24 jumpers positioned for a mass jump with 8 jumpers gathered at the door and on the outside step. Safety Board investigators also estimated weight and balance based on the airplane configuration described by the survivors. (See figure 5.)

All jumpers participating on the day of the accident had filed "experienced jumper waiver and information" forms on which they also entered their weight. These weights and the typical weights of parachutes and equipment were used by the Safety Board to determine the airplane weight and balance when they were in position for the jump. The position of each jumper as described by the jump coordinator who had assigned each jumper a specific place in the jump sequence and the body dimensions from the cited reference were used to estimate the placement of each jumper in the cabin. The fuel on board was estimated based on the number of flights since last refueling and the typical fuel consumption of previous jump flights. Using this information, the Safety Board calculated a jump configuration center of gravity location of 214.5 inches aft of the datum.

Item	Weight	Arm inches aft of Datum	Moment
Airplane			
Empty Weight	14,499	131.53	2,776,931.40
Door Removed	- 28.25	429.3	- 12,127.00
Ballast in			
Lower cargo bin	200.0	220.0	44,000.00
Step end			
Handholds	+ 12.70	375.0	+ 4,762.00
Pilots	400.0	135.0	54,000.00
Compartment A (5 jumpers)	1055.0	217.0	405,790.00
Compartment B (5 jumpers)	905	262.5	237,562.00
Compartment C (4 jumpers)	815	298.0	242,870.00
Compartment F (5 jumpers)	1,490	422.0	628,780.00
Fuel inboard fwd tanks (80 gals.)	480	167.5	80,400.00
Outer wing tanks 60 gals.	960	175.0	168,000.00
Total weight	<u>20,788</u>	<u>Loaded airplane moment</u>	<u>4,630,968.00</u>

Center gravity = moment divided by weight

Figure 5.—Jumper positions and center of gravity position at time of upset.
