NATIONAL TRANSPORTATION SAFETY BOARD

AIRCRAFT ACCIDENT REPORT

**FLYING TIGERS, INC., FLIGHT 2468
McDONNELL DOUGLAS DC8-63, N797FT
CHAMBERS FIELD, NAVAL AIR STATION
NORFOLK, VIRGINIA
OCTOBER 25, 1983
(REVISED: SEPTEMBER 1, 1984)**

NTSB/AAR-84/08

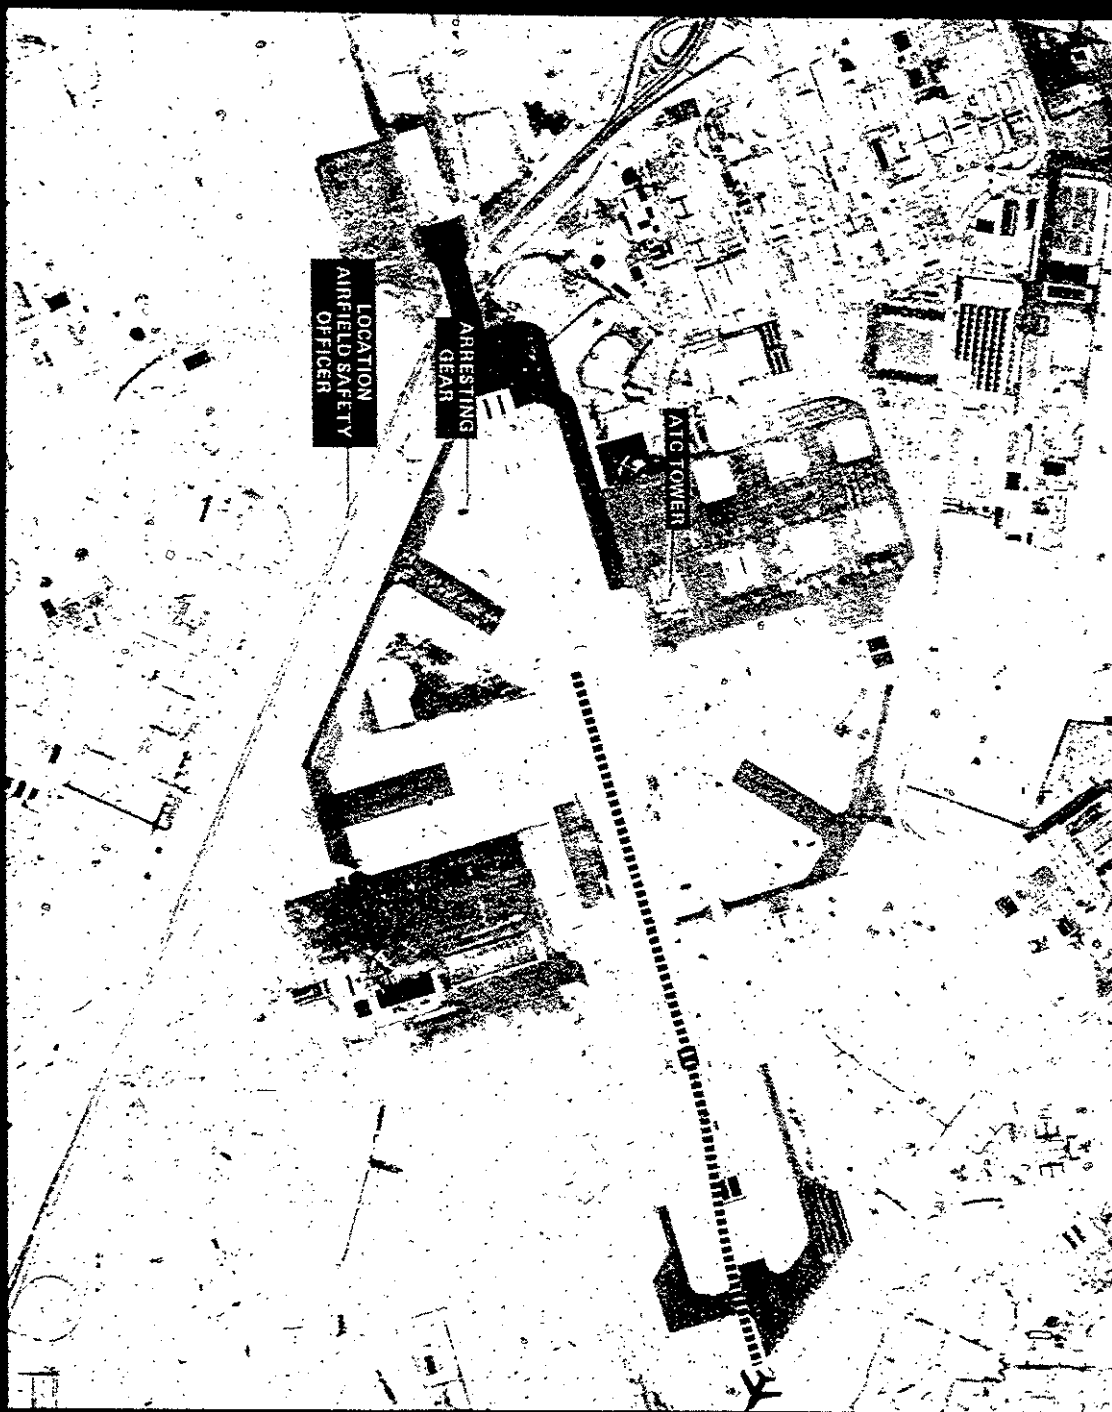
Figure 1.—Airfield diagram and ground track of airplane.

The local controller, who was located in the tower cab (see figure 1), stated that the airplane touched down at the No. 1 arresting gear and bounced 50 to 100 feet into the air and finally touched down a second time abeam of the tower, or just before reaching the tower. An off-duty ground control trainee saw the airplane touch down by the No. 1 arresting gear, bounce about 50 feet, and touch down a second time abeam of the tower just before midfield. Neither the local controller or any other controllers was aware about a tendency for the runway to flood under certain meteorological conditions.

A flight data controller who first saw the airplane at midfield said the airplane was "going very fast." Both the flight data controller and the local controller said that they did not hear the sound of reverse thrust. The flight data controller recalled seeing water spray emanating from the airplane as it went down the runway. The airfield aviation safety officer, a Naval aviator, was driving to work and saw a DC8 touch down on runway 10 "just east of the southwest taxiway centerline" which was between the intersection of the two runways and a point abeam of the tower.

Three firemen were located at the "hot spot" located about 1,200 feet east of the intersection of the two runways. They said that they saw the airplane touchdown abeam of the tower, that they heard the engines in reverse thrust as the airplane passed their position, and that they saw spray from behind the airplane. The lieutenant in charge of the crash-fire-rescue (CFR) truck ordered the vehicle to respond while the airplane was still moving down the runway because he believed the airplane would not be able to stop on the runway.
