**NATIONAL
TRANSPORTATION
SAFETY
BOARD**

AIRCRAFT ACCIDENT REPORT

**AIR CANADA FLIGHT 797
McDONNELL DOUGLAS DC-9-32, C-FTLU
GREATER CINCINNATI
INTERNATIONAL AIRPORT
COVINGTON, KENTUCKY
JUNE 2, 1983**

NTSB/AAR-84/09

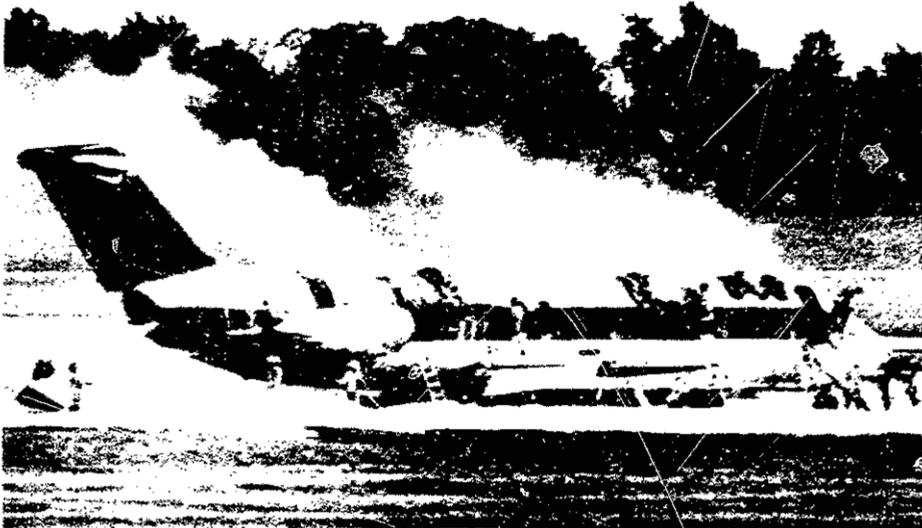
Figure 2.—Airplane after fire burned through top of fuselage.

The cabin area of the upper fuselage down to below the level of the cabin windows was damaged heavily by fire; below that level the fuselage was relatively intact. The majority of the cabin windows were either missing or had partially melted out. (See figures 5 and 4.) Forward of the aft pressure bulkhead, the upper areas of the cabin windows were discolored and burned away in several locations. The fuselage skin above the left aft lavatory was intact, but a rectangular area corresponding closely to the shape of the lavatory had been discolored to dark brown and a large area of paint had been burned away. The rectangular area began above the engine pylon and extended to the top of the fuselage. (See figures 3 and 4.)

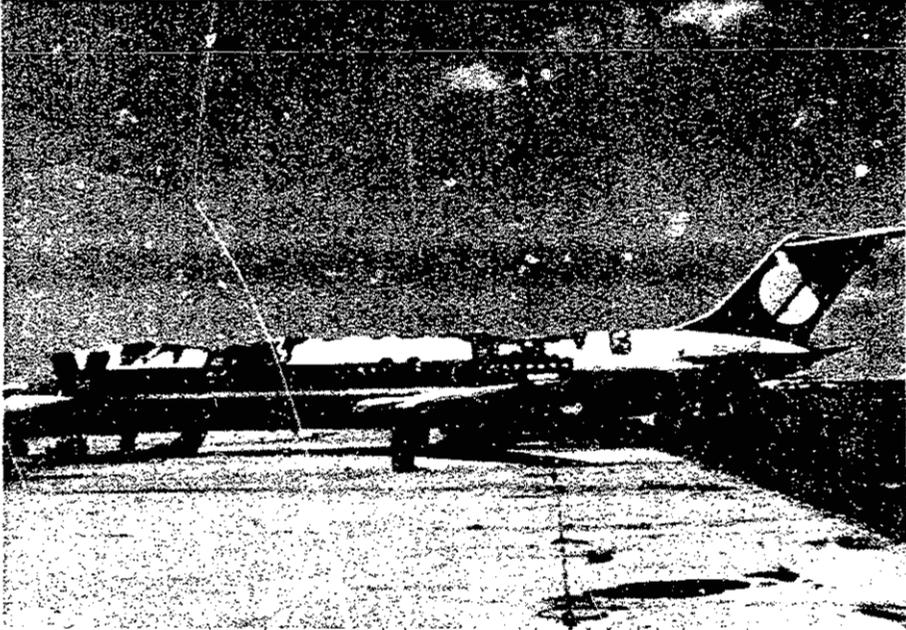
Figure 3.—Left side of the airplane.

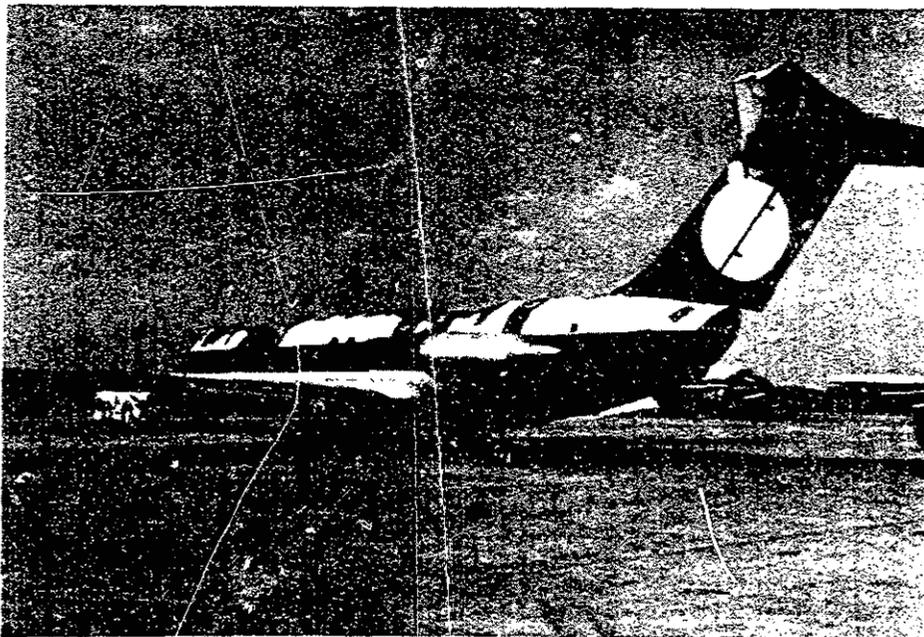
Figure 4.—Left side of the airplane, rear view, depicting rectangular burn pattern and soot trail.

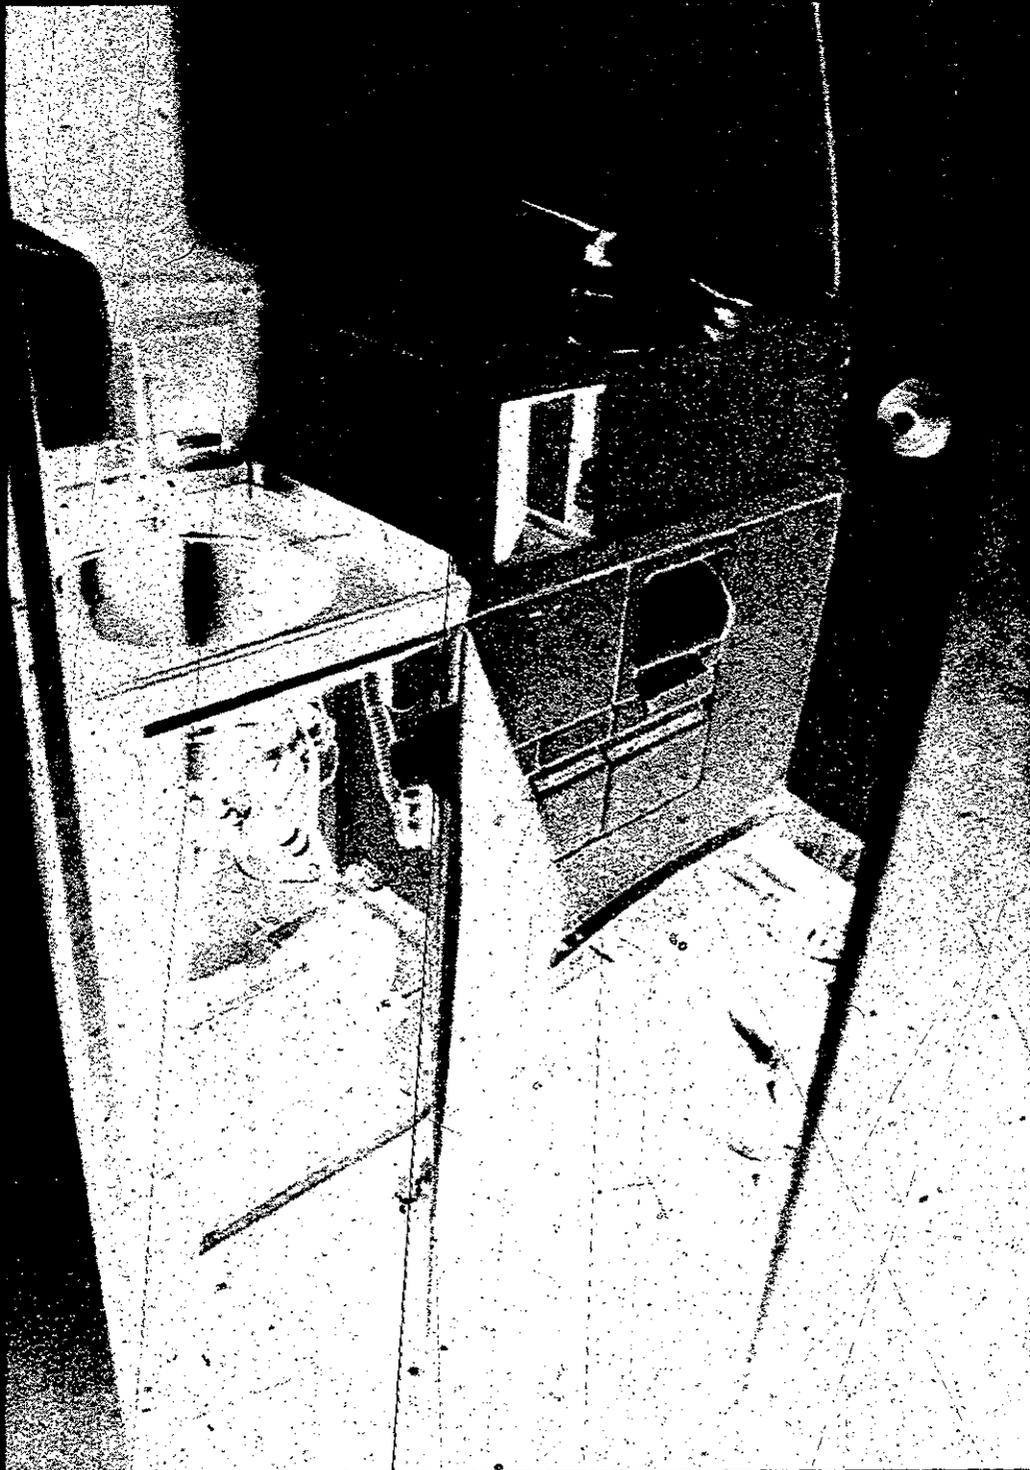
Figure 10.—Aft lavatory viewed toward aft and outboard wall.
Lavatory sink door is open exposing trash receptacle.
Toilet shroud has been removed showing the top of the
flush motor between the commode and forward wall of
the amenities section.

The aft lavatory was damaged extensively by fire and heat. Most of the lavatory's interior walls had been burned away. The entry door, which had been kept closed, was destroyed except within 16 inches of the floor. The aft pressure bulkhead and fuselage skin which comprised the outermost portion of the lavatory enclosure were intact, but were buckled and discolored to dark brown.

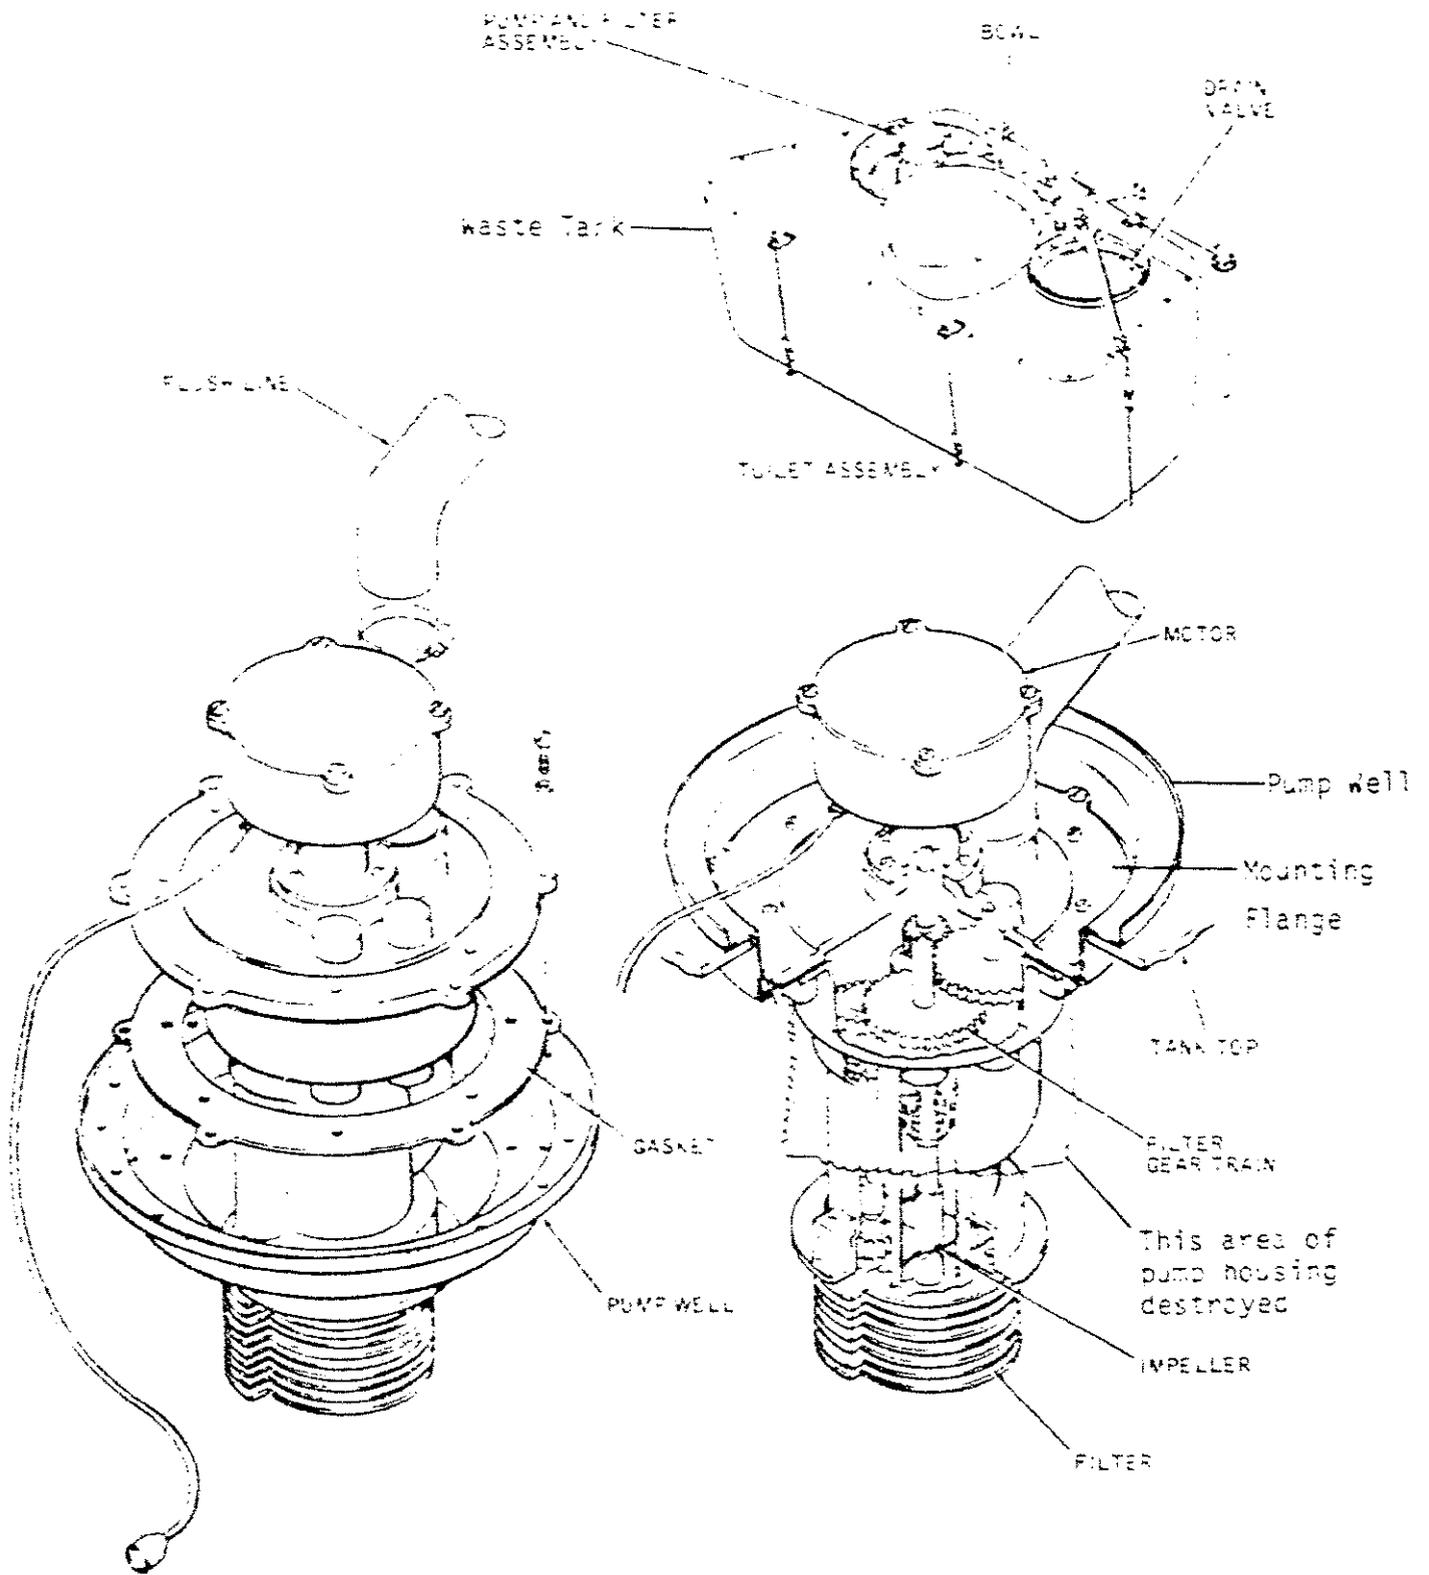
The flush motor was found attached to its mounting flange which was attached to the pump well. The flush motor assembly was found in approximately its normal position in the waste tank next to, but detached from, the flush pump and filter assembly. The motor housing was completely melted. Large concentrations of molten metal were found on the forward side of the mounting flange facing the toilet bowl, and on the aft side where the 3-phase electrical leads enter the motor housing. A portion of the wiring harness which supplies a.c. power to the flush timer, flush motor, and flush button was encased in the molten metal on the aft side of the motor. The rotor section of the flush motor was encased in molten metal above the field windings; however, the rotor did not appear to have been damaged extensively by heat. (See figure 11.)

The flush pump and filter assembly found in the waste tank was partially intact. The filter and pump mechanisms, which apparently had been located below the water line in the waste tank, were in good condition. Above the water line, the plastic housing for the pump and filter was melted away. This housing also encloses the filter gear train and is part of the assembly used to mount the pump and filter to the pump well. The exposed shaft and gears showed heat damage. The gears, which make up the filter gear train that connects the motor to the pump and filter, were found lying in the waste tank. The plastic mounting ring, which mates the pump and filter housing to the pump well, was found intact among the debris in the waste tank. There was some slight melting of the top surface of the mounting ring. All of the components of the flush motor and pump assembly were removed for further examination.

Figure 11.—Lavatory pump and filter system.
