AIRCRAFT ACCIDENT REPORT

**CENTRAL AIRLINES FLIGHT 27
HUGHES CHARTER AIR
GATES LEARJET MODEL 25 (N51CA)
NEWARK INTERNATIONAL AIRPORT
NEWARK, NEW JERSEY
MARCH 30, 1983**

NTSB/AAR-84/11

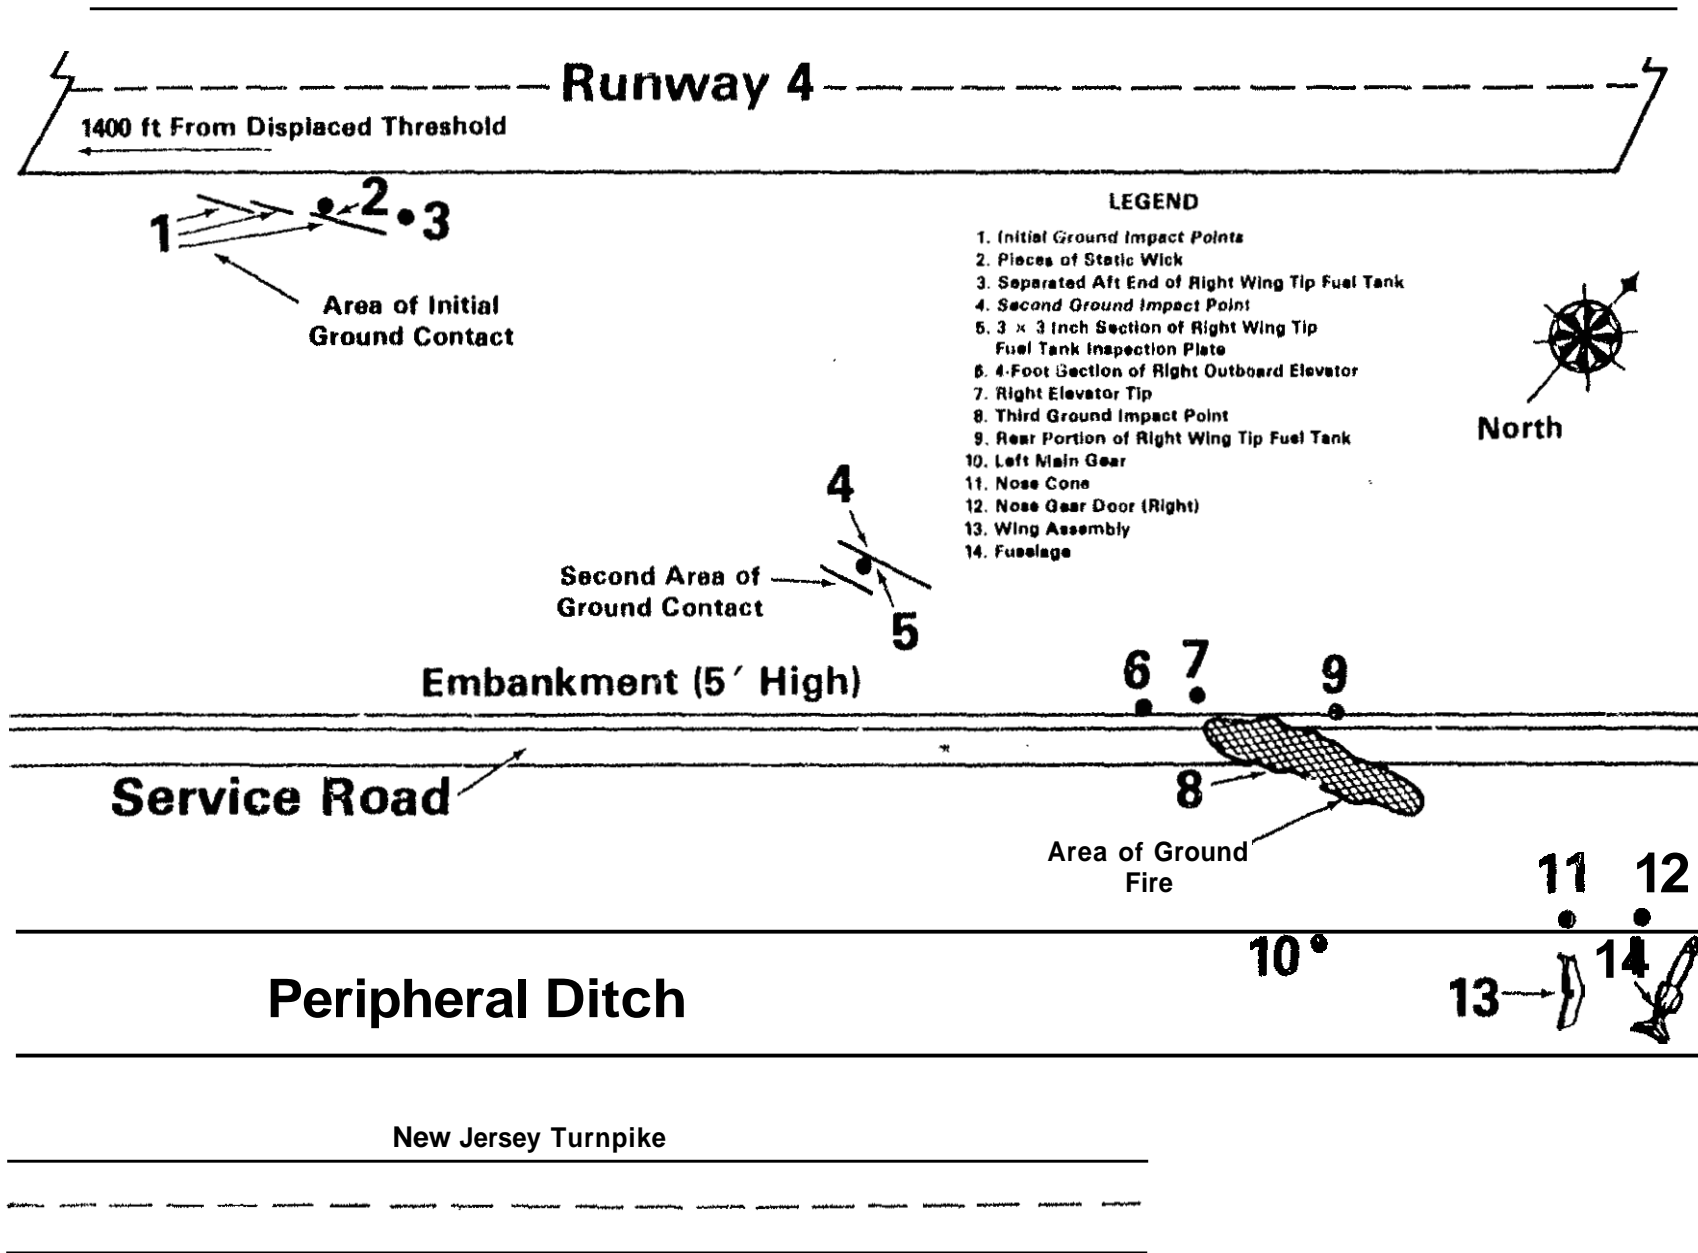
Figure 1.—Wreckage Diagram.

The airplane came to rest about 750 feet to the right of runway 4 right, about 1,500 feet from the poinr where it departed from the runway. (See figure 1) The fuselage came to rest partially submerged in a canal alongside ihe New Jersey Turnpike. The wing section came to rest about 50 feet from the fuselage in the middle of the canal. The airport crash/fire/rescue crew extinguished the ground fire about 3 minutes after the accident. The accident occurred during lawn at location 40° 42' N and 74° 10' W.

The first identifiable marks on the ground made by N51CA were found about 18 feet to the right of the edge of runway 4R about 1,400 feet beyond the runway displaced threshold. No marks made by N51CA could be located on the runway surface where it presumably touched down. The initial impact area was an area of three ground scars made by the right wingtip fuel tank and the landing gear. The scars were aligned about 30" to the right of the runway heading. (See figure 1.) A second area of ground impact was located about 600 feet beyond the initial marks along a path oriented about 070°. These marks were gouges made by the right wing and right horizontal stabilizer/elevator.

A third area of impact was located at the edge of an airport perimeter service road, about 600 feet beyond the second area. This area was about 86 feet long and 66 feet wide. Pieces of the cockpit windshield were embedded in the dirt along with numerous small pieces of debris from the cockpit. The main fuselage came to rest in a drainage ditch about 150 feet from the road surface. The fuselage was oriented in a northerly direction and was partially submerged in the water. The entire wing section, which had separated from the fuselage, came to rest partially submerged in the center of the ditch about 50 feet to the south of the fuselage.

There was evidence of fuel spillage and ground fire in the area of the road and up to the edge of the drainage ditch. Fire had damaged a small area on the left lower fuselage aft of the wing root attachment. The remainder of the airplane was not burned.
