AIRCRAFT ACCIDENT REPORT

**AIR CANADA FLIGHT 965,
LOCKHEED L-1011, C-FTNJ,
NEAR CHARLESTON, SOUTH CAROLINA
NOVEMBER 24, 1983**

NTSB/AAR-84/13

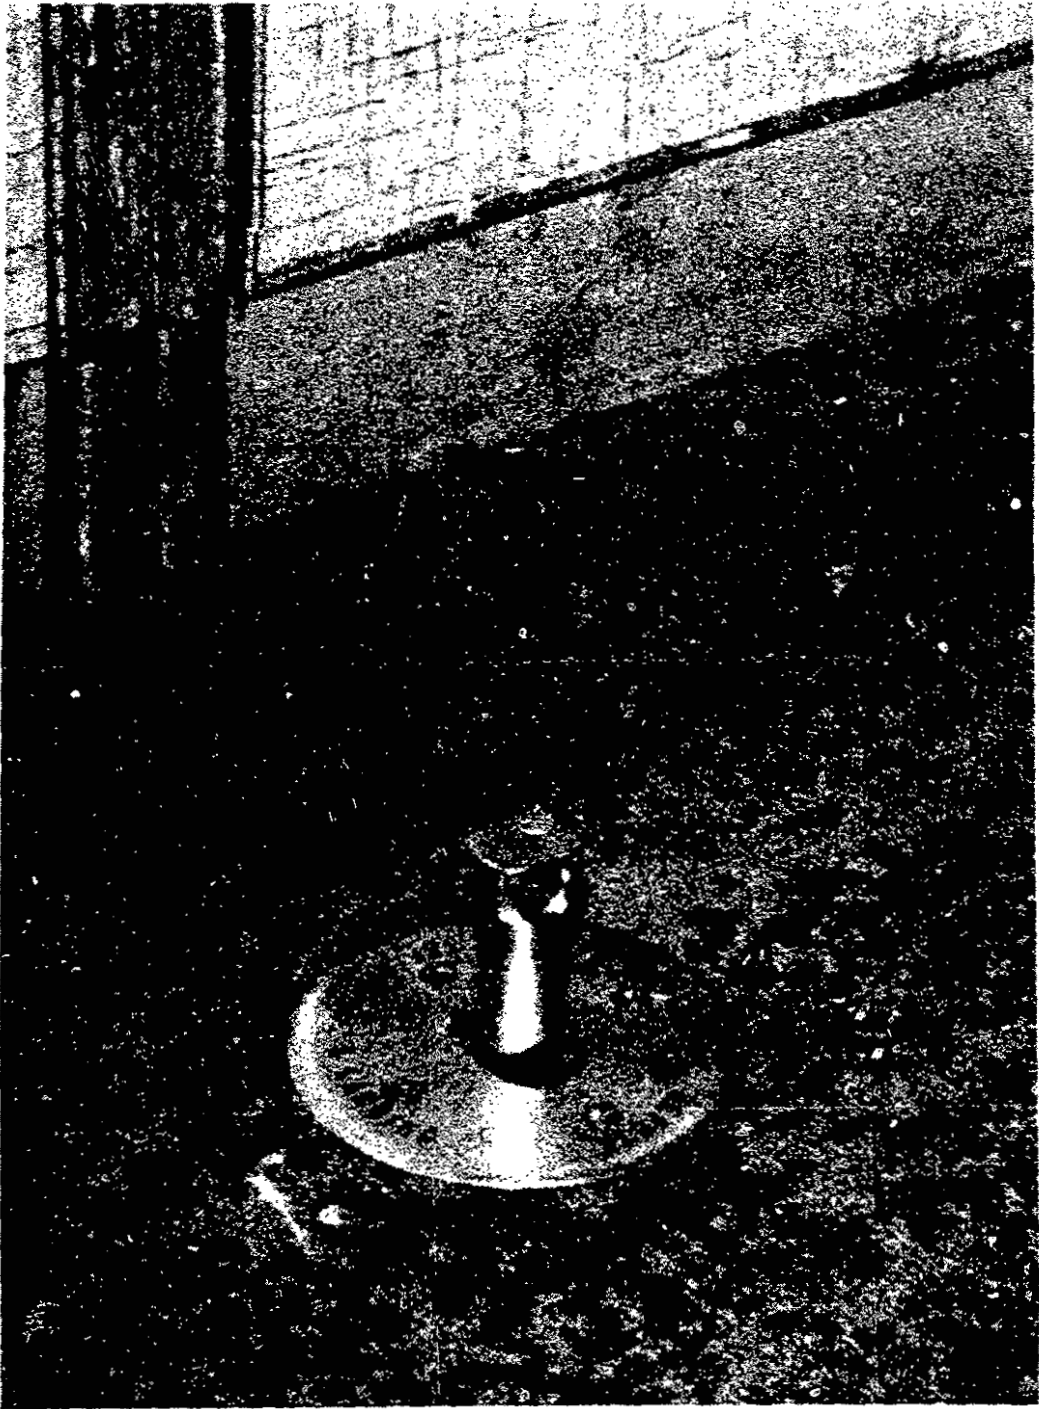
The anchor-type devices in the floor of the L-1011 consist of a standard flush-mounted plate with a retractable anchor pin. To anchor the passenger service cart, the pin is pulled upward and also rotated slightly to lock into position. (See figure 1.) There is also a locking mechanism mounted on the underside of the passenger service cart itself. The mechanism consists of a locking pin and lever assembly, a channel bracket (guide), a spring steel stop, and a brake for the rear wheels. (Figure 2 shows the underside of a typical passenger service cart used in Air Canada's L-1011.) The cart is designed in accordance with Air Canada's specification No. 25-30-030. The locking pin and wheel brake are both attached to the toe-operated lever. In order to anchor the cart to the floor, it is positioned over the floor-mounted pin so that the anchor pin is within the guide bracket and up against the steel spring stop. The toe-operated lever is then moved to the left to its locked position. This action brakes the rear wheels and slides the locking pin horizontally through the guide bracket. If the cart is properly positioned, its locking pin will slide through the hole in the anchor pin without difficulty, thus securing the cart to the cabin floor.

Figure 1.—Floor-mounted, retractable anchor pin.
