**NATIONAL
TRANSPORTATION
SAFETY
BOARD**

AIRCRAFT ACCIDENT REPORT

**WESTERN HELICOPTERS, INC.,
BELL UH-1B, N87701
VALENCIA, CALIFORNIA
JULY 23, 1982**

NTSB/AAR-84/14

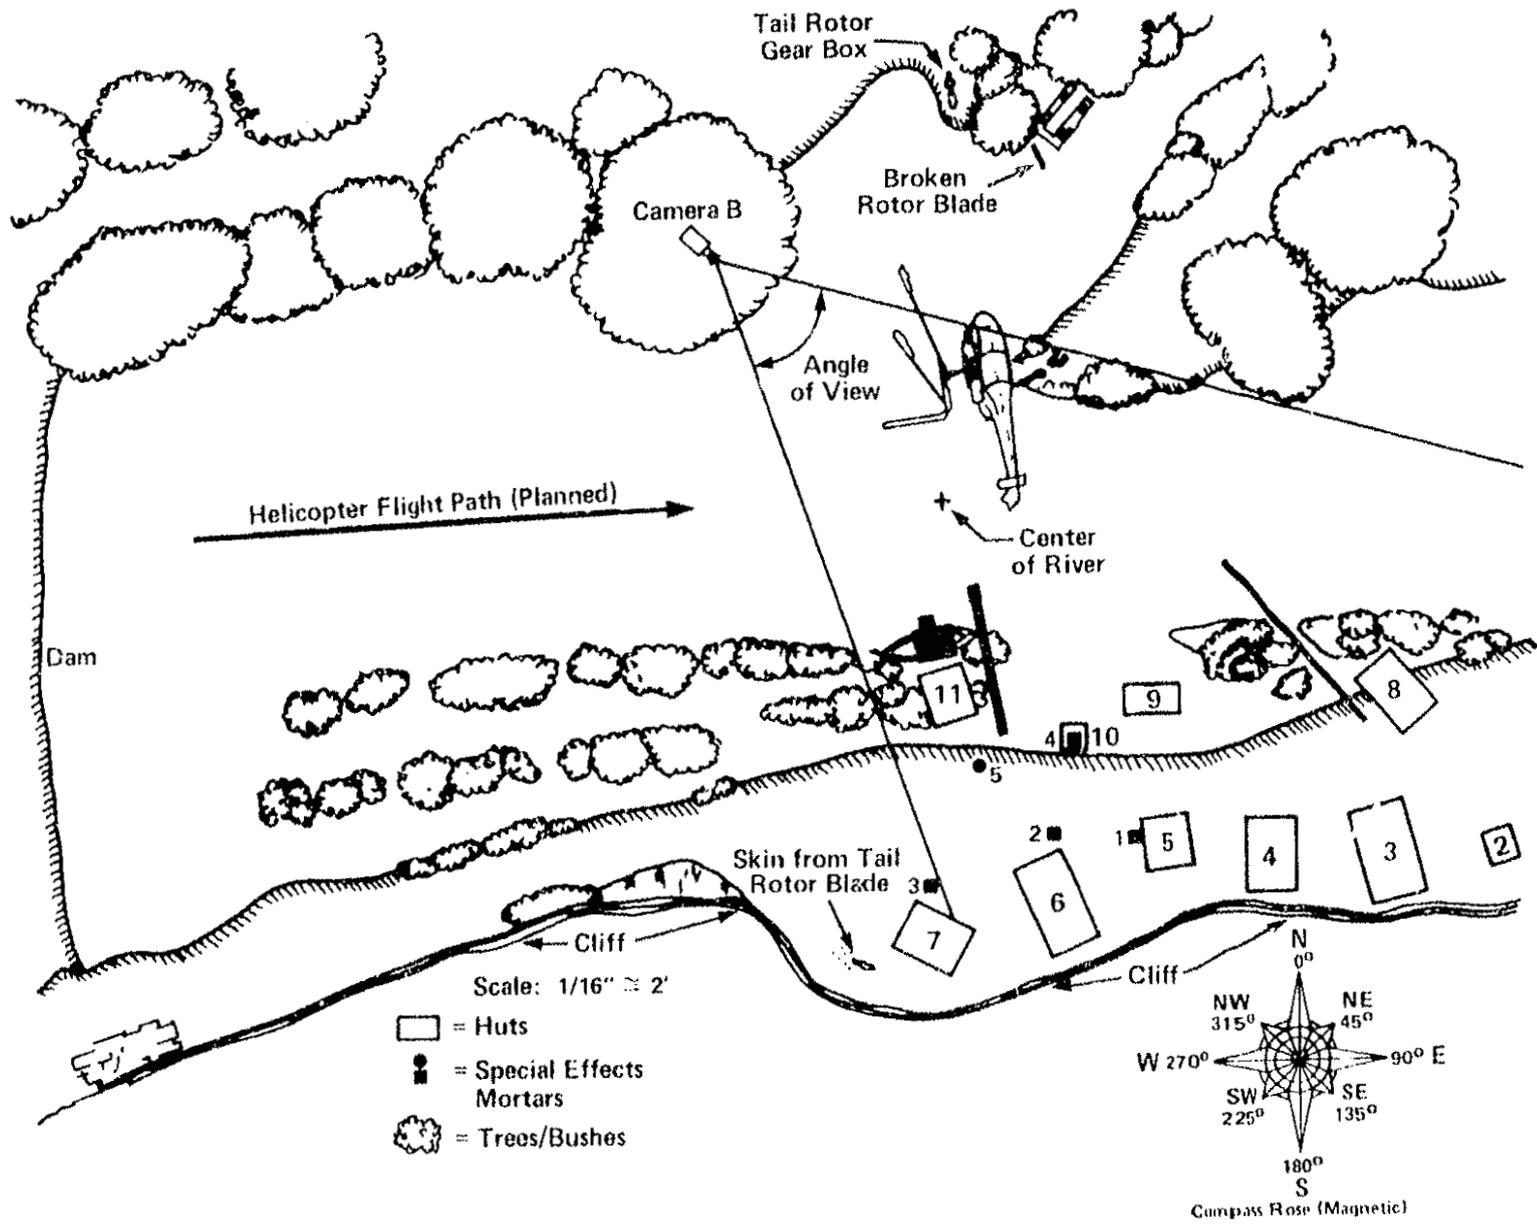
Figure 1.—Accident site.

The helicopter stopped turning to the left and stabilized on a magnetic heading of about 009° for less than 1 second. The helicopter began a right ascending turn until it left the film frame. About 2 seconds later the helicopter reappeared in the film frame in about a 20° tail down attitude, and was still turning to the right, but descending. The tail rotor assembly was missing. The helicopter crashed into the peninsula on the north side of the river in a noseup 45° left bank attitude, while the helicopter was still turning to the right. The helicopter's main rotor blades continued to turn to the left and struck the adult actor and the two children as they were crossing the river. This entire sequence of events, including the explosions resulting from the detonations of special effects devices and the subsequent crash of the helicopter, was recorded on film by the ground cameras. The accident occurred at night about 0220 hours at latitude 31° 25 feet north and longitude 118° 35 feet west. The elevation of the crash site was 1,000 feet m.s.l.

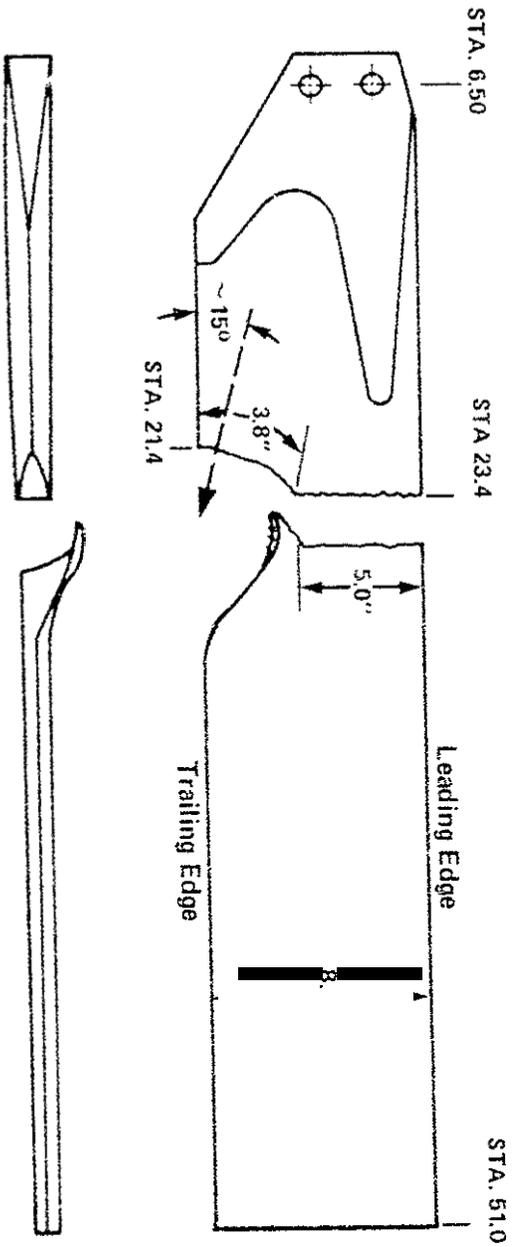
Figure 2.—Blade damage.

A foreign object impacted the tail rotor blade trailing edge approximately 18.25 to 22.3 inches (463.55 - 566.42 mm) from the butt end. The impact of the foreign object deformed the aft 4 inches of the tail rotor blade trailing edge at station 25. This deformation created an out-of-track condition of the tail rotor blade that may have resulted in the separation of the 90° gearbox and blades from the aircraft.

The separated portion of one tail rotor blade was found 21 feet away from the tail rotor gearbox to which the blade hub with the mating fracture surface was still attached. A matching semicircular indentation existed on the trailing edges of both portions of the fractured tail rotor blade. The matching indentations are conclusive evidence that the blade was struck by an object before the blade fractured, and that the fracture may have been precipitated by the damage inflicted by the object or by vibrational forces caused by the resulting imbalance in the tail rotor system.

The large piece of skin from the other tail rotor blade was found behind the No. 7 hut on the south side of the river. Tests showed that the skin had separated at the bonding surface (delamination) because of exposure to excessively high temperatures. Since the only source of high temperatures was the special effects explosions, the Safety Board concludes that the delamination resulted from the blade's exposure to the heat of the fifth special effects explosion which engulfed the tail rotor assembly. The delamination and high speed rotation of the blade would have caused the skin to flap as it separated from the blade structure. The consequent disruption of the blade's aerodynamic shape and the creation of a dynamic imbalance due to the loss of the skin could have resulted in forces sufficient to fracture the tail rotor gearbox flange and could have caused the tail rotor assembly to separate.

The Safety Board cannot identify with any degree of certainty the specific object which struck the tail rotor blade and caused the semicircular indentation at the point of fracture. The deformation of the fracture in the outboard portion of the blade

tends to indicate that the blade was struck from the right side and from the trailing edge. However, the Safety Board believes that any of the objects propelled upward by the special effects explosions would not have had sufficient mass and speed to inflict the evident damage if they had struck the **blade** from behind in its direction of rotation. It is more likely that an object traveling essentially perpendicular to the tail rotor blade's plane of rotation **and** striking the blade just forward of its trailing edge would have produced the necessary force to deform the blade. Under such conditions, the impulse force related to such an impact would have been very high because of the rotational speed of the blade. In these circumstances, the damage could have been inflicted **by** an object of relatively low mass. Furthermore, such an impact would have been consistent with the pressure differential across the blade (deflected to produce a left turn) and the movement of debris through the blade's rotational plane. The peculiar deformation of the fracture surface of the outboard portion of the blade could **be** explained by the twisting of the blade **by** the aerodynamic and dynamic forces which caused its fracture and **by** the impact of the blade against the drive shaft cover of the vertical pylon.
