NATIONAL TRANSPORTATION SAFETY BOARD

AIRCRAFT ACCIDENT REPORT

**US AIR, INC., FLIGHT 183
McDONNELL DOUGLAS DC9-31, N964VJ
DETROIT METROPOLITAN AIRPORT
DETROIT, MICHIGAN
JUNE 13, 1984**

NTSB/AAR-85/01

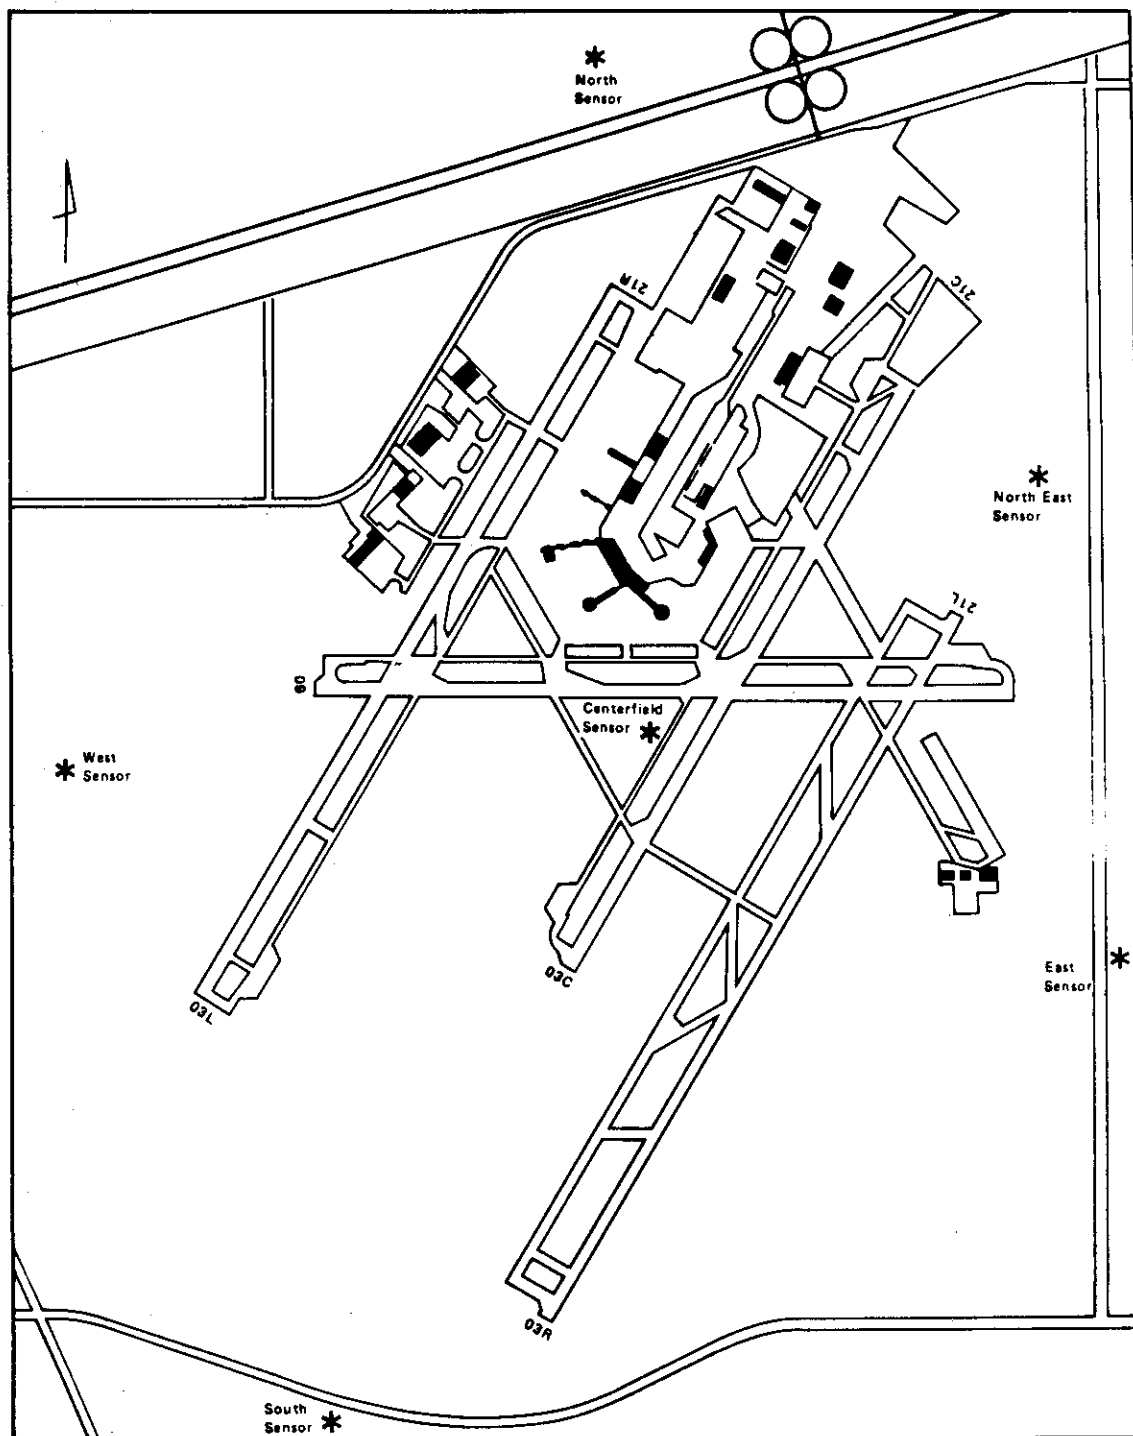
Figure 1.-- Airport diagram/low level wind shear alert system.

The landing area consists of four runways: 3L/21R, 3C/21C, 3R/21L, and 9/27. (See figure 1.) Runway 21R is 10,500 feet long and 200 feet wide, with a grooved concrete surface. Runway 21R has high-intensity runway edge lights, runway centerline lights, and a high-intensity approach light system with sequenced flashing lights.

Runway 3R/21L and 3L/21R each have three transmissometers located along the sides of the runway at each end and in the middle to provide RVR information to the tower. RVR information from the transmissometers was not recorded except from the transmissometer on the approach end of Runway 3R. The NWS receives RVR information from a separate transmissometer located on the approach end of runway 3R.

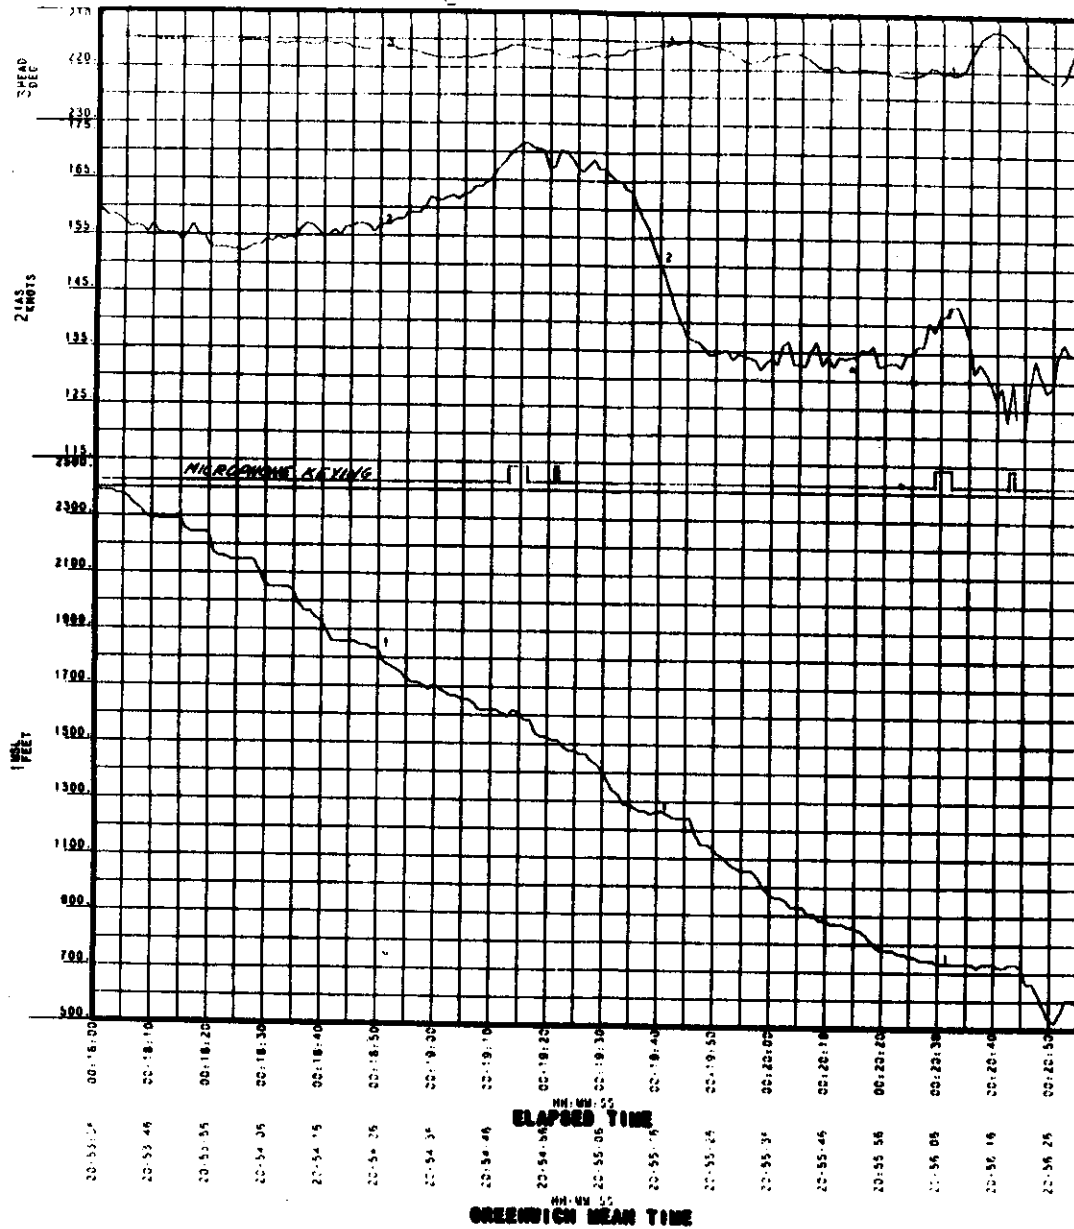
APPENDIX E READOUT OF FLIGHT DATA RECORDER

The flight recorder was undamaged and in working order. The data recovered from the recorder indicated that it operated normally during the flight of Flight 183, and that it stopped at 1656:31. However, the vertical acceleration values were invalid since the vertical acceleration sensor had failed before the start of Flight 183. (As a result of the accident investigation, USAir revised the DFDR test procedure for the accelerometer on August 2, 1984. The accelerometer is now checked at values of 1 "g", 0 "g", and -1 "g".)
