NATIONAL TRANSPORTATION SAFETY BOARD

AIRCRAFT ACCIDENT REPORT

**SOUTHERN AIR TRANSPORT
LOGAIR FLIGHT 51, LOCKHEED L-382G
KELLY AIR FORCE BASE, TEXAS
OCTOBER 4, 1986**

NTSB/AAR-87/04

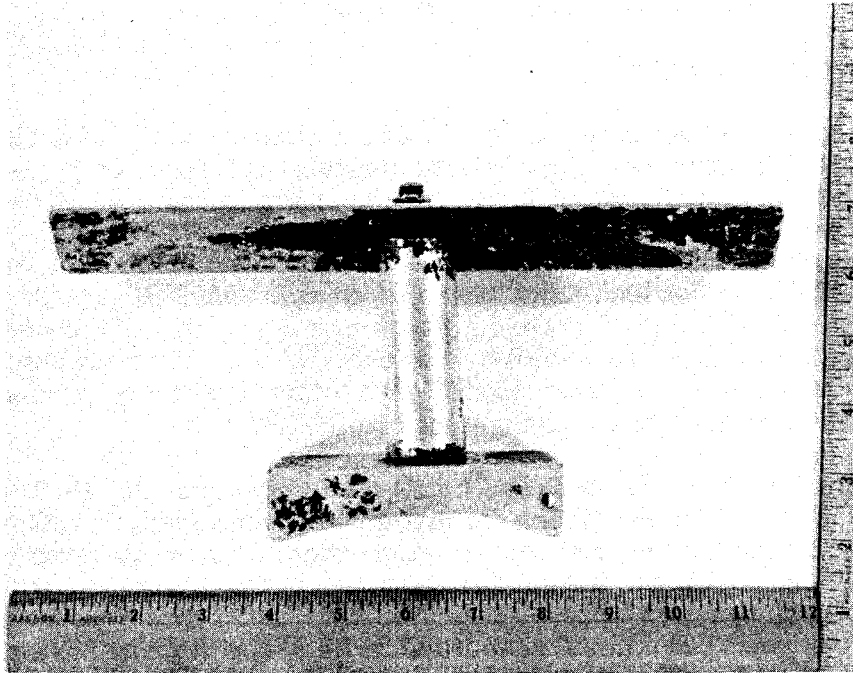
Figure 1.-TIA-type elevator control block.

installed was painted red, was intact and structurally sound with no visible defects, and was not bearing a “remove before flight” warning banner. The purpose of the banner would have been to attract attention to the elevator control block and to assure its removal.

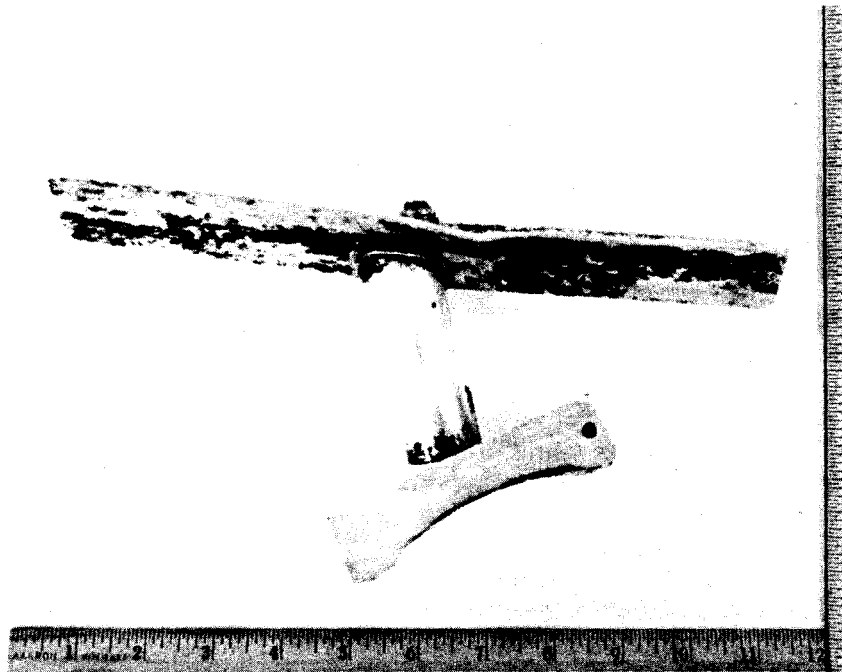
An elevator control block found in the wreckage of **N15ST** was identical to the TIA-type block which reportedly had been removed from N46965, another L-382, and placed in **N15ST** by a SAT flightcrew member on September 14, 1986, when **N15ST** was in San Francisco being prepared for operations in the **LOGAIR** system. (See figure 2.) N46965 was removed from the **LOGAIR** system at that time. Subsequently, **N15ST** was delivered to McClellan AFB to begin operations in **SAT's** fleet. The airplane from which the control block had been removed was operated by SAT under a long term lease agreement with South Africa Freight Air.

Figure 2.-Elevator control block found in wreckage of **N15ST**.

A damaged elevator control block matching the description of the one installed by the first officer of the previous flight was found in the wreckage in the vicinity of the cockpit. The aluminum tube showed evidence of compressive overstress resulting in a tear in the area adjacent to the V-shaped channel. Additionally, the control column and a **metal** shroud (see figure 5) used to cover the rudder controls, located between the rudder pedals just forward of the first officer's control column, were recovered. The aft face of the metal shroud had a lateral puncture and scratch marks which conformed to the flange width of the 4-inch U-shaped channel of the damaged elevator control block. (See figure 6.) There were no marks or gouges found on the control column which could be associated with the elevator control block.

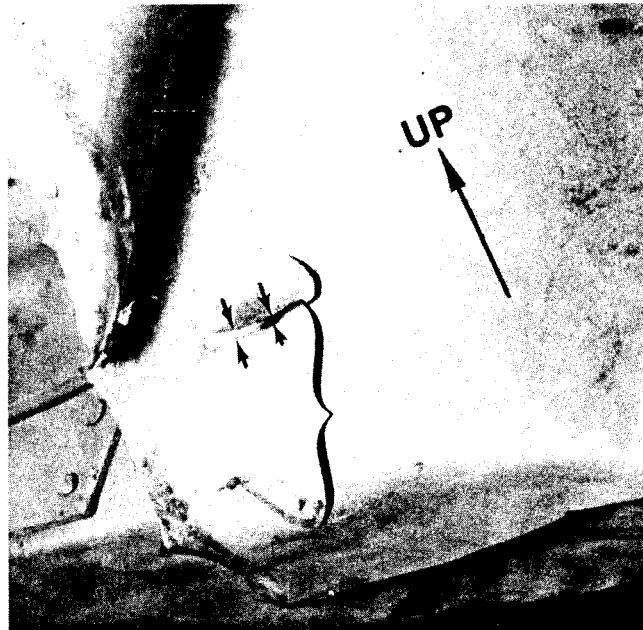
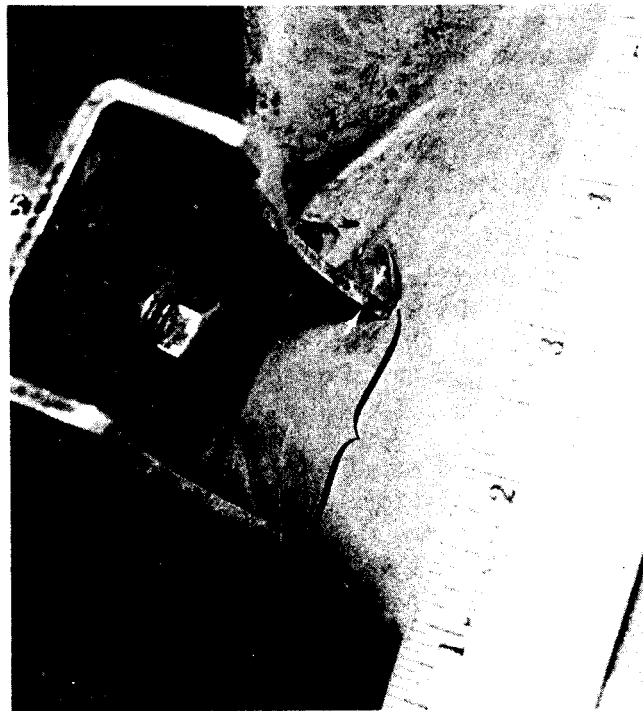
Figure 6.-Mating of witness marks and elevator control block.

The aluminum box structure which formed a metal shroud between the first officer's rudder pedals was heavily deformed by crash impact forces. A puncture and scrape mark on the left side of the aft face of the shroud were found about 1 to 2 inches above the floor line. The distance between these marks matched the distance between the legs of the U-shaped channel of the elevator control block. (See figure 6.)

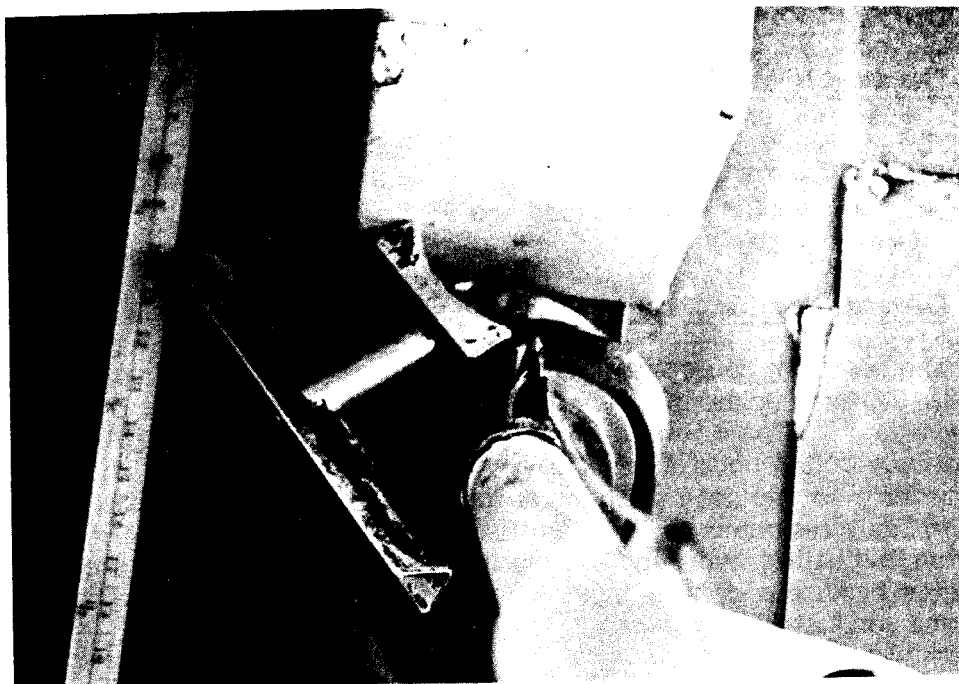
Figure 7.-Two views of probable position in which elevator control block jammed.

Lockheed C-130s were examined both at Kelly AFB during the on-scene investigation and at Andrews AFB on November 26, 1986. Numerous attempts were made to lodge an identical elevator control block between the control column and the metal shroud. When the device was positioned so that the interconnecting tube was oriented forward and aft, the control column had to be pulled to its **aftmost** position in order to jam the control block. Any forward control column movement caused the device to slip easily out of the wedged position. In order to replicate the positioning of the elevator control block, as indicated by the evidence of the components submitted for examination, the intact control block was placed with the 4-inch U-shaped leg resting between the shroud and the rubber boot around the control column and with the 10-inch V-shaped leg free from impingement upon either the shroud or the control column. (See figure 7.) When the control column was moved forward the soft sheet metal shroud was deflected forward by the U-shaped leg and the control block did not slip from the wedged position. Any further forward movement of the control column would have caused the U-shaped leg to penetrate the sheet metal shroud in the approximate location of the penetration in the accident airplane. With the control block jammed in this manner (see figure 8), the elevator of the C-130 was positioned in a trailing edge up position. (See figure 9.)

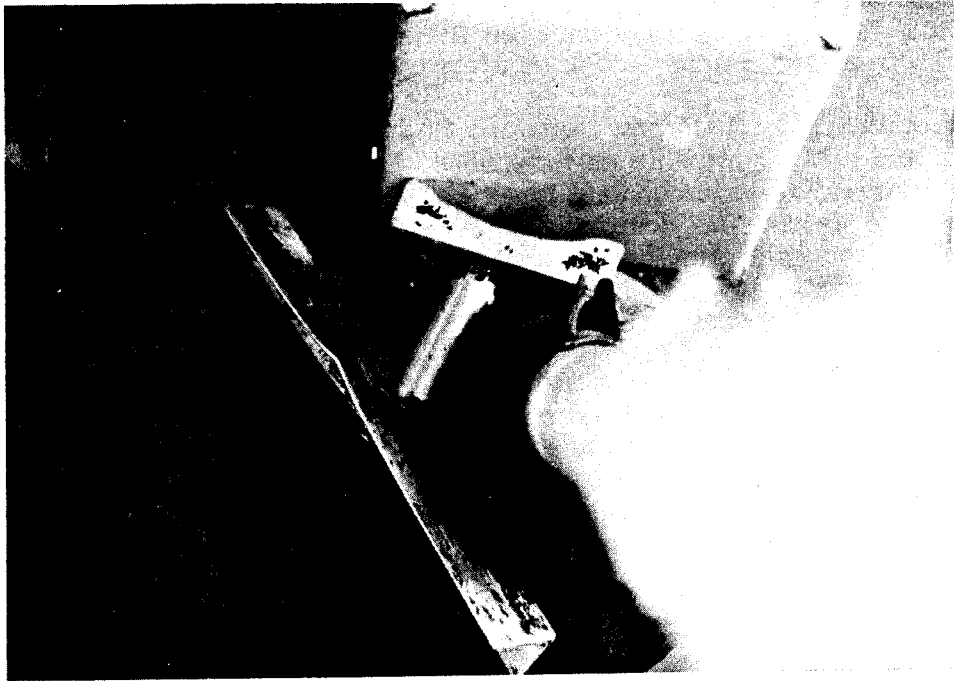
Figure 8.—Damaged control block in jammed position.

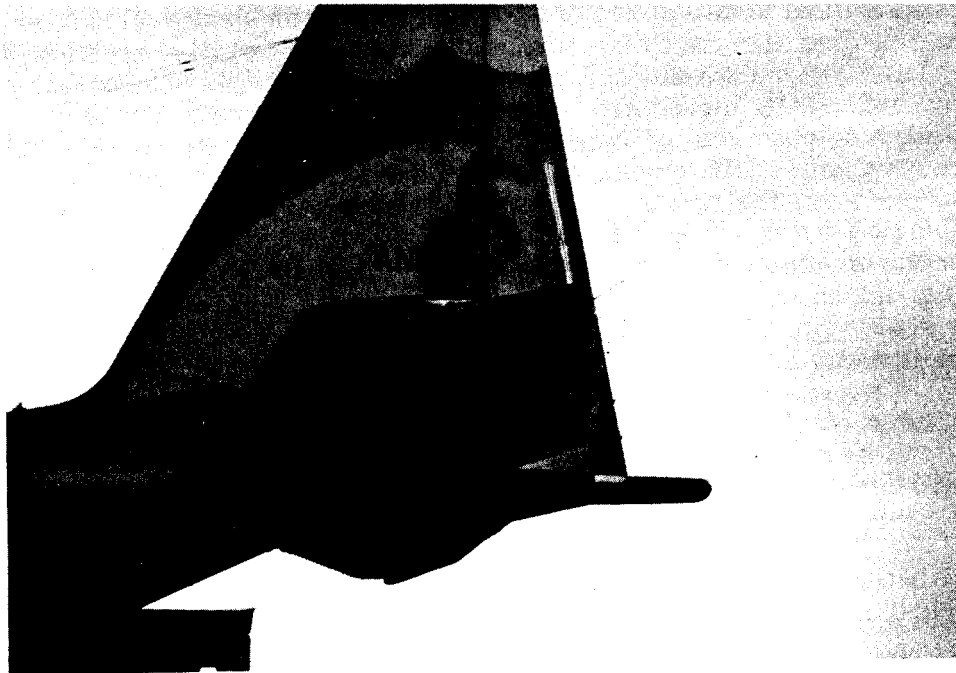
Figure 9.-Elevator position with control block jammed.
