# **NATIONAL TRANSPORTATION SAFETY BOARD**

## **AIRCRAFT ACCIDENT REPORT**

**MIDAIR COLLISION OF  
NABISCO BRANDS, INC.,  
DASSAULT FALCON, DA50, N784B AND  
AIR PEGASUS CORPORATION  
PIPER ARCHER, PA28-181, N1977H  
FAIRVIEW, NEW JERSEY  
NOVEMBER 10, 1985**

NTSB/AAR-87/05

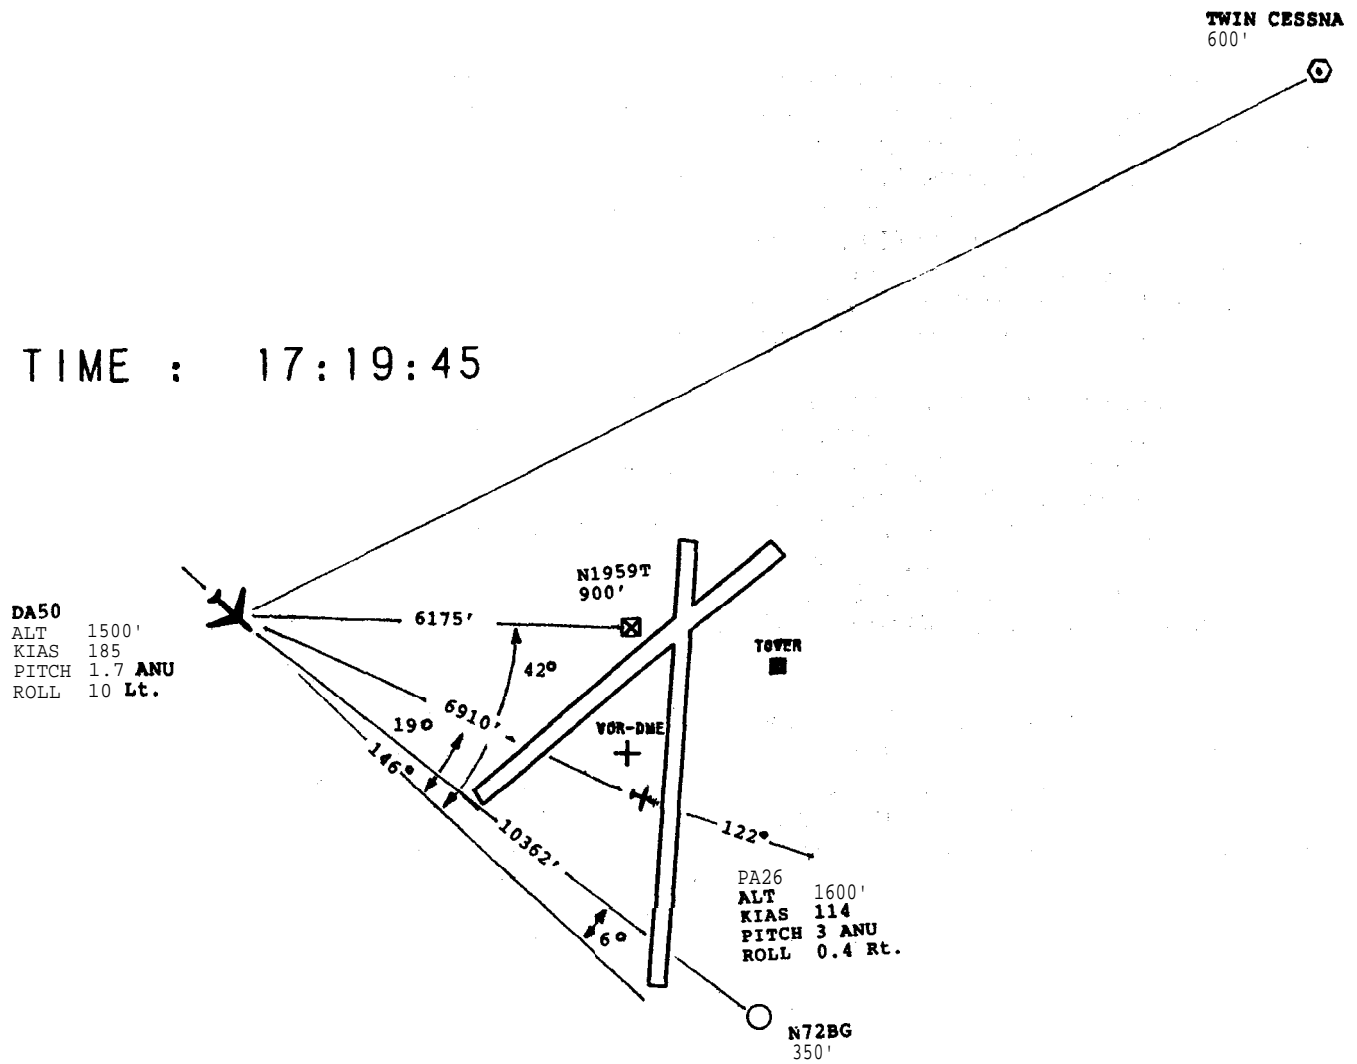
Figure P.-Radar positions of aircraft at 1719:45.

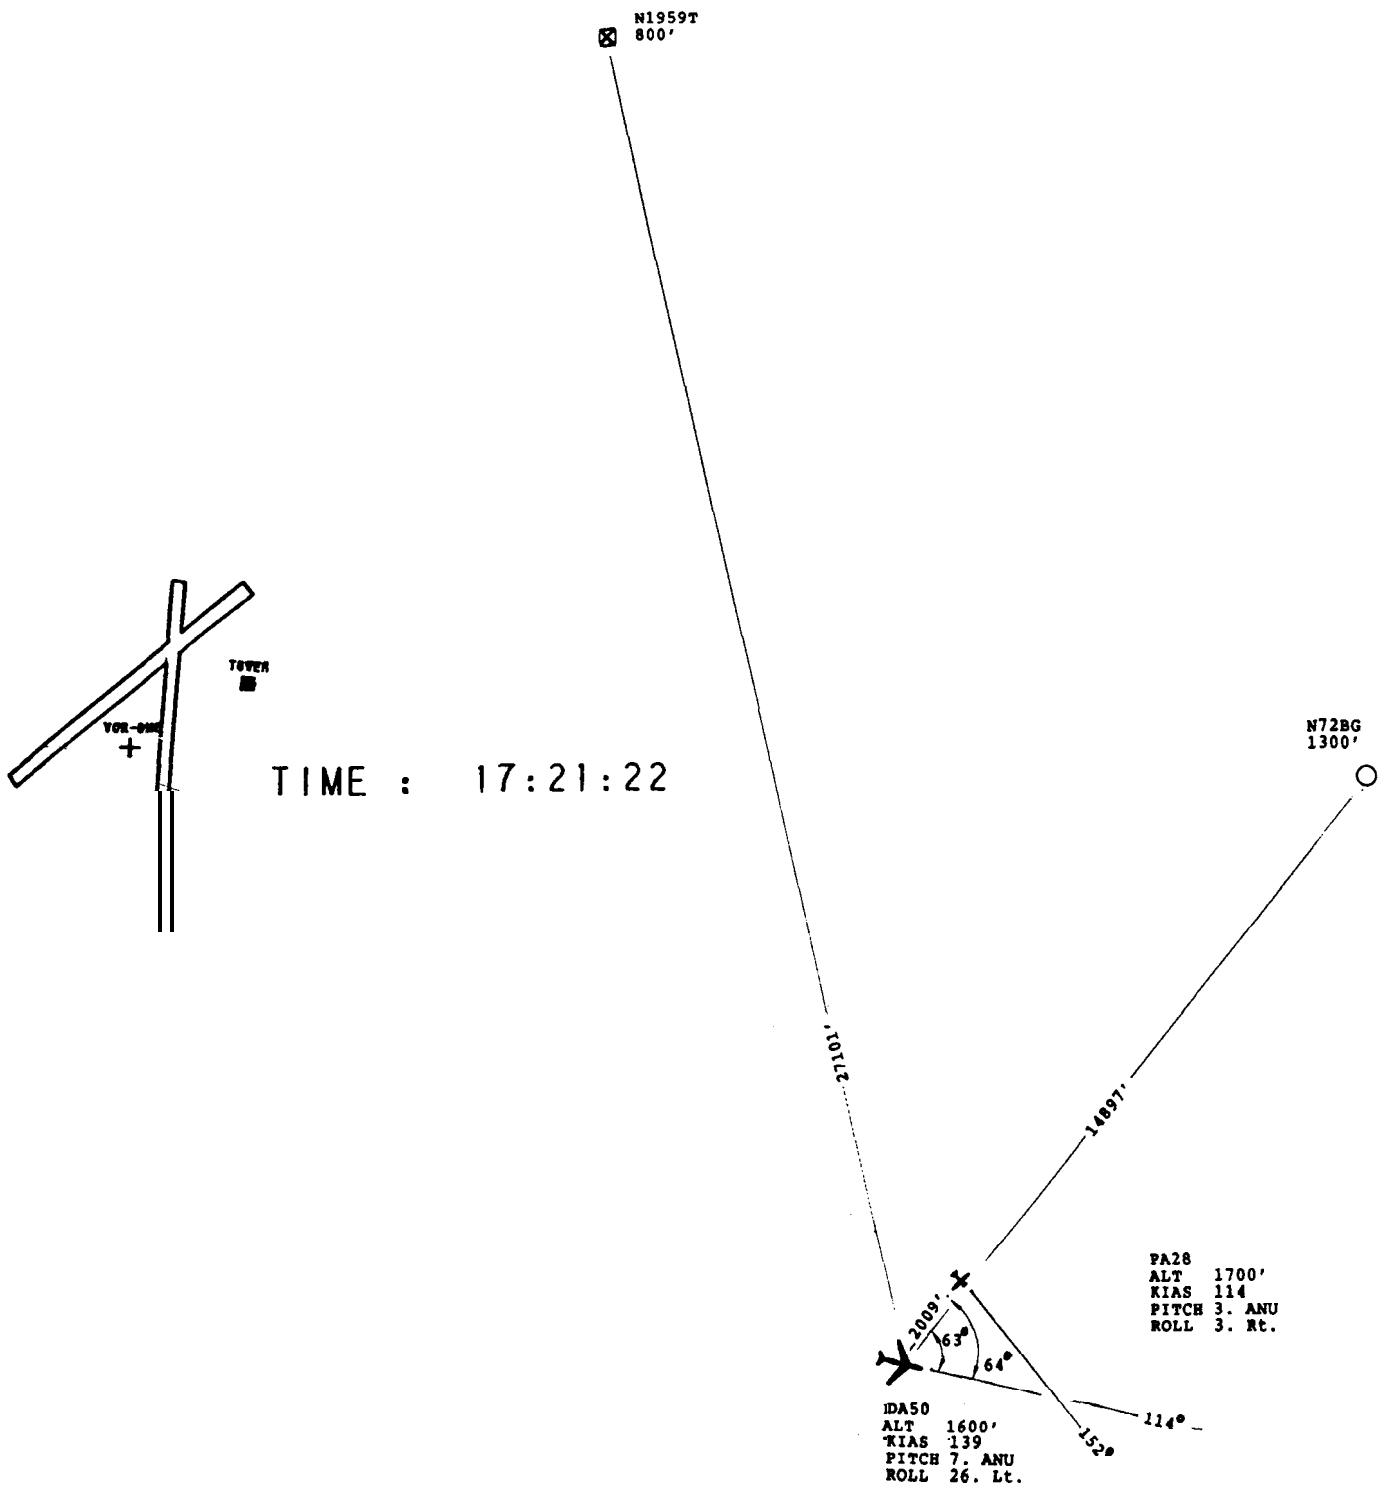
Figure 8.-Radar positions of aircraft 1721:22.

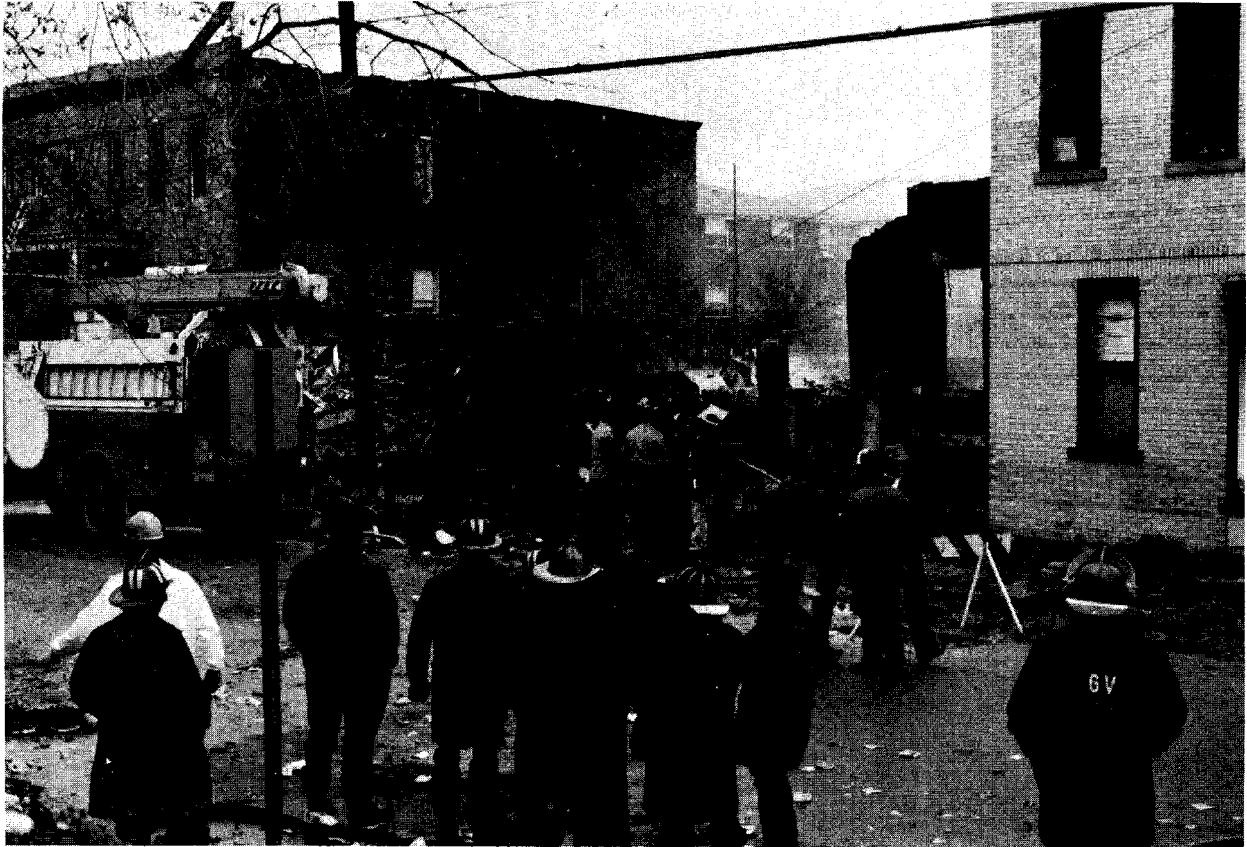
The main wreckage of the DA50 came to rest at 228, 230, and 232 Cliff Street in Cliffside Park. (See figure 11.) These three residences and the airplane were destroyed by the severity of the impact forces and subsequent fire. Two adjacent buildings and several automobiles were heavily damaged by fire and flying debris. One resident was killed at 228 Cliff Street and two bystanders were seriously injured. The left wing of the DA50 struck a light pole, landed at the intersection of Anderson Avenue and Kamena Street, and partially burned.

Figure 11.—The main wreckage site of the DA50 on Cliff Street, Cliffside Park, New Jersey.

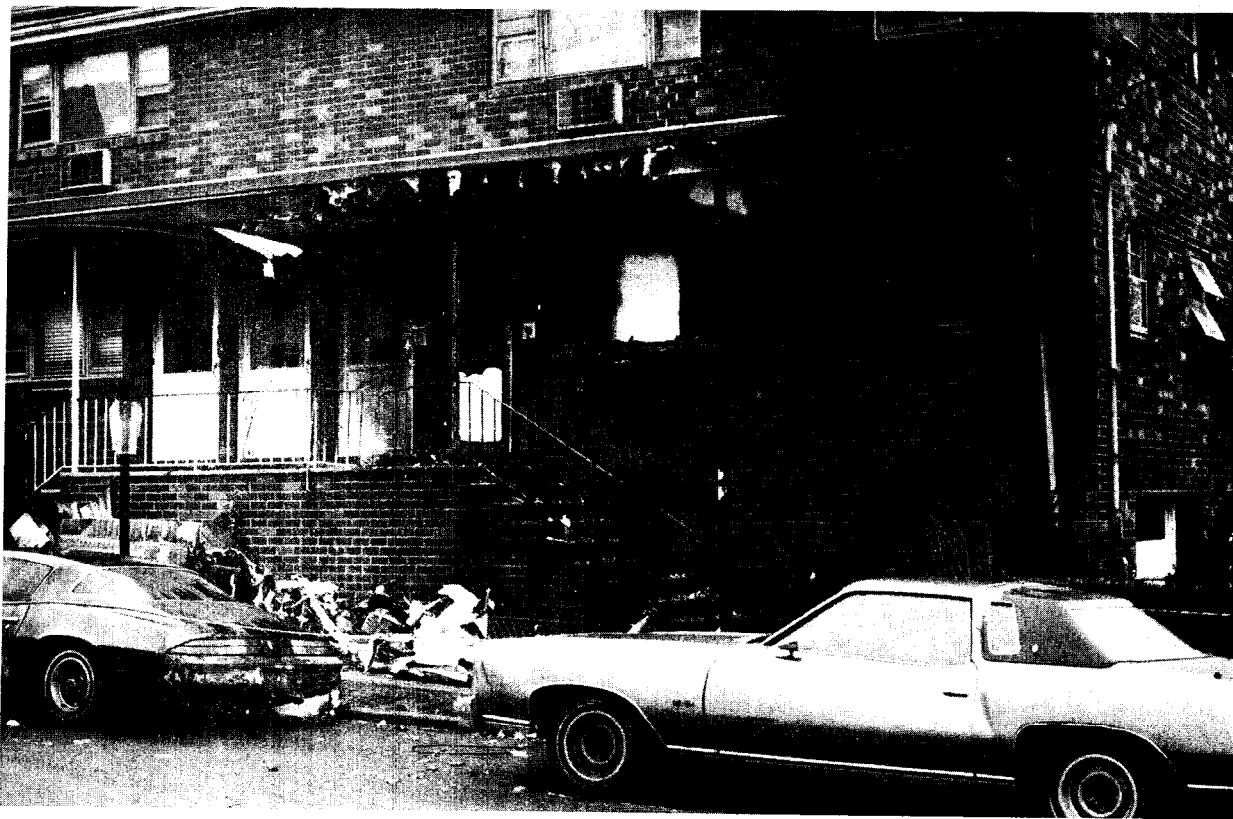
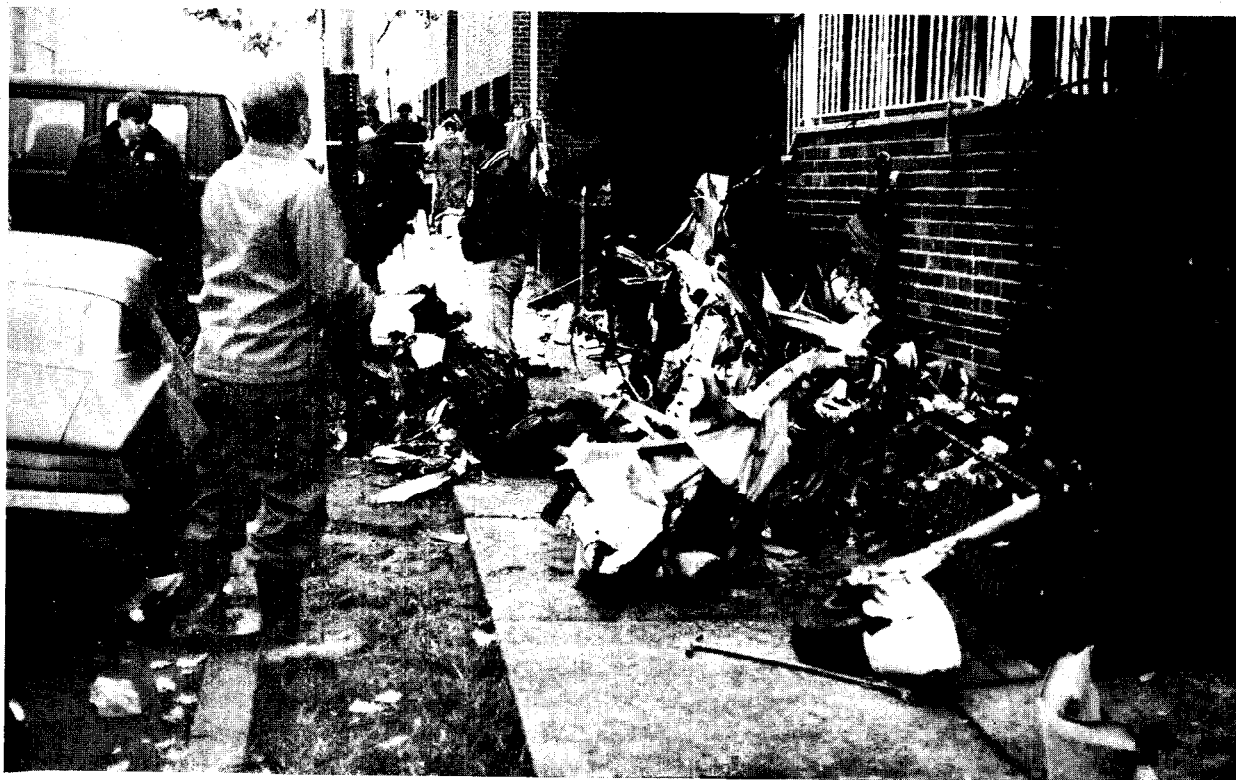
The main wreckage of the PA28 came to rest on the sidewalk in front of an apartment on Kamena Street in Fairview. It hit the ground from a near vertical descent. There was some impact damage and substantial fire damage to a porch and a nearby parked automobile. (See figure 12.) The engine with the propeller and spinner attached penetrated the roof of a cabana in a near vertical angle in the backyard of a residence on Third Street. No one was killed or injured from the wreckage of the PA28.

Figure 12.-The main wreckage site of the PA-28  
on Kamena Street, Fairview, New Jersey.

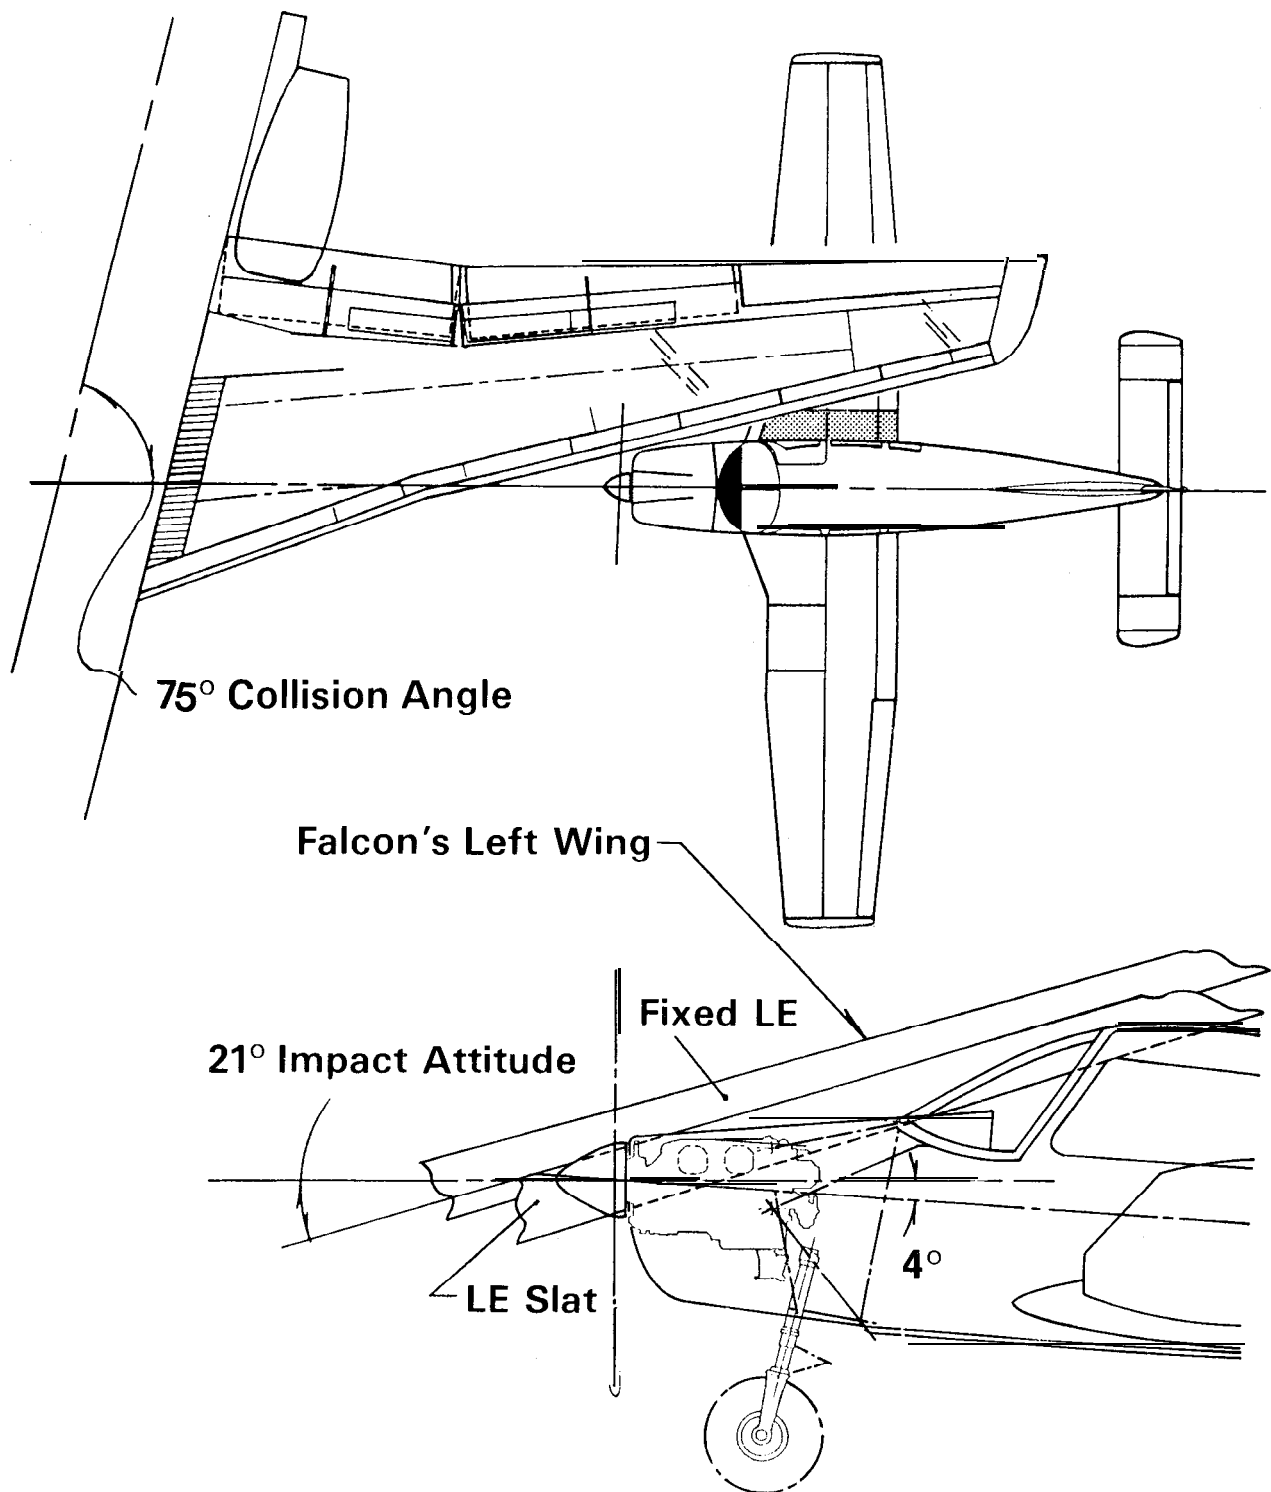
Damage to the right side cylinder rocker box covers of the engine in the PA28 was matched to the damage on the outboard left wing slat of the DA50. The propeller from the **PA28's** engine slashed through the **DA50's** left wing inboard of rib 12 at about a **75° angle**. Black paint from the blade face (back of the blade) was found on the slat skin. The propeller cut through the front wing spar and one propeller blade separated 8 inches from the tip. The other blade struck but did not penetrate the upper center wing panel. Damage to the cabin door on the right side of the PA28 matched the outboard indentation in the left wing slat. The distance between the two separate slat indentations coincided with the distance between the **PA28's** engine and the top cabin door latch. Scratch marks on the lower surface wing panels and outboard flap of the DA50 indicated that the PA28 traveled under the **DA50's** left wing tearing off the outboard section of the outboard flap and destroying the top of the cabin of the PA28.

Since the radar data showed that the PA28 was in straight and level flight moments before the collision, it was estimated that it would have been in a **4°-noseup**, wings level attitude. Based on the physical damage, the DA50 was in about a **21°-right** bank relative to the PA28. The collision angle between the two aircraft, as indicated by the initial propeller slash mark, was about **75°**. (See figure 16.)

Figure 16.—Collision angle and relative impact attitude.

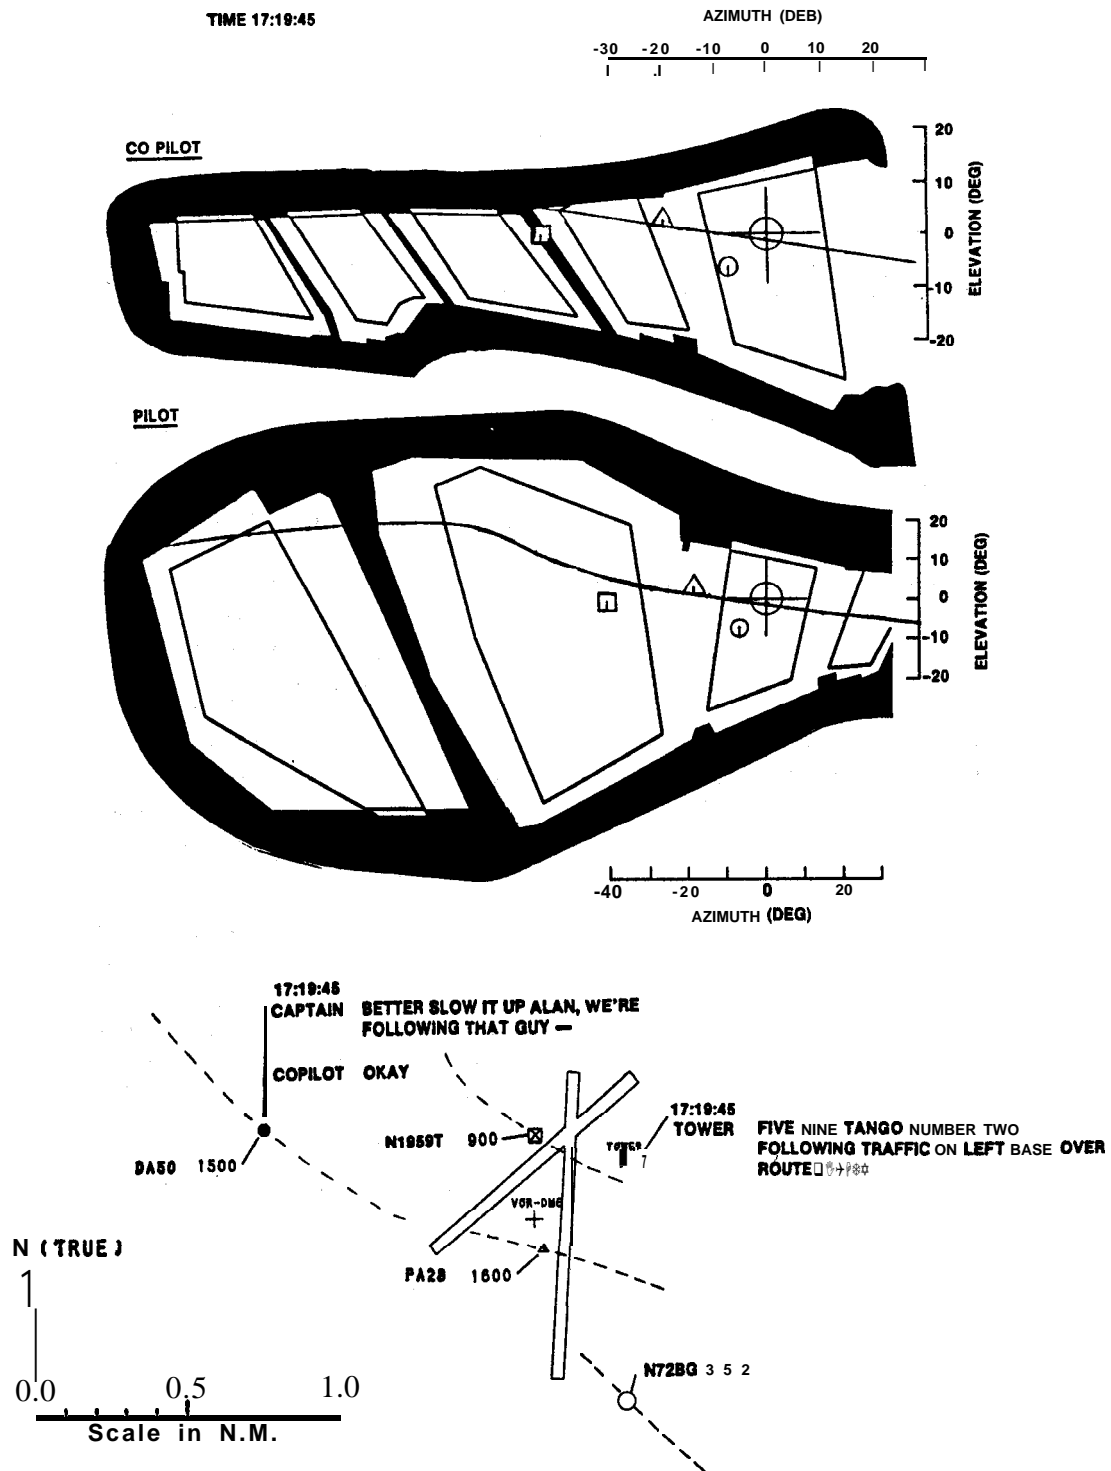
Based on the radar data and cockpit visibility study at 1719:45, when the DA50 was about a mile west of the airport, the Twin Bonanza, **N1959T**, and the PA28 were passing over the airport in front of and in the DA50 flightcrew's view. (See figure 17.) **N1959T** was about 40° to the left at 900 feet and the PA28 was about 20° to the left of the crew's DER at 1,600 feet on the horizon. The Beech Baron, **N72BG**, which had departed to the east after takeoff from runway 19, was located slightly to the left of the crew's DER, and to the right of the PA28 and slightly below the horizon at 350 feet. At 1720:05, when the local controller told the DA50 flightcrew that they were to plan to be number three and there was additional traffic at the one o'clock position westbound at 1,500 feet, **N1959T** was about 20° to the left of the crew's DER, the PA28 was directly ahead at the 12 o'clock position, and **N72BG** was 1.5 miles ahead at 873 feet, 25° to 30° to the right of the DA50 crew's DER or in about a 1 to 2 o'clock position. (See figure 18.)

Figure 17.-Composite radar positions and cockpit visibility plot of aircraft at 1719:45.

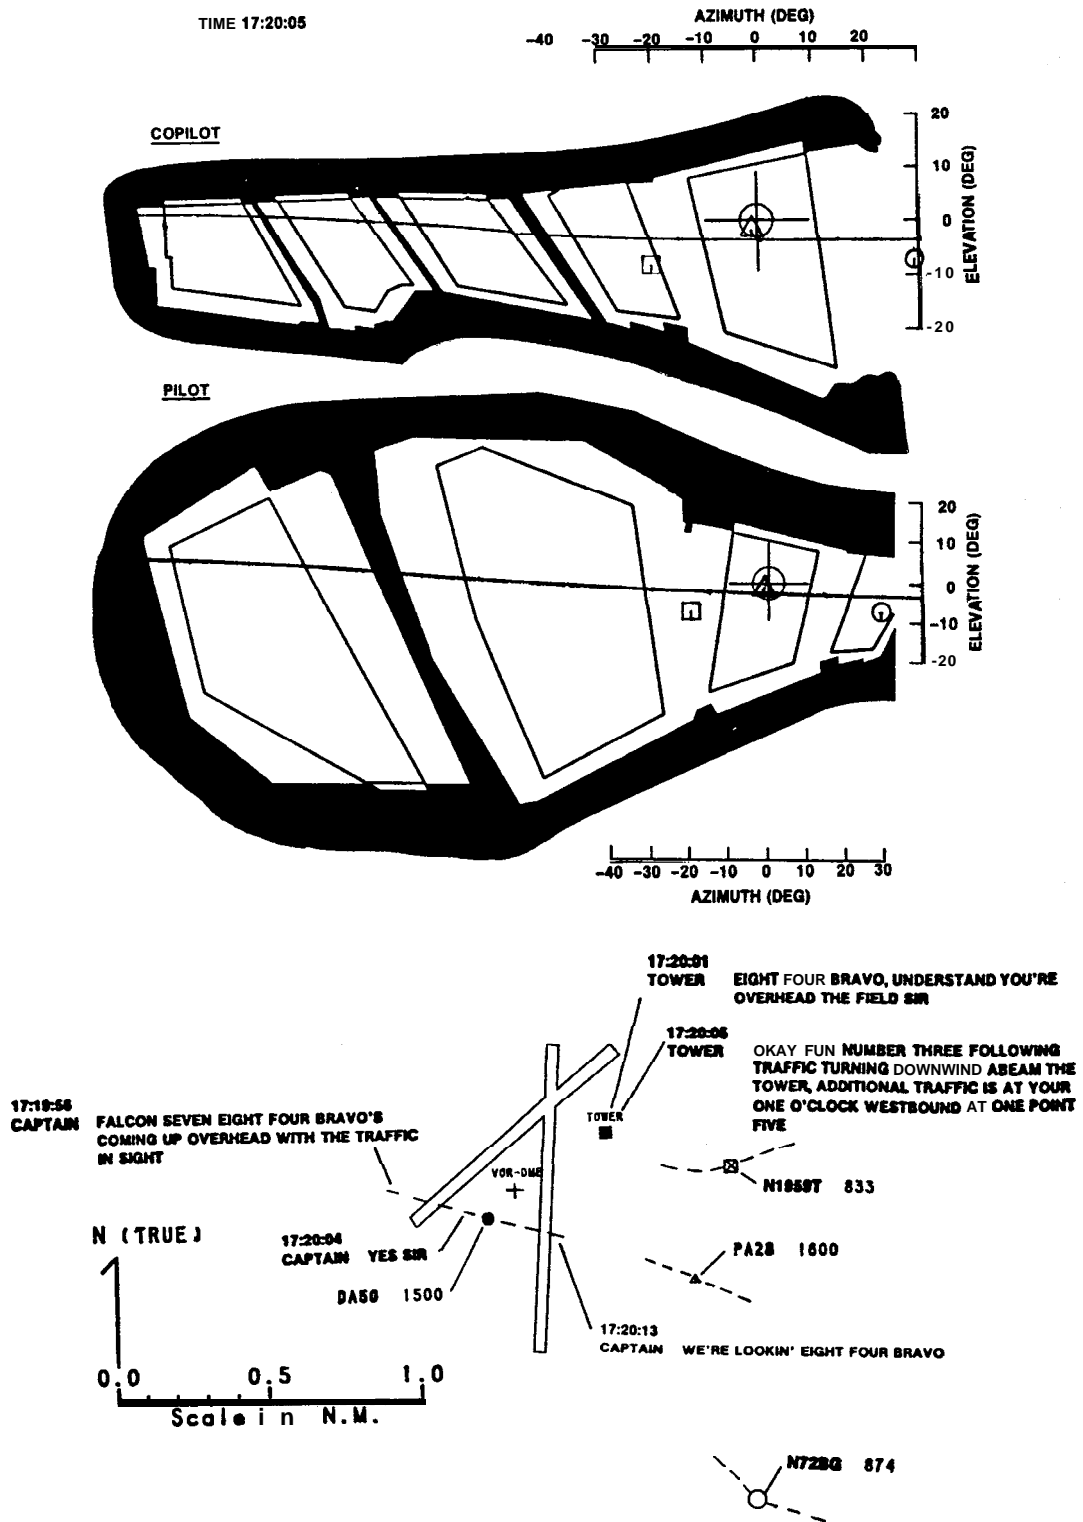
Figure 18.-Composite radar positions and cockpit visibility plot of aircraft at 1720:05.
