# **NATIONAL TRANSPORTATION SAFETY BOARD**

## **AIRCRAFT ACCIDENT REPORT**

**PIPER PA-23-150, N2185P  
AND PAN AMERICAN WORLD AIRWAYS  
BOEING 727-235, N4743  
TAMPA, FLORIDA  
NOVEMBER 6, 1986**

**NTSB/AAR-87/06**

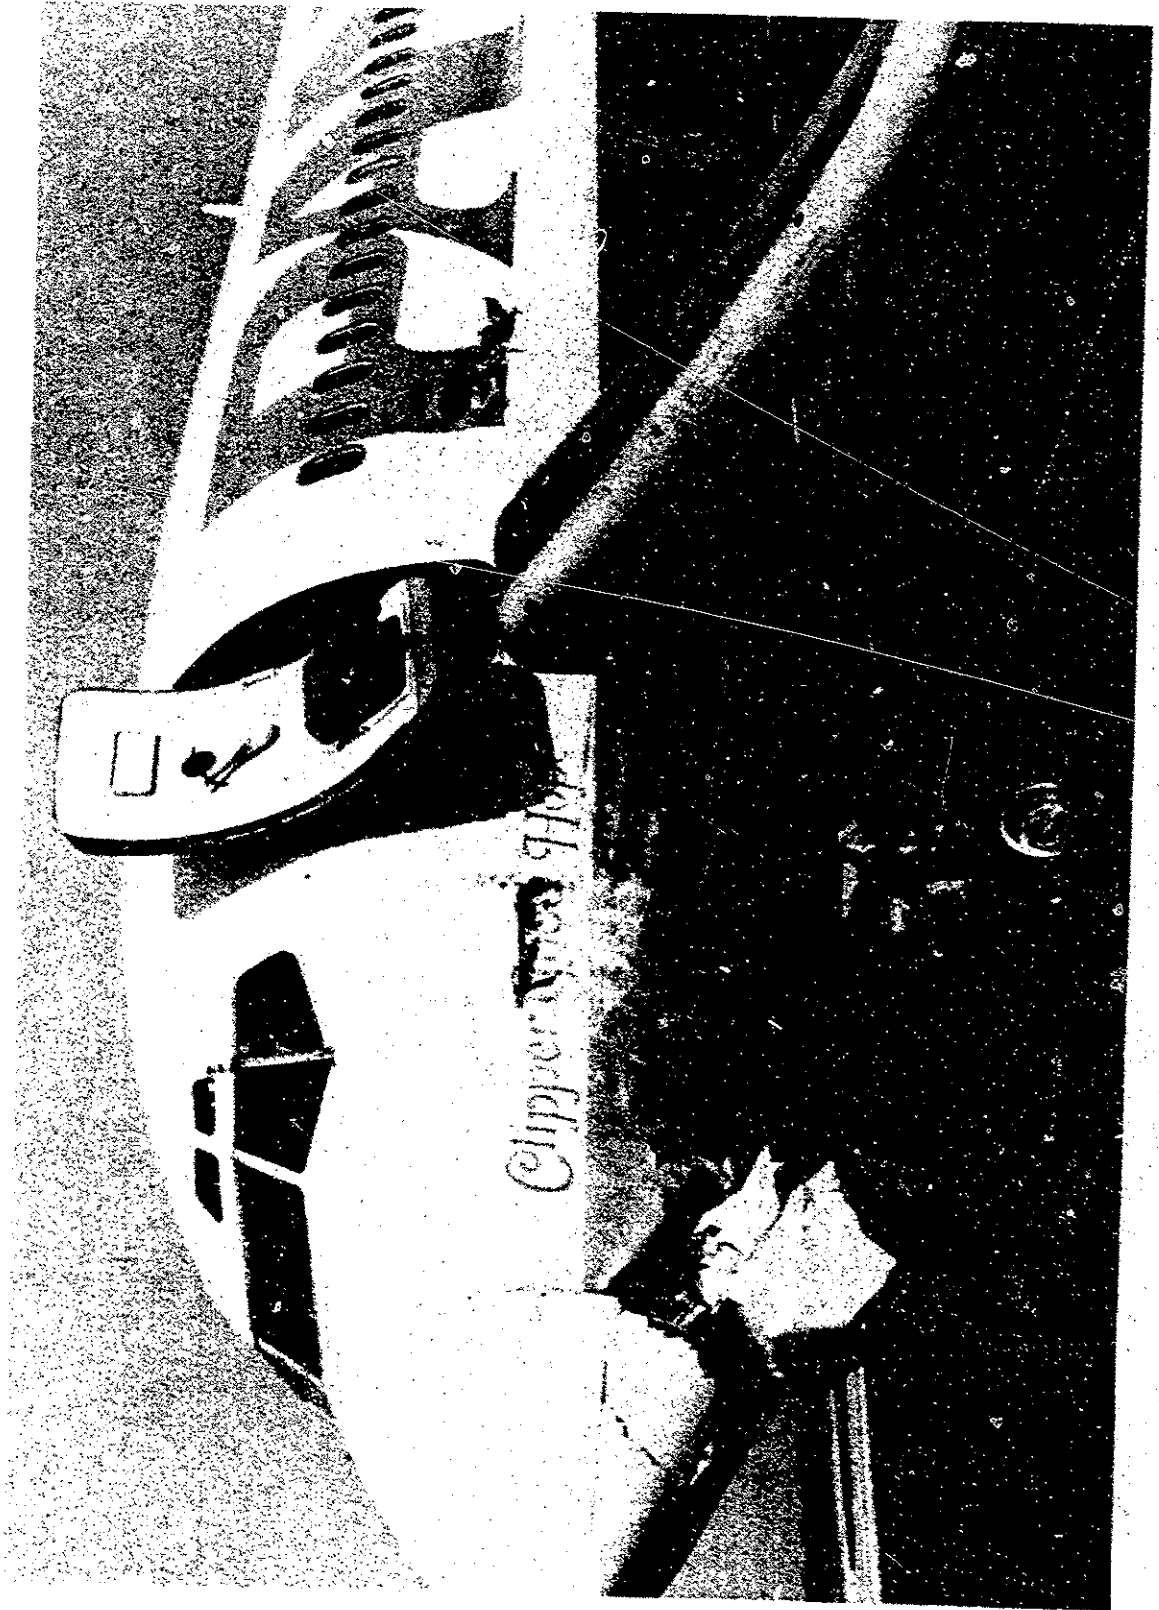
Figure 3.--N4743, a Boeing 727.

The Boeing 727, N4743, sustained substantial damage in the area of the radome and forward electronic compartment. The left side fuselage skin was scratched, dented, and torn. Fire damage was confined to the surface of the left lower wing and adjacent fuselage area.

The left engine and propeller of the Apache separated at impact and remained imbedded in the B-727 in the radome area. The radome and radar antenna were destroyed. The forward half of the B-727 nose gear left wheel well door was torn away. The electrical cable for the left main landing gear anti-skid system was severed. The horizontal stabilizer control drum mechanism and all mechanical systems located in the forward electronic compartment were damaged by the impact. The left side of the B-727 fuselage sustained scratches; dents and tears, including a deep dent; and scratches on the lower surface of the left forward entry door. Heat and fire damage were evident on the underside of the left wing between the fuselage and the midwing area. The left fuselage area and air conditioning bay access panels also were damaged by heat and fire.

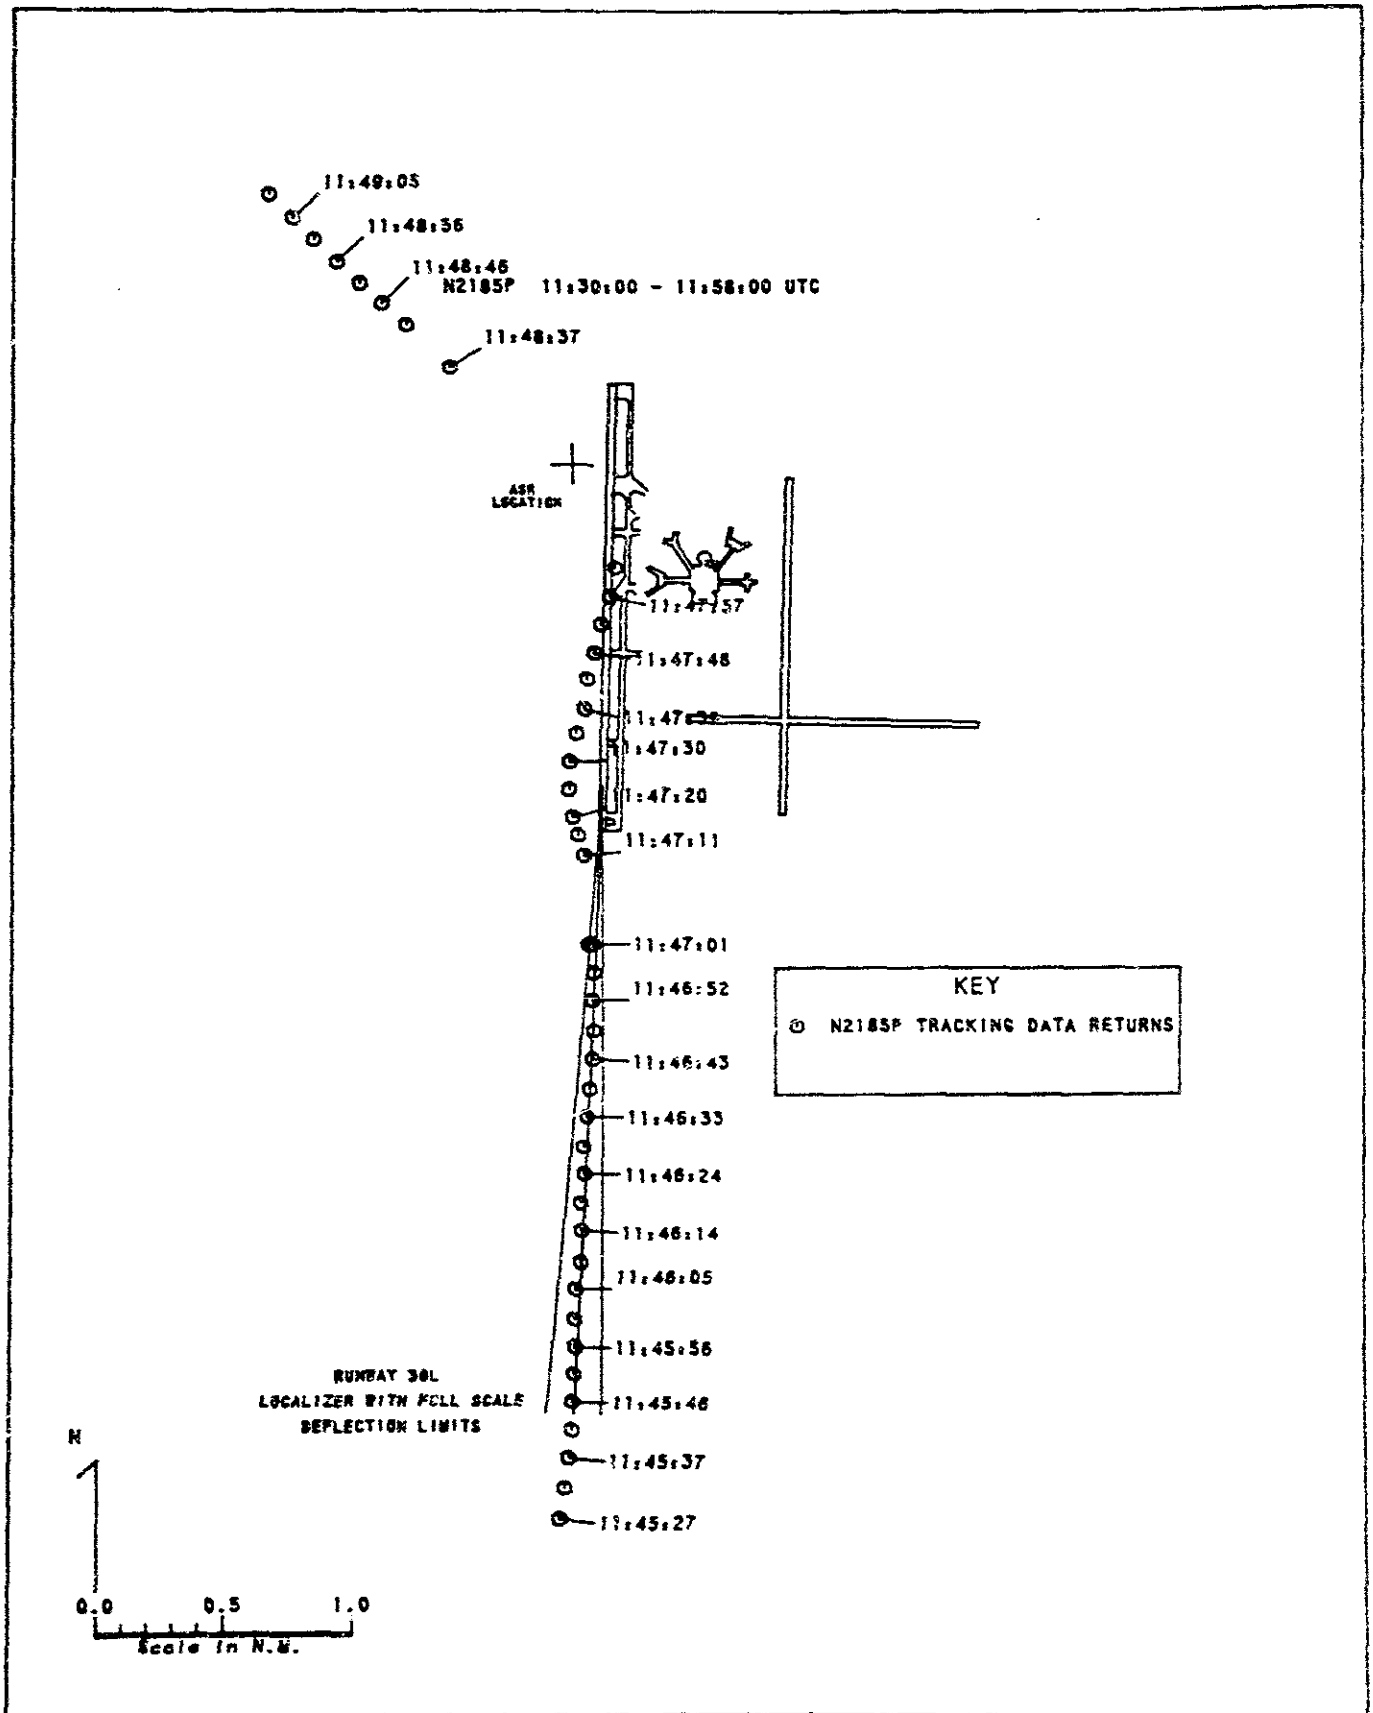
Figure 4.--First approach of the Piper Apache.

With the exception of the failure of the local controller to issue a landing clearance during the Apache's first approach, all air traffic control procedures were correctly observed. On the Apache's first approach, a change of local controllers resulted in the failure to issue a landing clearance. The failure occurred because the two controllers used different techniques for issuing landing clearances. The breakdown in coordination between the controllers did not contribute to the events that led to the accident, but it is of concern to the Safety Board. It illustrates the need for careful coordination whenever one controller turns over his responsibility to another controller.

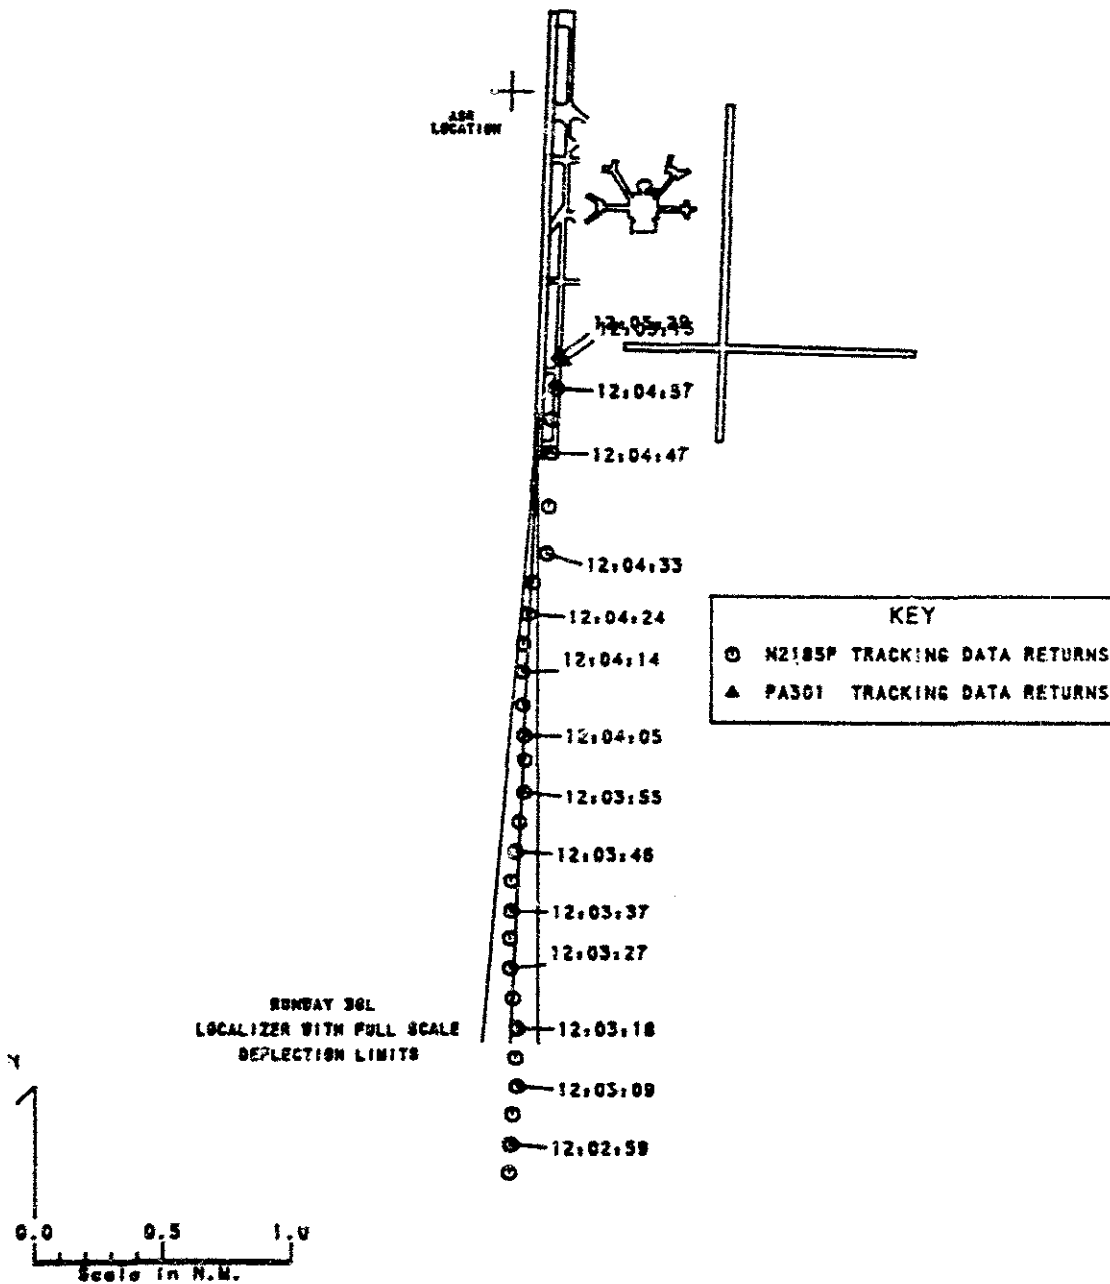
Figure 5.--Second approach of the Piper Apache.

The only information available concerning the Apache pilot's execution of the two ILS approaches is found in the radar data recorded by Tampa Approach Control. Although the airplane was equipped with a transponder, it did not have an altitude reporting capability or an encoding altimeter. Therefore, there is no data available to determine the altitudes flown during those approaches. The course data indicate that both approaches were flown with a high degree of precision. There was normal bracketing of the localizer centerline, but no significant deviations were evident. As the two approaches progressed toward the middle marker, located 0.5 nautical mile from the end of the runway, the slight deviations decreased. Just inside the middle marker, however, at a point where the airplane should have been arriving at DH, slight excursions from the localizer were noted. On the first approach, this deviation was to the left (west) of course, and on the second approach, the airplane moved to the right (east) and lined up with taxiway W. At this point, the pilot would probably have been looking for the visual

11. The failure of the local controller to issue a landing clearance during the Apache's first approach did not contribute to the accident.
12. The Apache pilot flew both approaches with precision until he passed the middle marker, after which slight deviations from the localizer occurred.
