## **AIRCRAFT ACCIDENT REPORT**

**NORTH STAR AVIATION, INC.  
PA-32 RT-300, N39614  
AND ALAMEDA AERO CLUB  
CESSNA 172, N75584  
OAKLAND, CALIFORNIA  
MARCH 31, 1987**

**NTSB / AAR-87/09**

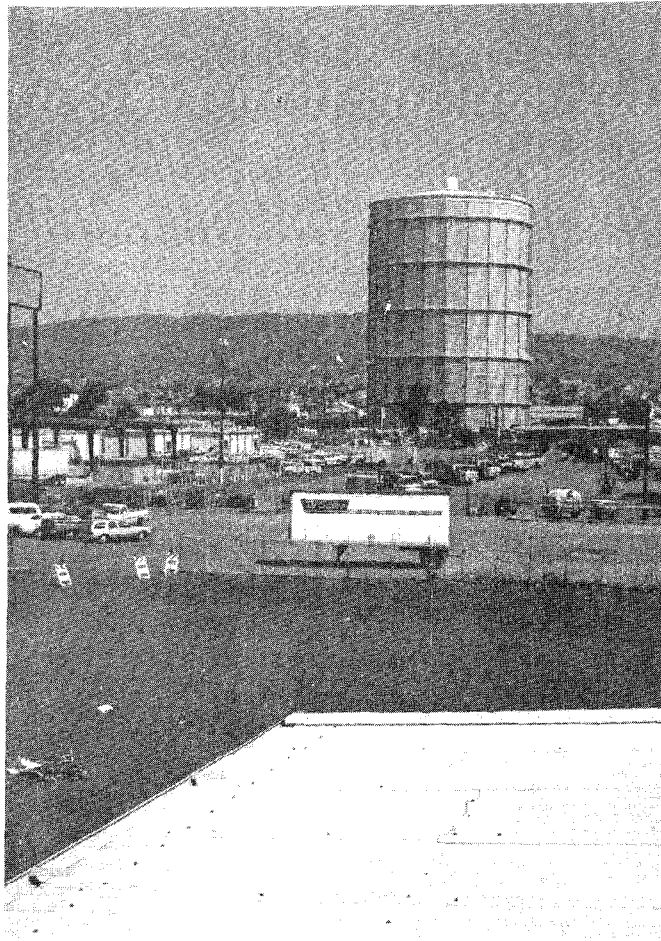
Figure 1. View of green tank from south of freeway.

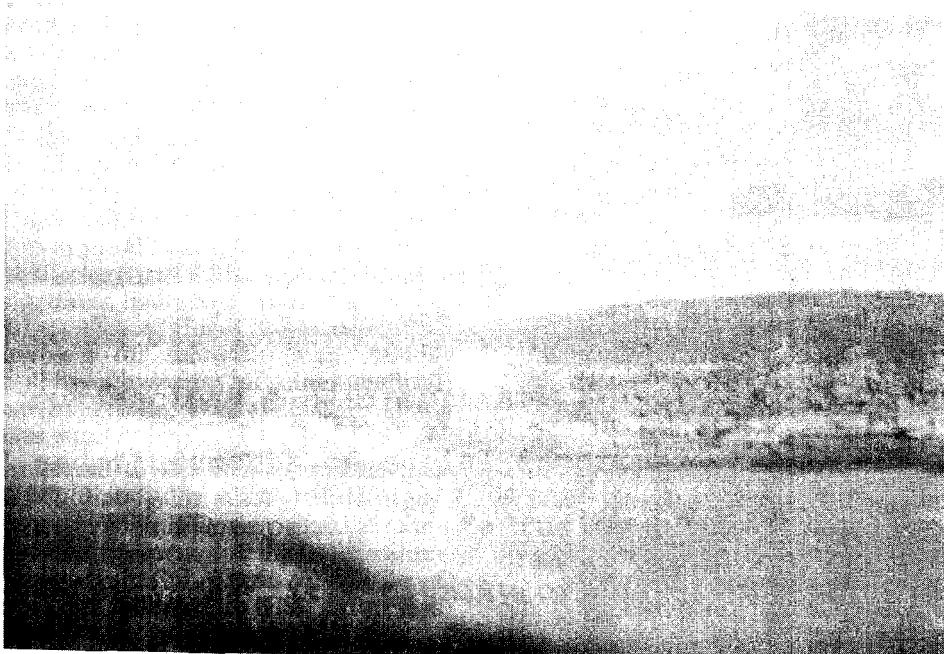
Figure 2. Green tank as seen on climbout from runway 33 of OAK.

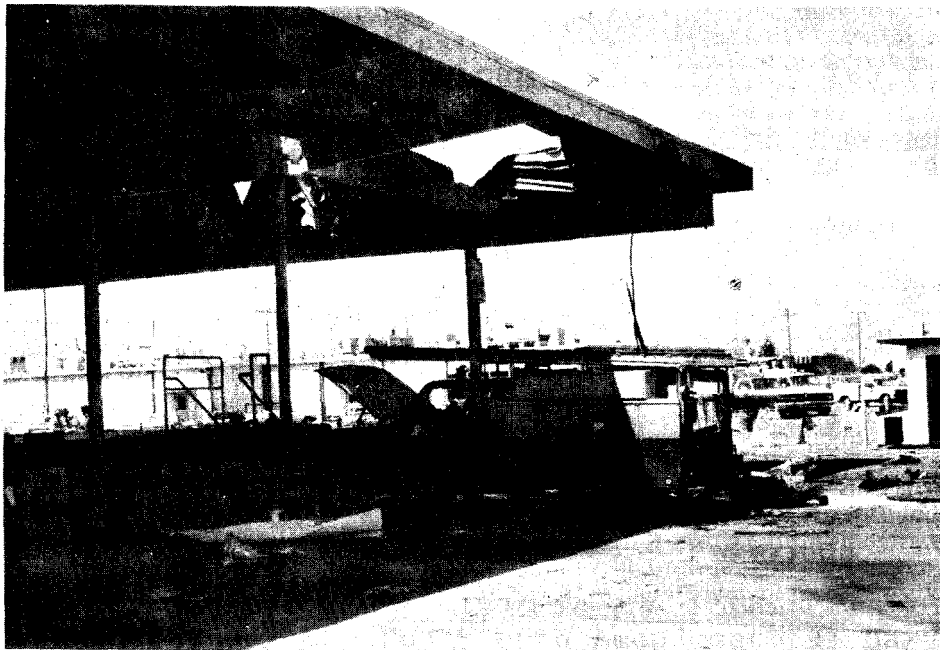
A warehouse on the PG & E facility was damaged by falling portions of the Cessna. Some of the Cessna wreckage fell through a roof overhanging the warehouse. A truck parked under the warehouse roof was destroyed by the impact and postimpact fire. (See figures 3 and 4.)

Figure 3.--View of roof and truck damage, facing west.

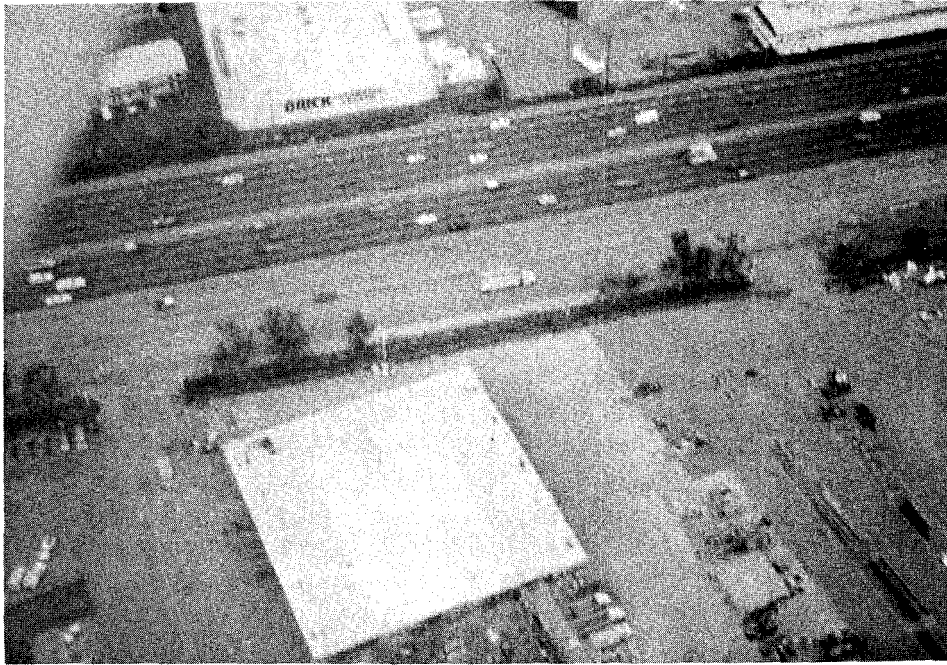
Figure 4.--View of roof damage, facing north, from about 600 feet above ground level.

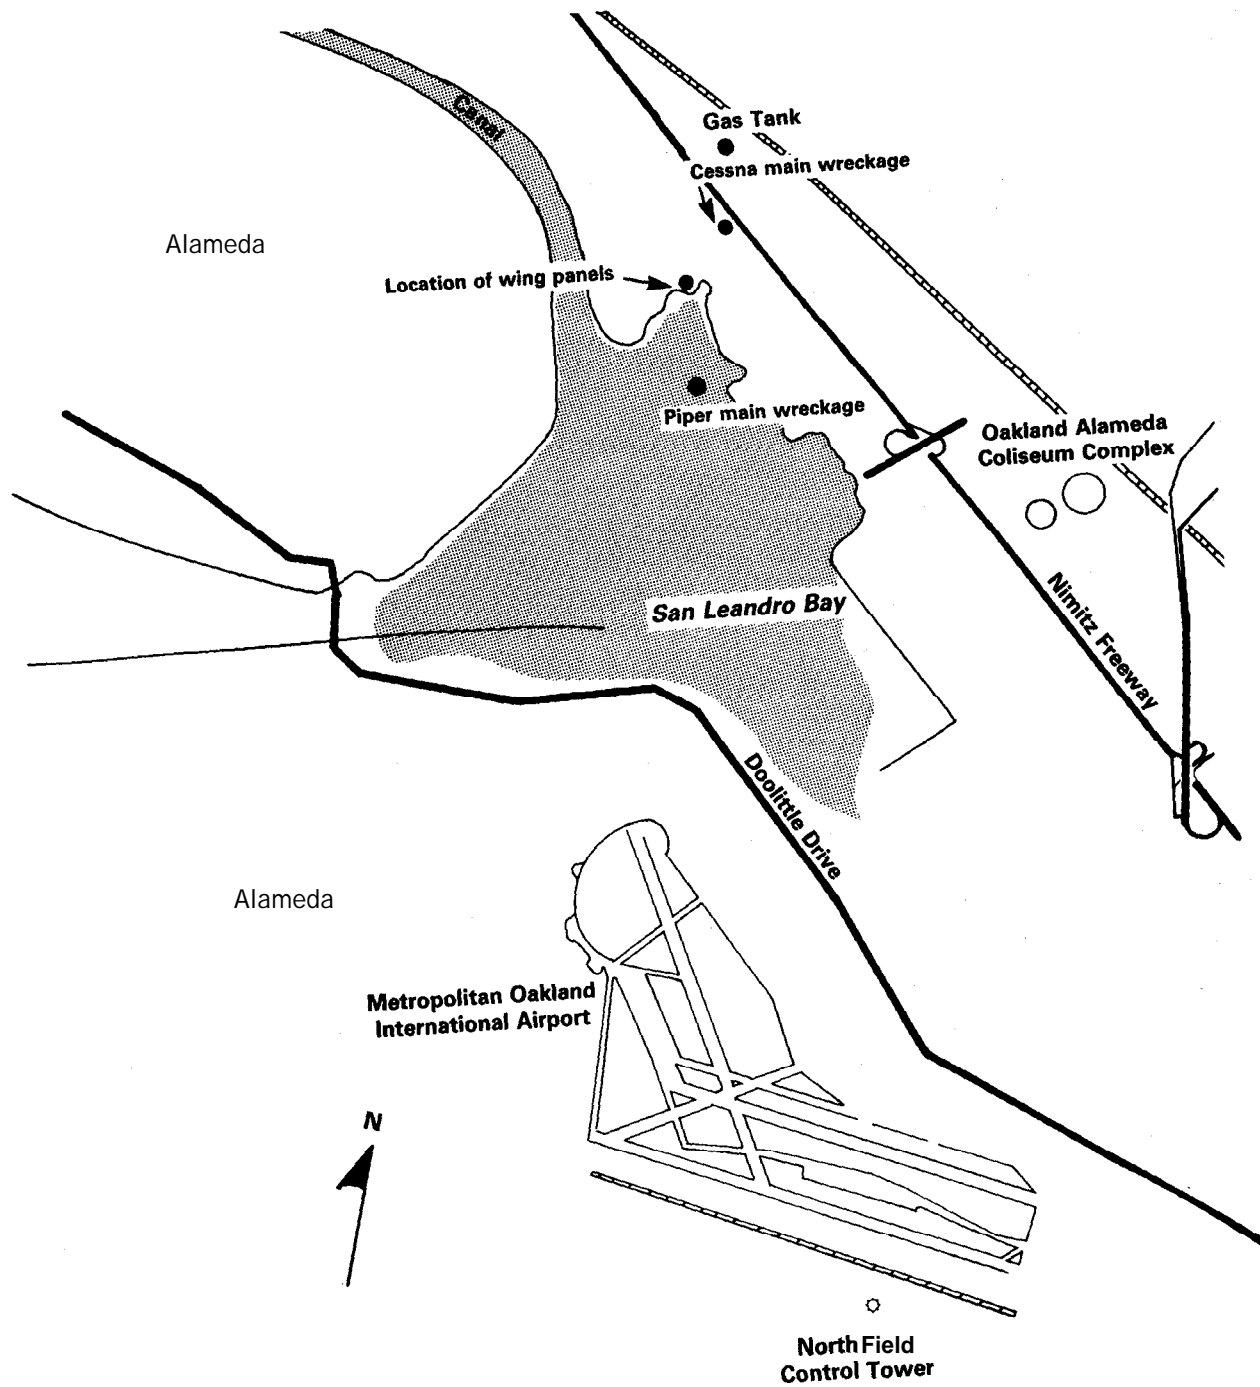
The main wreckage of both airplanes was found within a 2,500-foot diameter circle centered about 7,900 feet north of the departure end of runway 33. (See figure 5.) The center of the circle was aligned on a magnetic heading of 357° from the departure end of runway 33.

Figure 5.--Wreckage distribution.

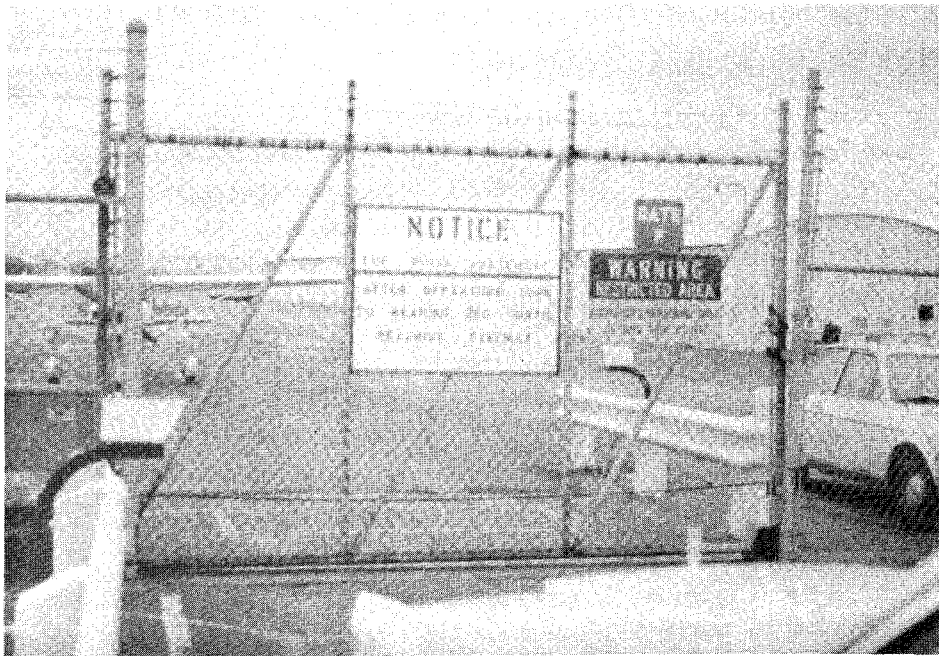
Figure 6.--Noise abatement sign on gate at entrance to ramp.

In addition, the evidence indicates that the manner in which the procedure was implemented was contrary to Federal aviation regulations. That is, the OAK airport manager placed signs describing the procedure at several locations around the north field without the required FAA authorization. Such authorization was implicit within the regulation assigning responsibility for airspace management to the FAA. The locations of the signs were such that pilots operating on the north field could hardly fail to notice them. For example, a sign was placed in the center of the gate across the main entrance from outside the airport to the general aviation ramp, and another was placed on the **taxiway** just ahead of the **runup** area of runway 33. In addition, the signs did not state that the noise abatement procedure was presented for guidance only, i.e., that it was not mandatory.

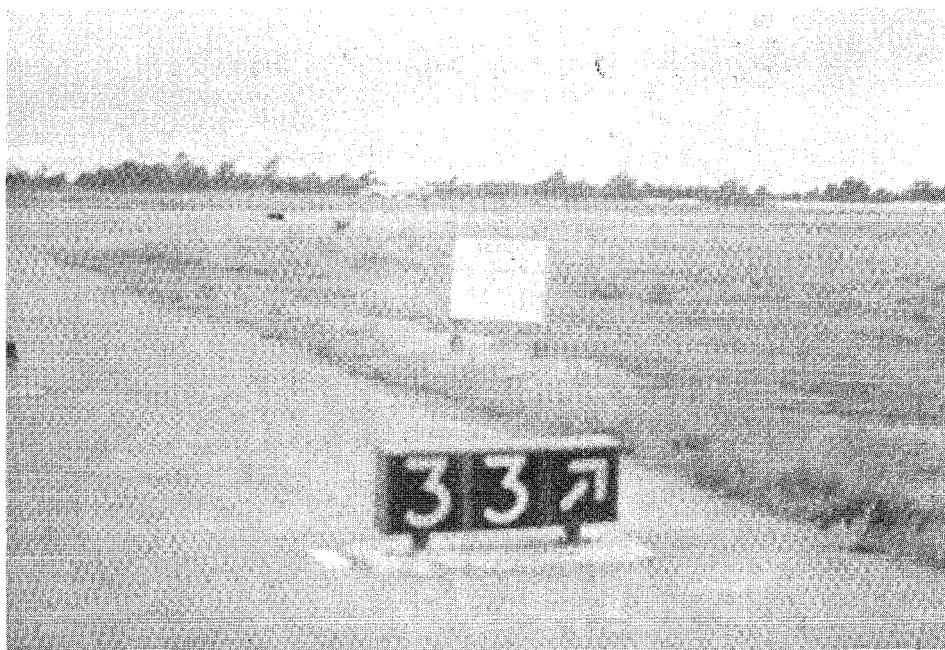
Figure 7.--Noise abatement sign just ahead of runway 33 runup area.
