NATIONAL TRANSPORTATION SAFETY BOARD

AIRCRAFT ACCIDENT REPORT

**MIDAIR COLLISION OF
U.S. ARMY U-21A, ARMY 18061,
AND SACHS ELECTRIC COMPANY
PIPER PA-31-350, N60SE
INDEPENDENCE, MISSOURI
JANUARY 20, 1987**

NTSB/AAR-88/01

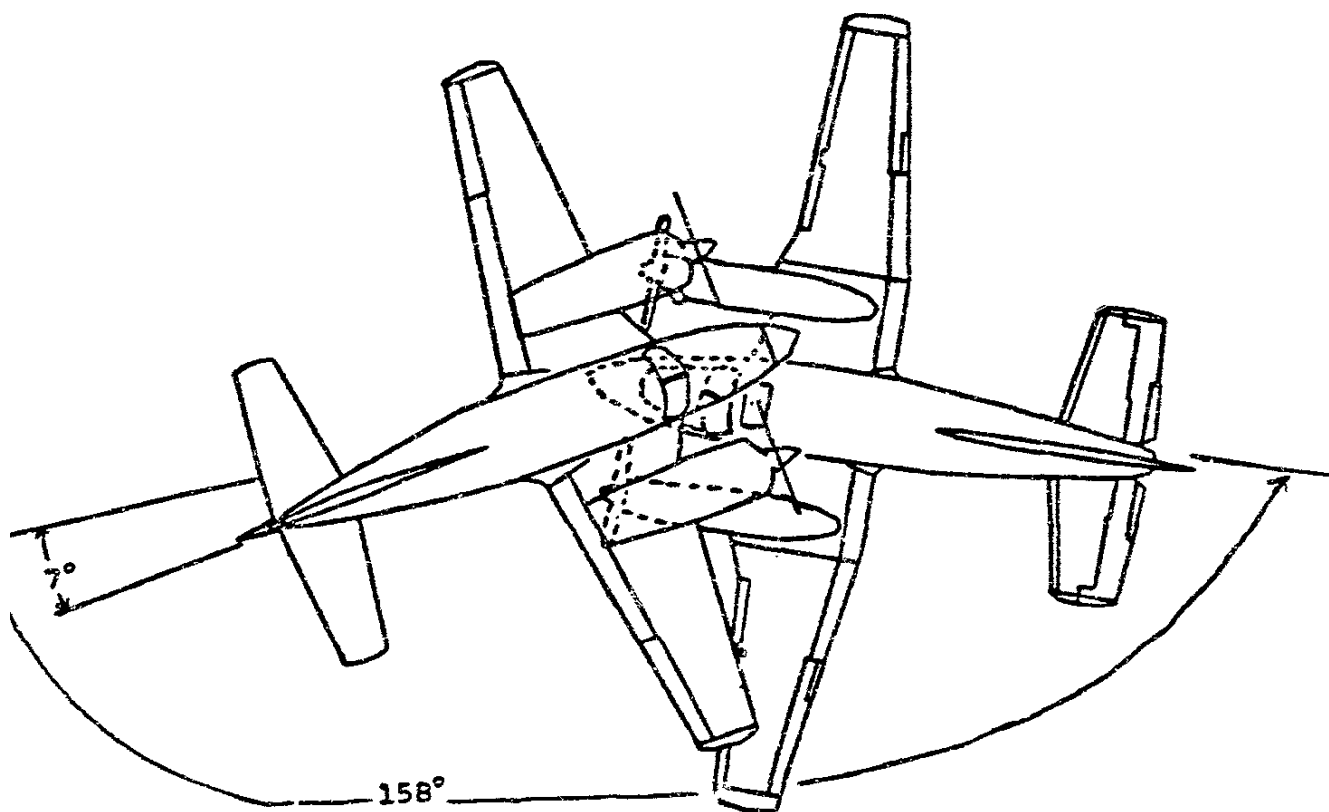
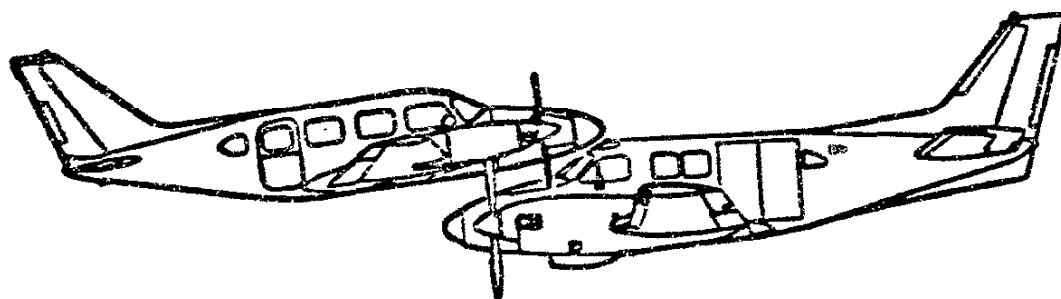
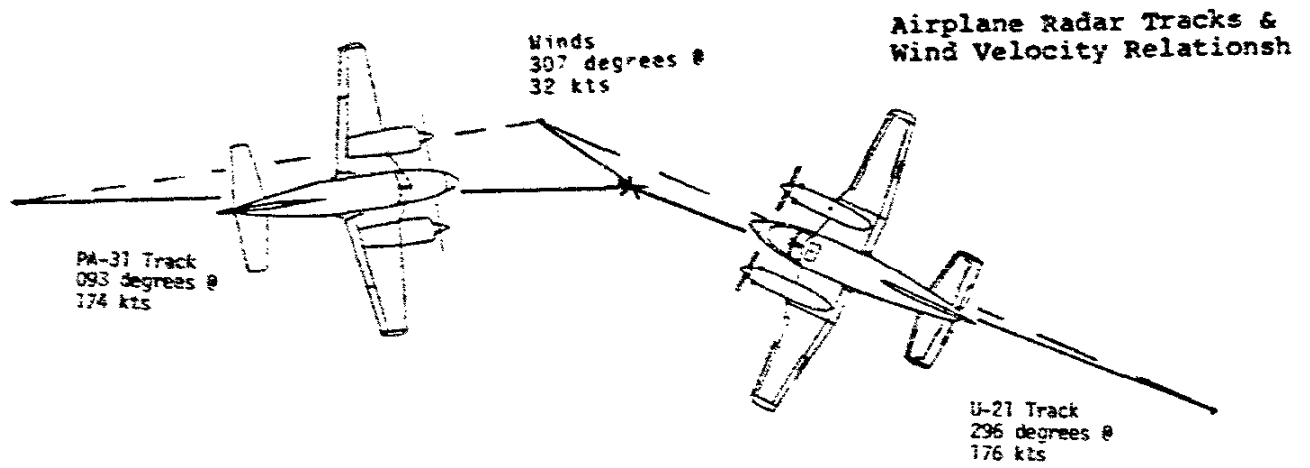
Figure 3.--Horizontal and vertical relationship of the airplanes at impact.

In addition to the cabin roof, the entire aft fuselage and empennage of the U-21 was separated from the forward cabin area in the collision. This was evidenced by the disintegration of the empennage and the scatter of the aft fuselage and empennage debris. Contact between the PA-31 cabin or right wing, as the PA-31 rode over the top of the U-21, would have caused such damage. The recovery of a piece of the vertical stabilizer from the U-21 in the PA-31 cabin showed that the vertical stabilizer had contacted or passed through the PA-31 cabin. (See figure 3.)

KNOWNS
 Angle A = Scratch Angle - Drift Angle = $(20-7)= 13$ degrees
 Side a = PA-31 True Airspeed = 150 kts
 Side b = U-21 True Airspeed = 207 kts

Resultants
 Angle C = Collision Angle = 158 degrees
 Side c = Closure Speed = 350 kts

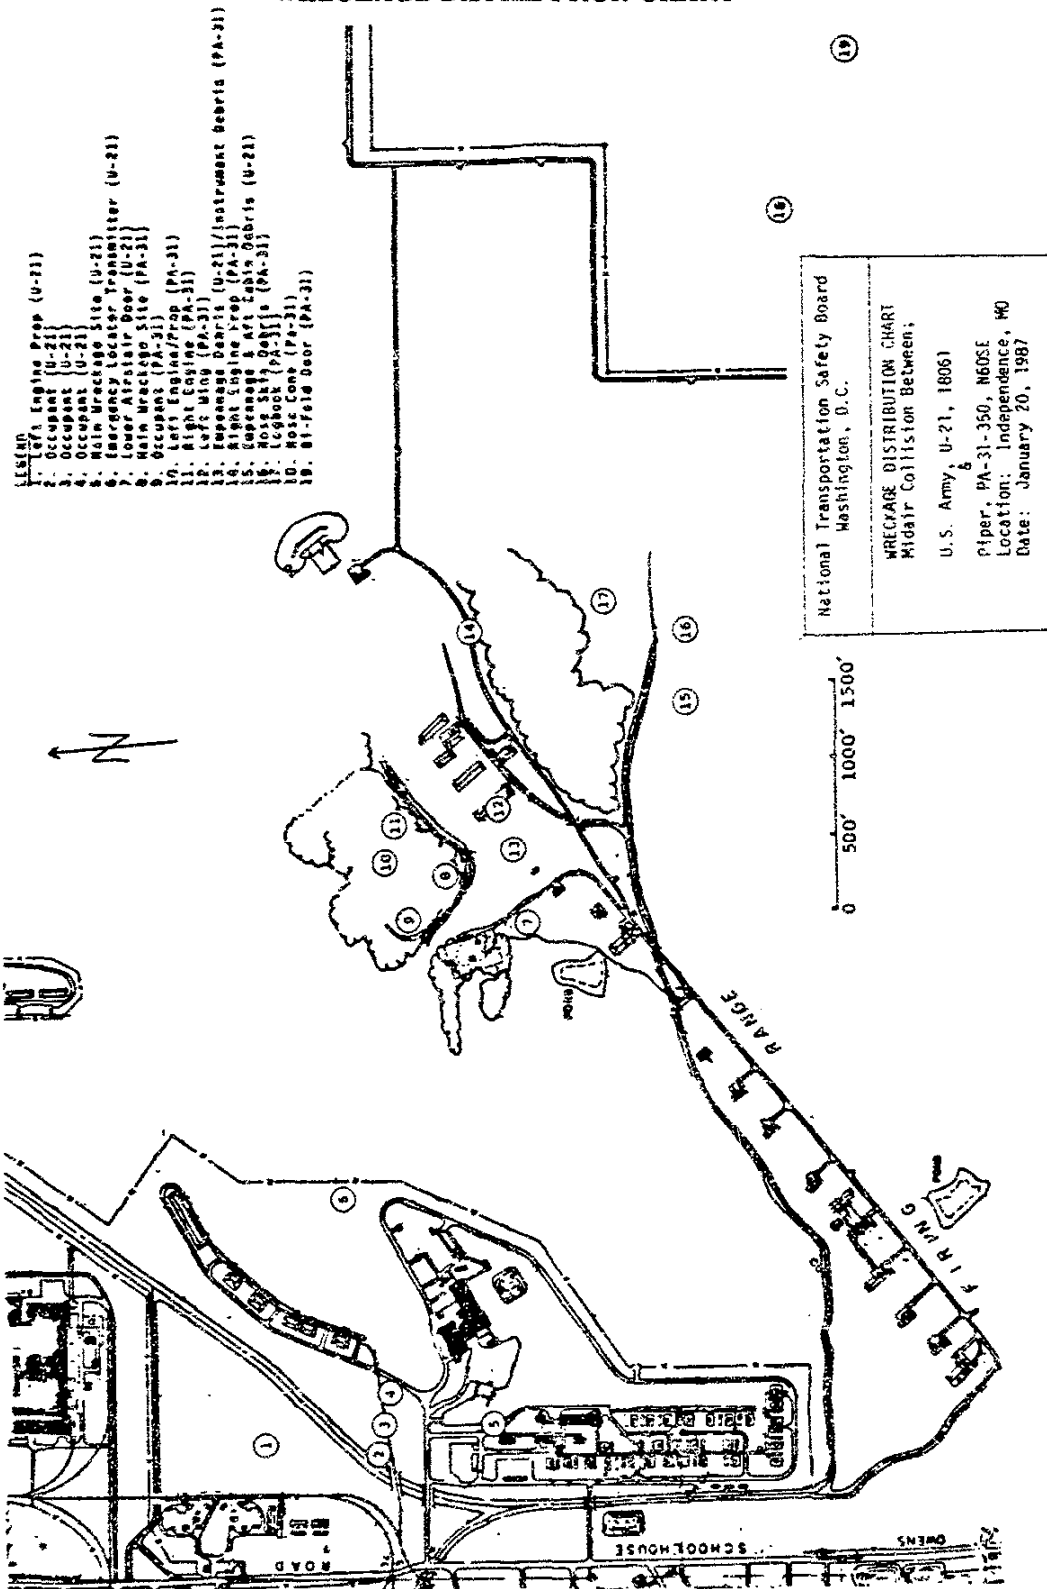
WRECKAGE DISTRIBUTION CHART

A section of forward fuselage structure with the left windshield wiper attached was found 2,200 feet southeast of the main wreckage site. The top of the fiberglass nosecone cover was intact; the lower third of the nosecone was crushed and separated from the larger top section. The right side of the fuselage was crushed inboard at the midcabin window area and aft of that area. An imprint in that area contained black scuff marks. A parallel black scuff was noted on the outboard side of the right engine nacelle, starting at the juncture between the front wing spar and the nacelle and continuing rearward and upward, 45 degrees to the airplane longitudinal axis. A clean slice through the cabin floor and carpet was noted on the right side of the cabin and opposite the cabin door. The slice was oriented from outboard to inboard (as viewed looking rearward). A styrofoam and plastic ice chest about 12 inches high, normally placed at that location in the airplane by Sachs Electric Company employees, was also cleanly slashed. The inside of the cabin was substantially distorted. A piece of the vertical stabilizer structure of the U-21 was found inside the PA-31 cabin.

The left wing was separated from the fuselage at the wingroot and came to rest 580 feet southwest of the main wreckage site. The fractures associated with the wing separation revealed no evidence of preexisting damage. The upper surface of the left wing revealed no obvious collision damage. However, the lower surface contained gouges, scrapes, and a slice through the lower surface. The slice through the lower surface was 3 inches wide and 28 inches long. It began about 7 feet outboard of the fuselage and 30 inches aft of the wing leading edge. The slice progressed rearward at an angle 10 degrees from that of the wing spar. Several scrape marks swept rearward and outboard (about 30 inches) from the inboard leading edge of the wing lower surface, at an angle 20 degrees from the fuselage centerline. The left flap position was up, and the left landing gear was retracted.

Beech U-21, Army 18061.--The main wreckage of the U-21 came to rest at the edge of a blacktop road about 50 feet northeast of Building 64A of the Lake City Army Ammunition Plant. Three 1/2-inch-diameter high voltage power lines, normally suspended 30 feet above the ground, were broken above the wreckage. Portions of the cabin roof and the fuselage, aft of the airstair (main cabin) door, were scattered about the wreckage path remote from the main wreckage. The wreckage and debris at the main wreckage site was severely fire damaged. The airplane pieces and other debris along the

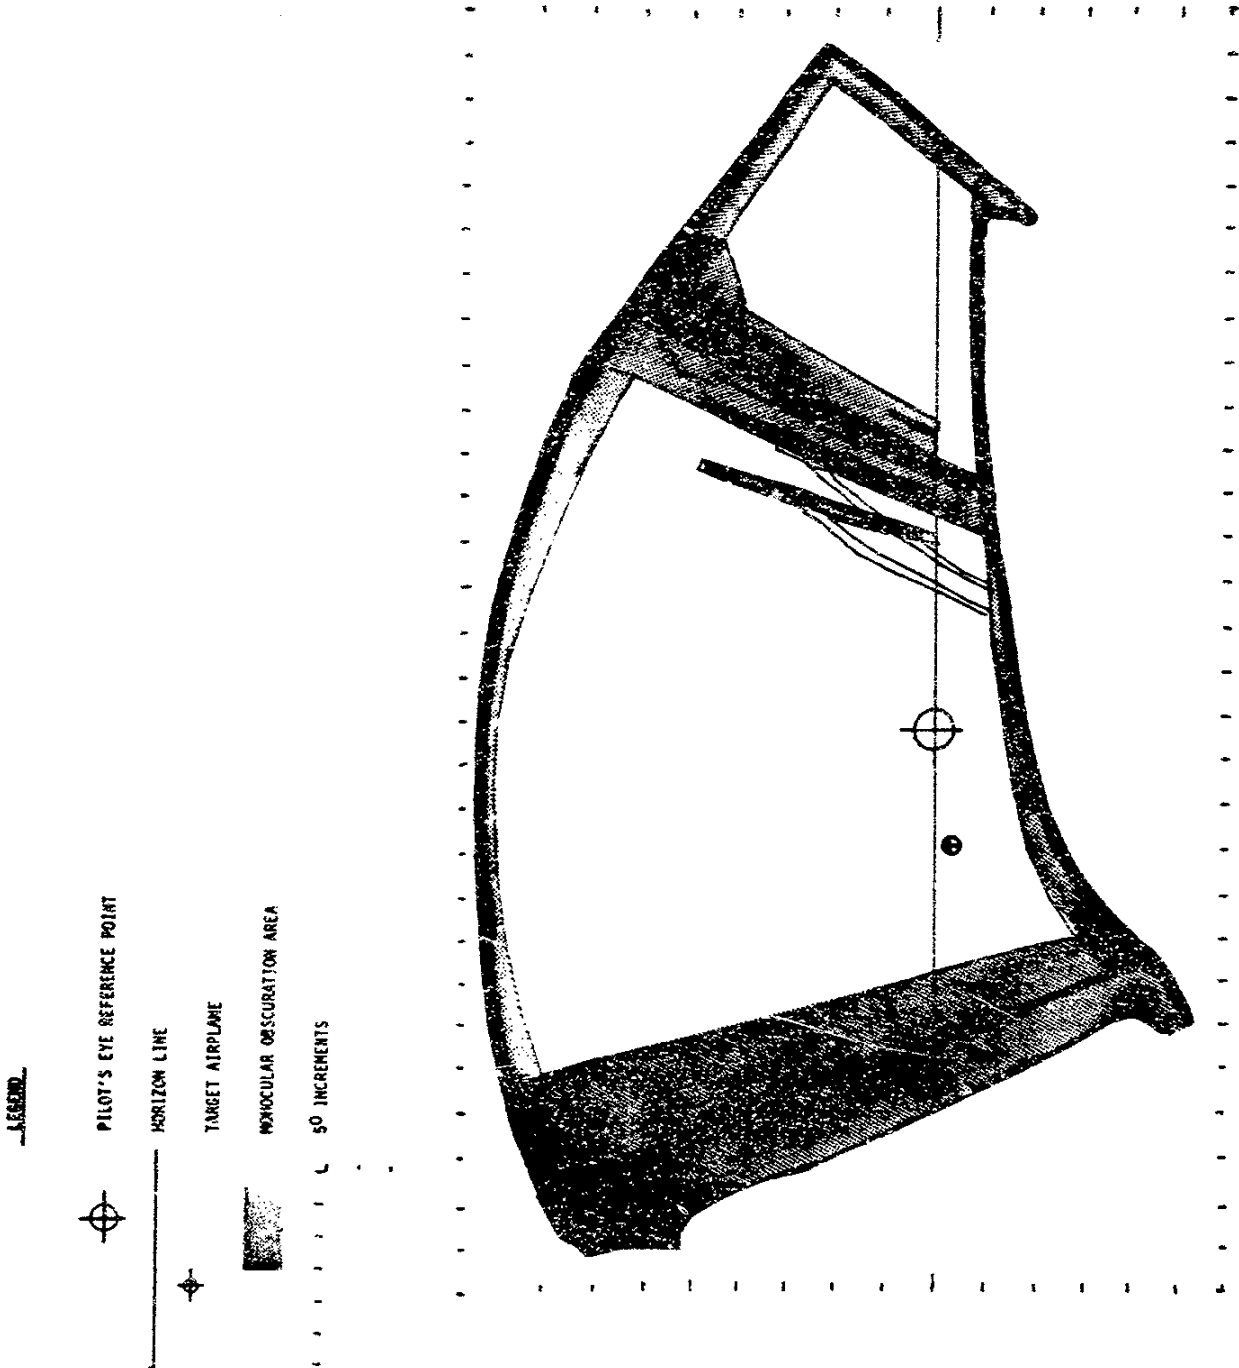
Figure 1. U21A, R18061, Pilot's Design Eye Reference Position at 41.5 in. Above the Floor and 5 in. Aft of the Rear Most Column Movement.

The cockpit visibility study showed that the PA-31 was visible through the windshields of both U-21 pilots. Neither pilot's view would have been obstructed by windshield or door posts, windshield wipers, or other airplane equipment. There was no need to attempt to view the PA-31 by looking outside the viewing area associated with normal outside scanning. The sun should not have produced any abnormal glare on the windshield.

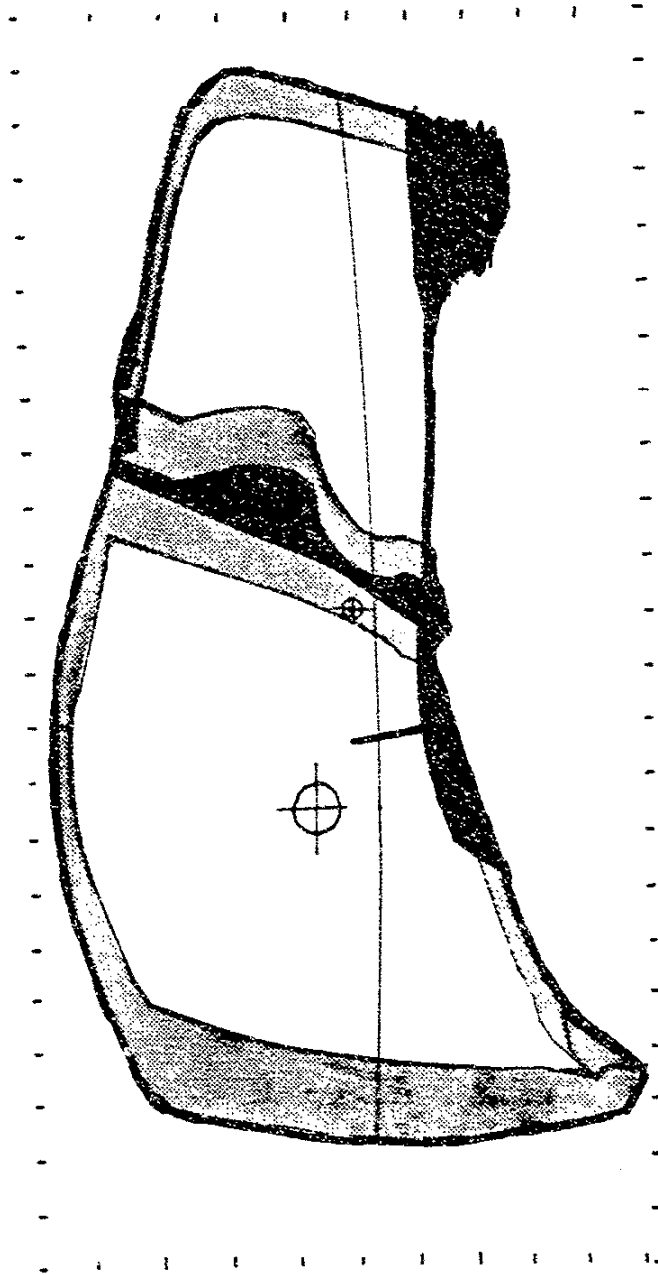
Figure 3. PA31-350, N60SE, Pilot's Design Eye Reference Position at 43.5 in. Above the Floor and 5 in. Aft of the Rear Most Column Movement.

The study showed that the U-21 would have been positioned near the center windshield post of the PA-31 pilot's windshield. If the pilot kept his head motionless, the U-21 would have been sufficiently obscured by the windshield post that the pilot would
