# **NATIONAL TRANSPORTATION SAFETY BOARD**

## **AIRCRAFT ACCIDENT REPORT**

**AIR NEW ORLEANS,  
DBA CONTINENTAL EXPRESS FLIGHT 962,  
BRITISH AEROSPACE 3101  
(JETSTREAM 31) N331CY,  
NEW ORLEANS INTERNATIONAL AIRPORT  
KENNER, LOUISIANA  
MAY 26, 1987**

NTSB/AAR-88/06

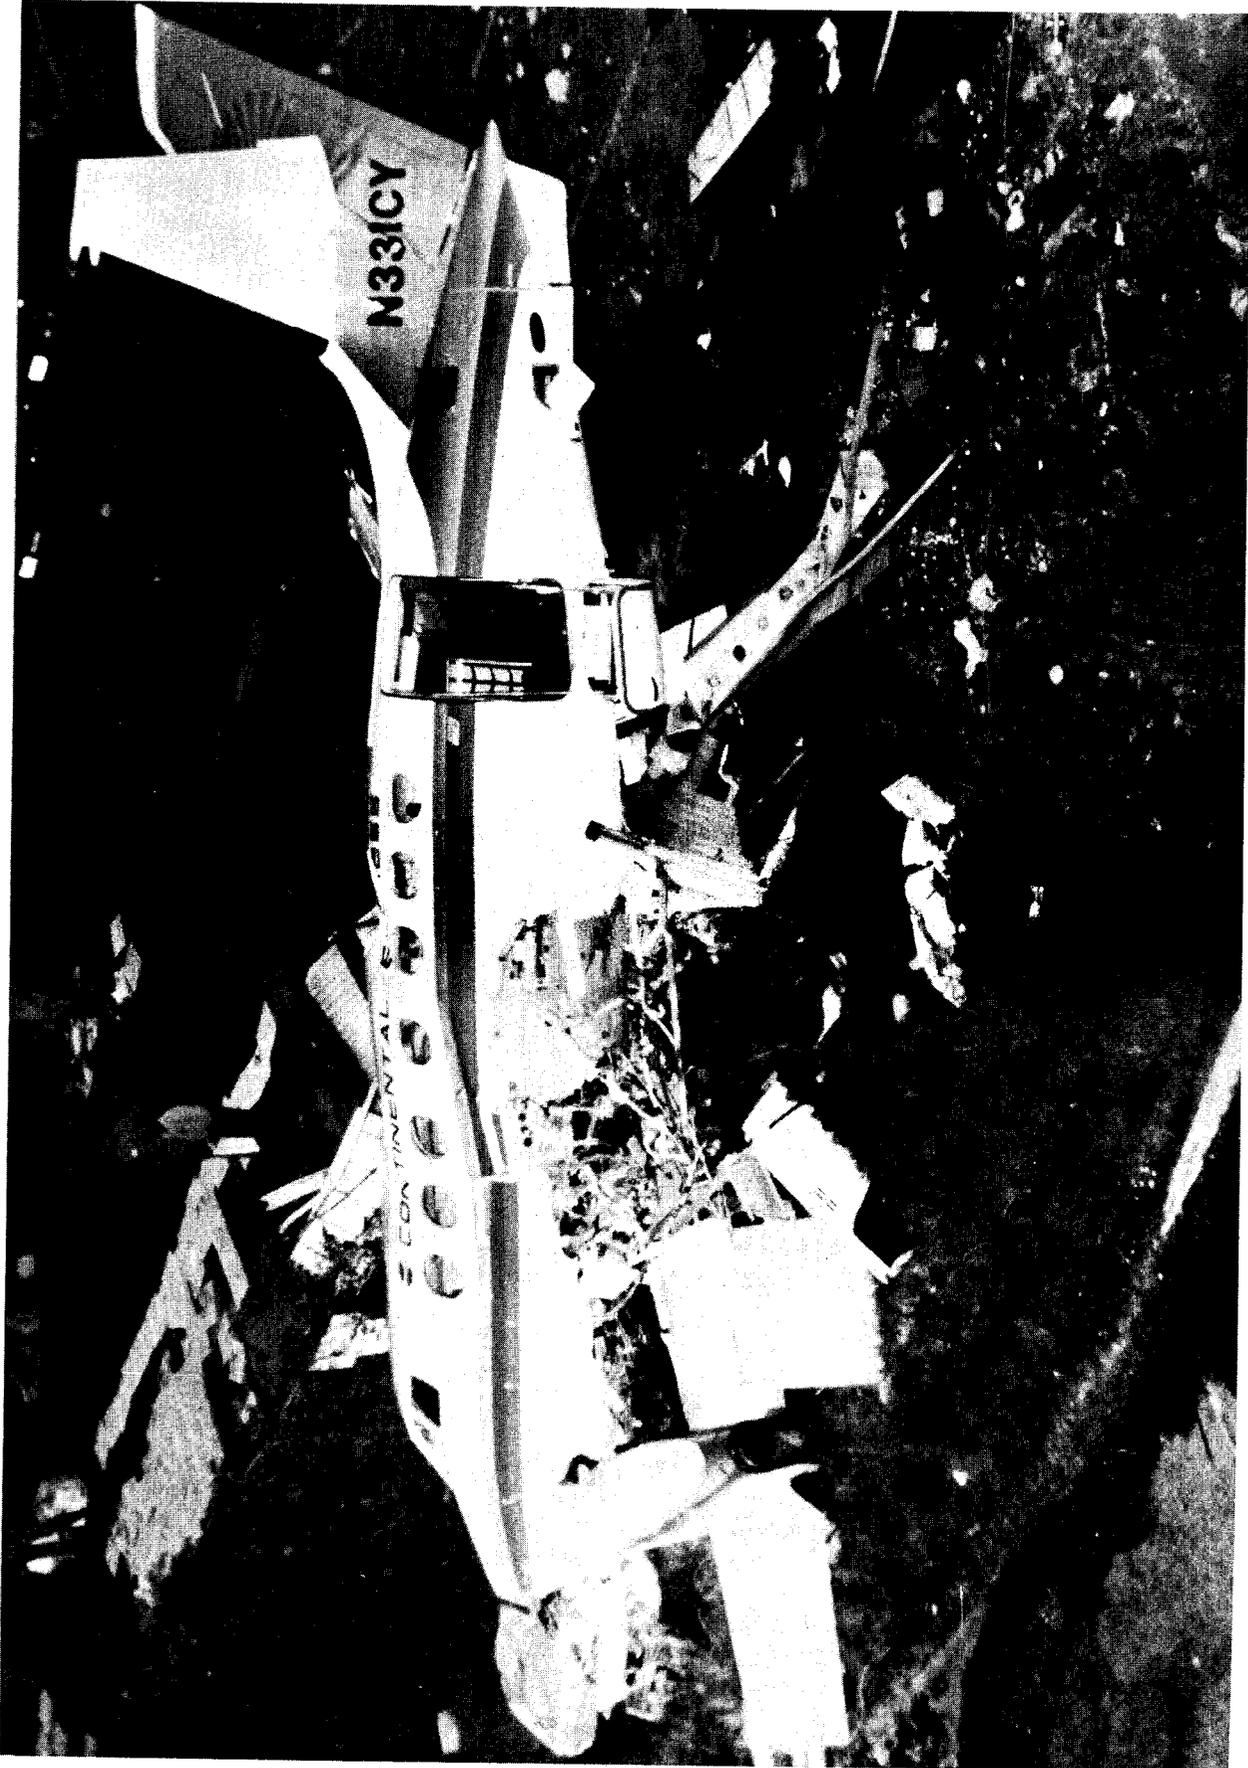
Figure 1.--Left view of wreckage.

Tire marks for all three landing gear were evident in the grass beyond the overrun and continued through a low gravel embankment along the airport access road. Just beyond this embankment, propeller strikes, which continued across the access road, were found in the ground. About 45 feet beyond the embankment, the airplane had passed through a 6-foot high chainlink fence. A piece of the left wingtip was located near this fence. The airplane had impacted a 2-foot-10-inch-high concrete barrier on the near side of a four-lane paved highway (U.S. Route 61). A large portion of the underbelly baggage pod straddled this damaged barrier. (See figures 1 and 2.)

The right wing was intact, but had separated from the fuselage at the wing root. Its location was slightly aft of where it had formerly been attached to the fuselage. This wing exhibited leading edge damage and scratch marks on its underside that corresponded to a chainlink fence pattern. The right engine was still attached to the wing; however, the engine mounts were broken and the propeller had been broken off.

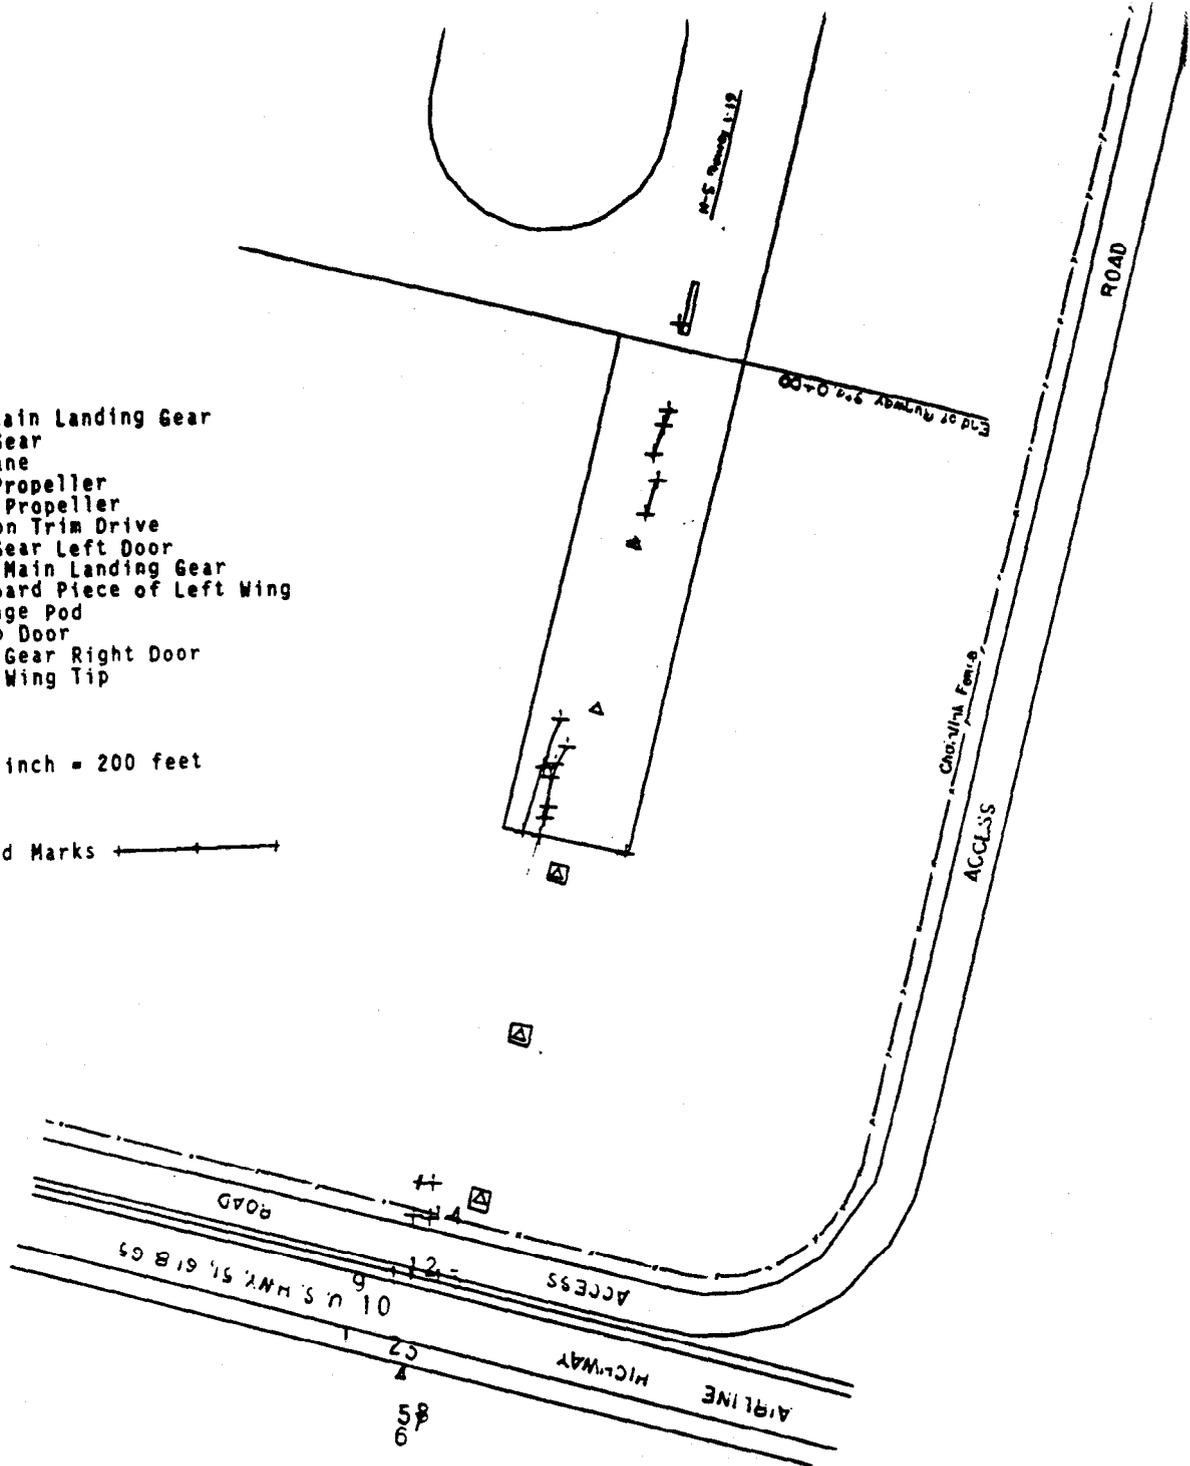
NATIONAL TRANSPORTATION SAFETY BOARD Washington, D.C.
<b>WRECKAGE DISTRIBUTION CHART</b>
Aircraft: BAC, Jetstream 31, N331CY Operator: Air New Orleans, FLT 962 Location: New Orleans Int. Airport, La Date: May 26, 1987

The wreckage scatter pattern began with tire skidmarks in the overrun of runway 19. The distance between the first tire skidmark and the final resting point of the main wreckage was about 1,100 feet. The initial skidmarks stopped after about 100 feet. A damaged runway centerline strobe light was located about 35 feet beyond the end of the first left gear skidmark. The tire skidmarks began again about 400 feet beyond the initial touchdown point and continued to the end of the paved overrun for runway 19.

The airplane had skidded across the highway and had stopped in the corner of a paved parking lot. Pieces of the airplane adjacent to the main wreckage included the propellers, landing gear, and other smaller components. In addition, a large fuel spillage occurred in the area from the fuselage and wings.
