PB90-910402  
NTSB/AAR-90/02

## AIRCRAFT ACCIDENT REPORT

EVERGREEN INTERNATIONAL AIRLINES  
McDONNELL DOUGLAS DC-9-33F, N931F  
SAGINAW, TEXAS  
MARCH 18, 1989

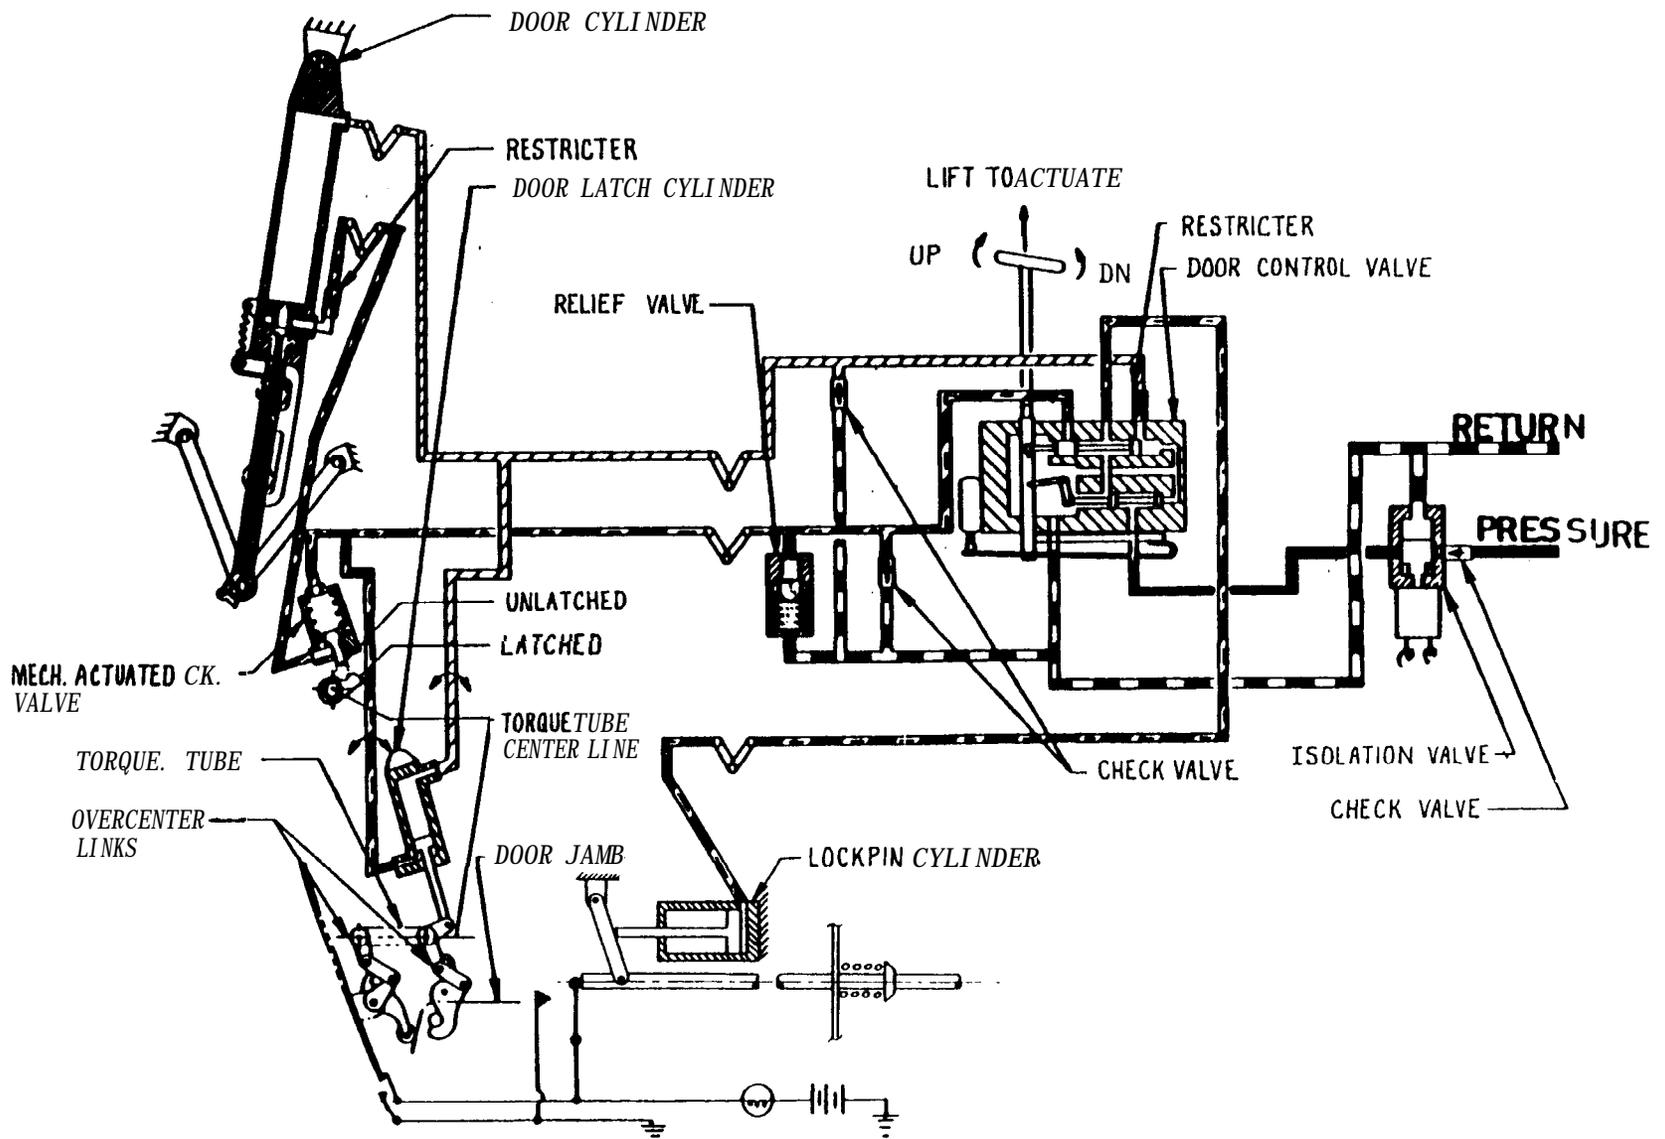
Figure I. -- Hydraulic routing within the cargo door hydraulic system.

1. The cargo door control valve - This valve was found in the "valve neutral" position (as opposed to the "door open" or the "door closed" position) within the wreckage. Damage to the valve did not allow testing in the "door open" or "door closed" positions. The valve was disassembled at its manufacturer's facility and no anomalies were found. See Figure 1 for a cut-away diagram of this valve in its three operating positions.

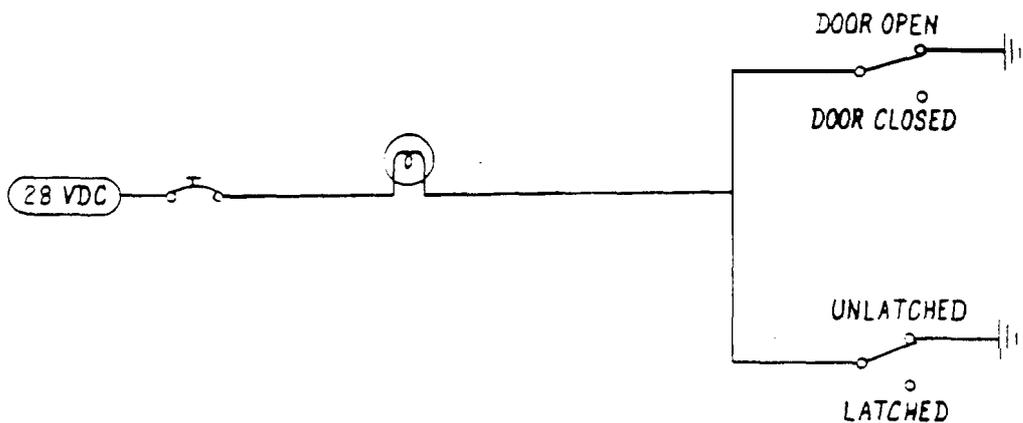
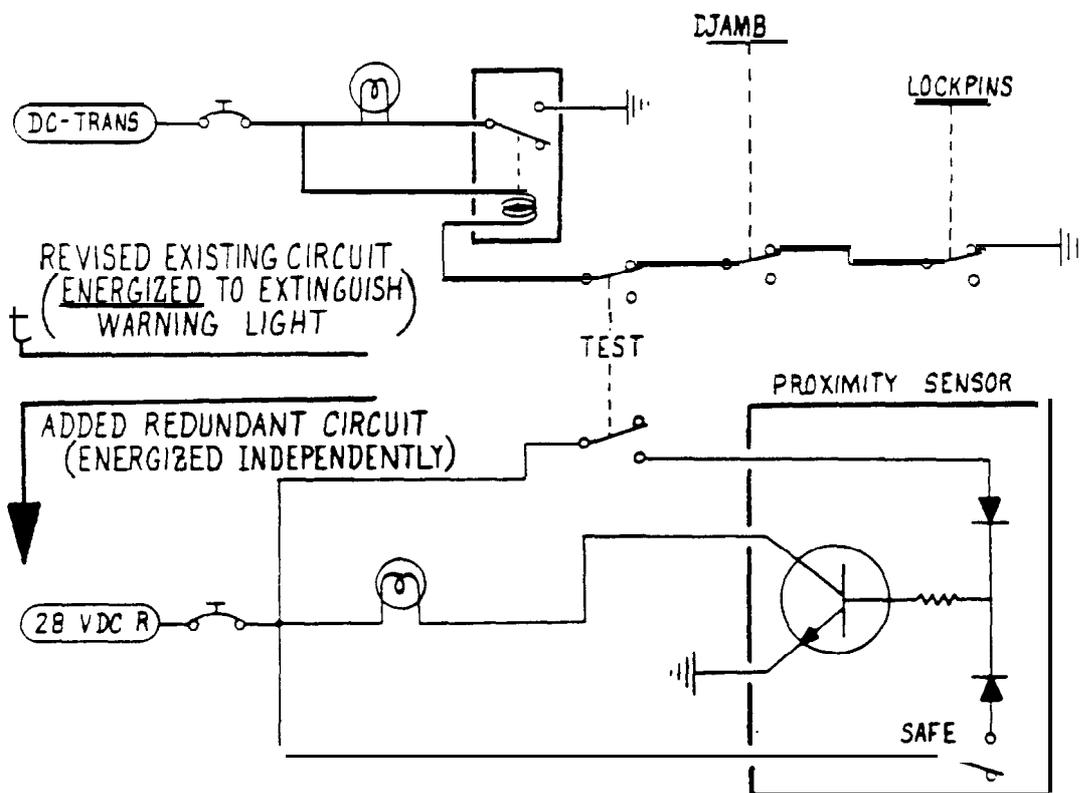
Figure 3. -- Cargo door warning switch electrical diagrams.

The SB modification eliminates an undesirable failure mode of the original cargo door cockpit warning light system wherein a failure of either the door jamb switch or the lockpin switch to close will remain undetected and the cockpit warning light will appear to function

normally; that is, the light would illuminate when the other functional switch closes and extinguish when it opens. Thus, if the lockpin switch is the one failed, the door will appear safe when closed even though it is not fully latched and locked. The modification to the existing circuit consists of adding a relay which must be energized with 28 volts dc to extinguish the cockpit warning light. The door jamb and lockpin switches are rewired in a series circuit so that electrical continuity through both switches will energize the relay. With the logic of the switches inverted and placed in series instead of parallel, a failure of either switch to close will result in an illuminated warning light.

- g. SB 52-92 - Issued on April 7, 1976, with revision 2 on November 21, 1985 - This SB recommended a modification of the original cargo door cockpit warning light system electrical circuit and the addition of a redundant independently energized warning light and circuit.
