AIRCRAFT ACCIDENT REPORT

INADVERTENT IN-FLIGHT SLAT DEPLOYMENT
CHINA EASTERN AIRLINES FLIGHT 583
McDONNELL DOUGLAS MD-11, B-2171
950 NAUTICAL MILES SOUTH OF SHEMYA, ALASKA
APRIL 6, 1993

Adopted: October 27, 1993
Notation 6180

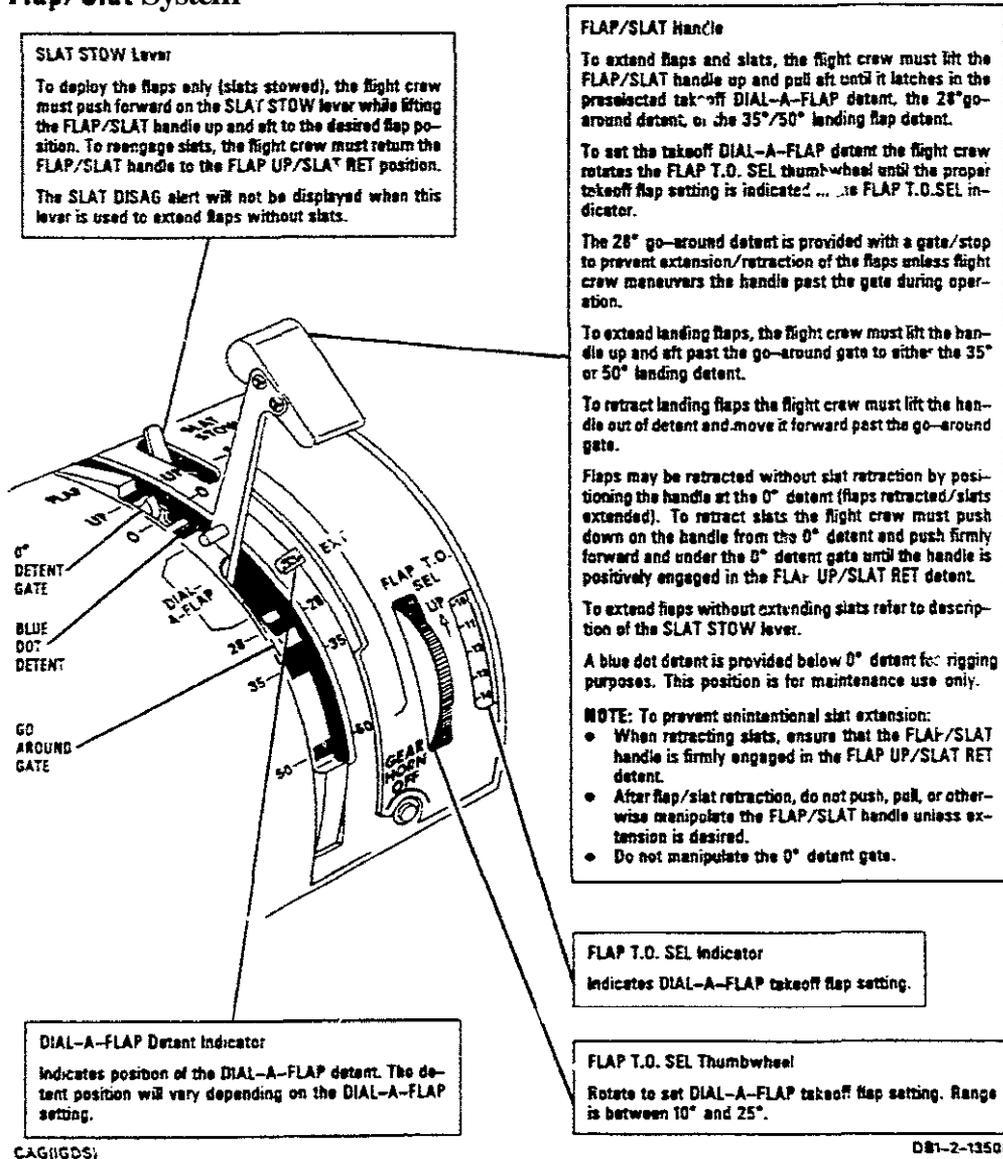
Figure 4.--Flap/slat handle module.

The flap/slat handle was found to operate normally through its range of movement. Examination of the slat stow lever revealed that when the lever was pushed forward (the disconnect position), then released, the lever did not return to its normal position.⁷ The lever was operationally tested several times, and it was determined that it could not be manipulated in such a manner that would cause or permit an uncommanded slat extension.

All slat-related control valves and inter-related systems were examined, functionally tested and found normal. The flap/slat handle module was examined and found to be operational within design limits, with the exception of the slat stow lever. The installation, normal and autoslat extension systems were also found to be correct and capable of normal operations.
