# **NATIONAL TRANSPORTATION SAFETY BOARD**

## **AIRCRAFT ACCIDENT REPORT**

**RUNWAY OVERRUN FOLLOWING REJECTED TAKEOFF  
CONTINENTAL AIRLINES FLIGHT 795  
McDONNELL DOUGLAS MD-82, N18835  
LaGUARDIA AIRPORT  
FLUSHING, NEW YORK  
MARCH 2, 1994**

**Abstract:** This report explains the accident involving Continental Airlines flight 795, an MD-82 airplane, which experienced a runway overrun following a rejected takeoff from runway 13 at LaGuardia Airport, Flushing, New York, on March 2, 1994. Safety issues discussed in the report include the availability of takeoff performance data for flightcrews, the proper functioning of pitot/static heat systems, the duration of cockpit voice recordings, and problems associated with passenger evacuations from airplanes. Safety recommendations concerning these issues were addressed to the Federal Aviation Administration and to Continental Airlines, Inc.

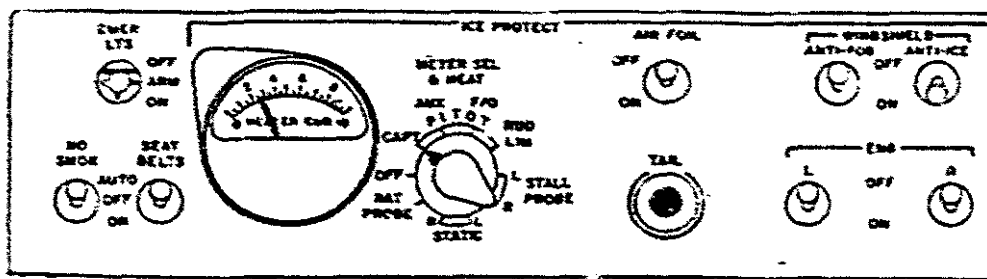
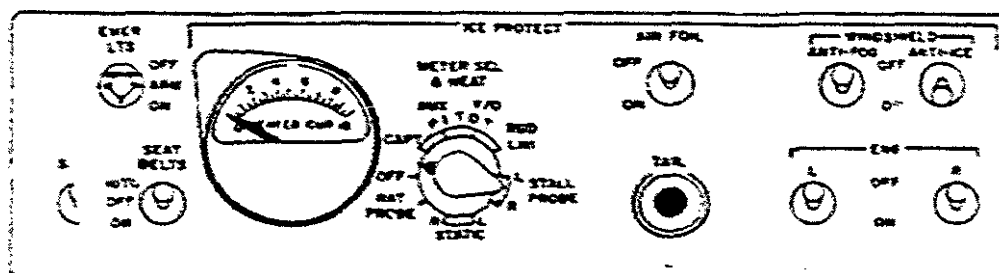
Figure 1.--Pitot/static/stail heater selector switch.

Upper Illustration-Normal position for system ON and reading CAPT Heater current.

**Middle Illustration—Approximate alignment of accident airplane's switch in OFF detent.**

Bottom Photo-Photo of accident airplane's METER SEL & HEat switch in OFF position. See arrow: ➤

The **METER SEL & HEAT**, which controls heat to the pitot tubes/static ports, RAT probe, and AOA [angle of attack] was found to be slightly misaligned. When the **switch** was set to the **OFF** position, the **switch** "pointer" indication was **approximately 1/3 of the distance** toward the **CAPT** position. The misalignment of the switch existed **as** it was rotated **throughout** each position. **Each** position was clearly identified by a detent. The switch rotated freely without apparent binding or malfunction.

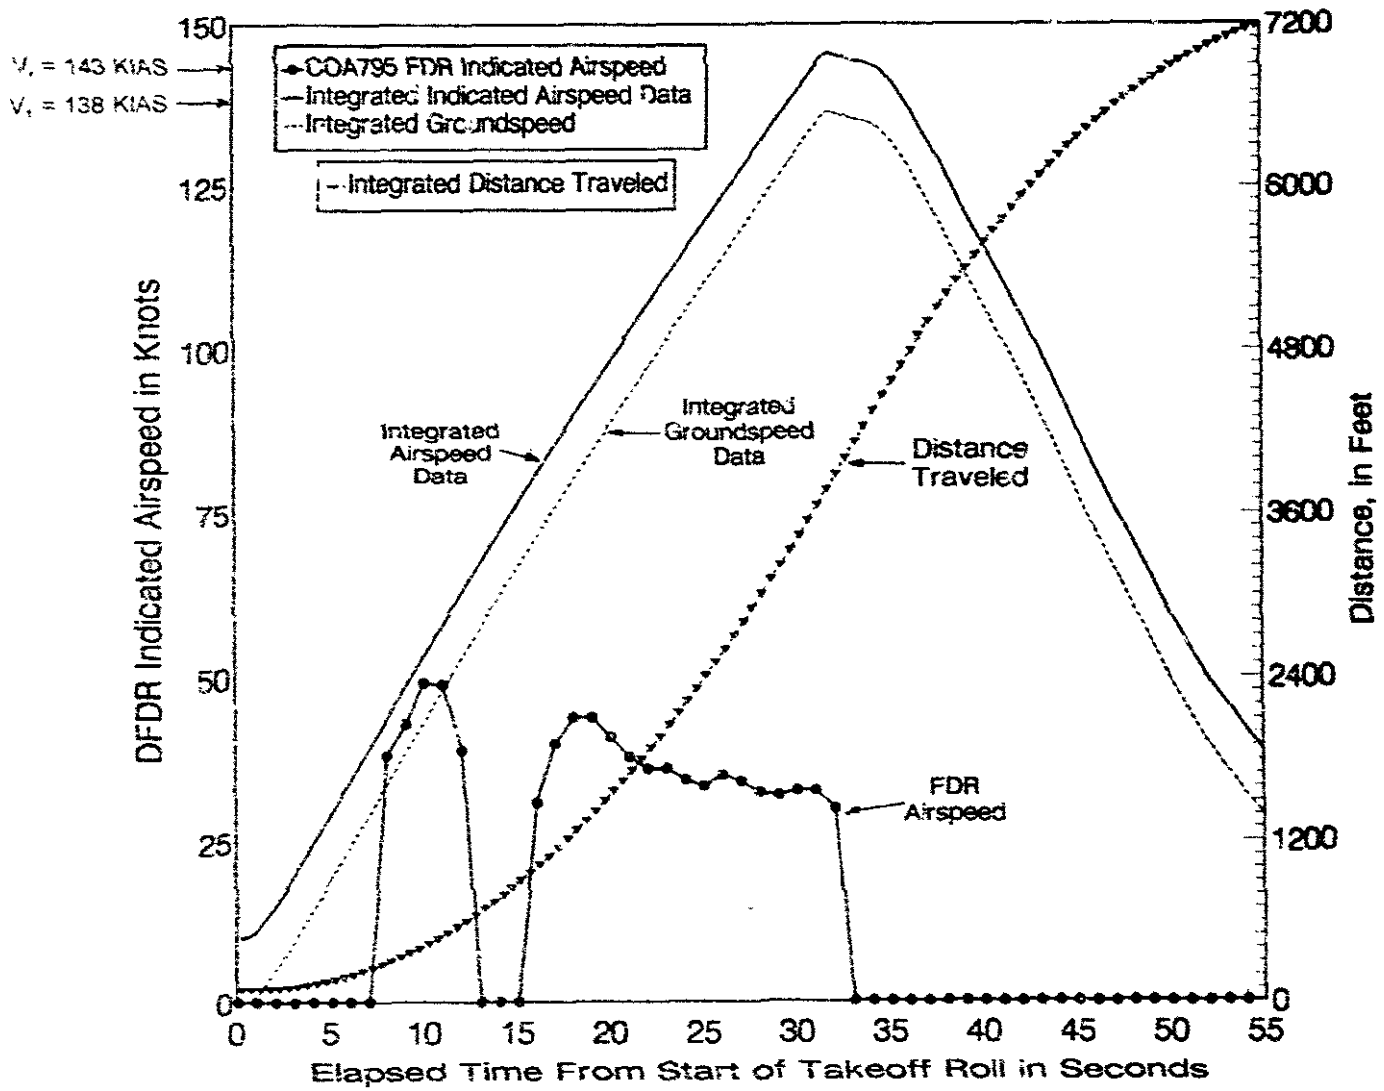
Figure 5.--Comparison of FDR airspeed and integrated airspeed.

1. The accelerations and decelerations were consistent with expected airplane performance for the conditions present.
2. The takeoff was rejected at a computed indicated airspeed of 143 KIAS. (See figure 5).
3. The maximum computed indicated airspeed during the takeoff was 145.5 KIAS.
4. The airplane departed the end of runway 13 at a computed indicated airspeed of 53 KIAS.
5. The airplane struck the dike at a computed 39 KIAS.
6. The time between 60 KIAS and the start of the abort (as determined by the performance evaluation, not the cockpit indicators) was 19.25 seconds.

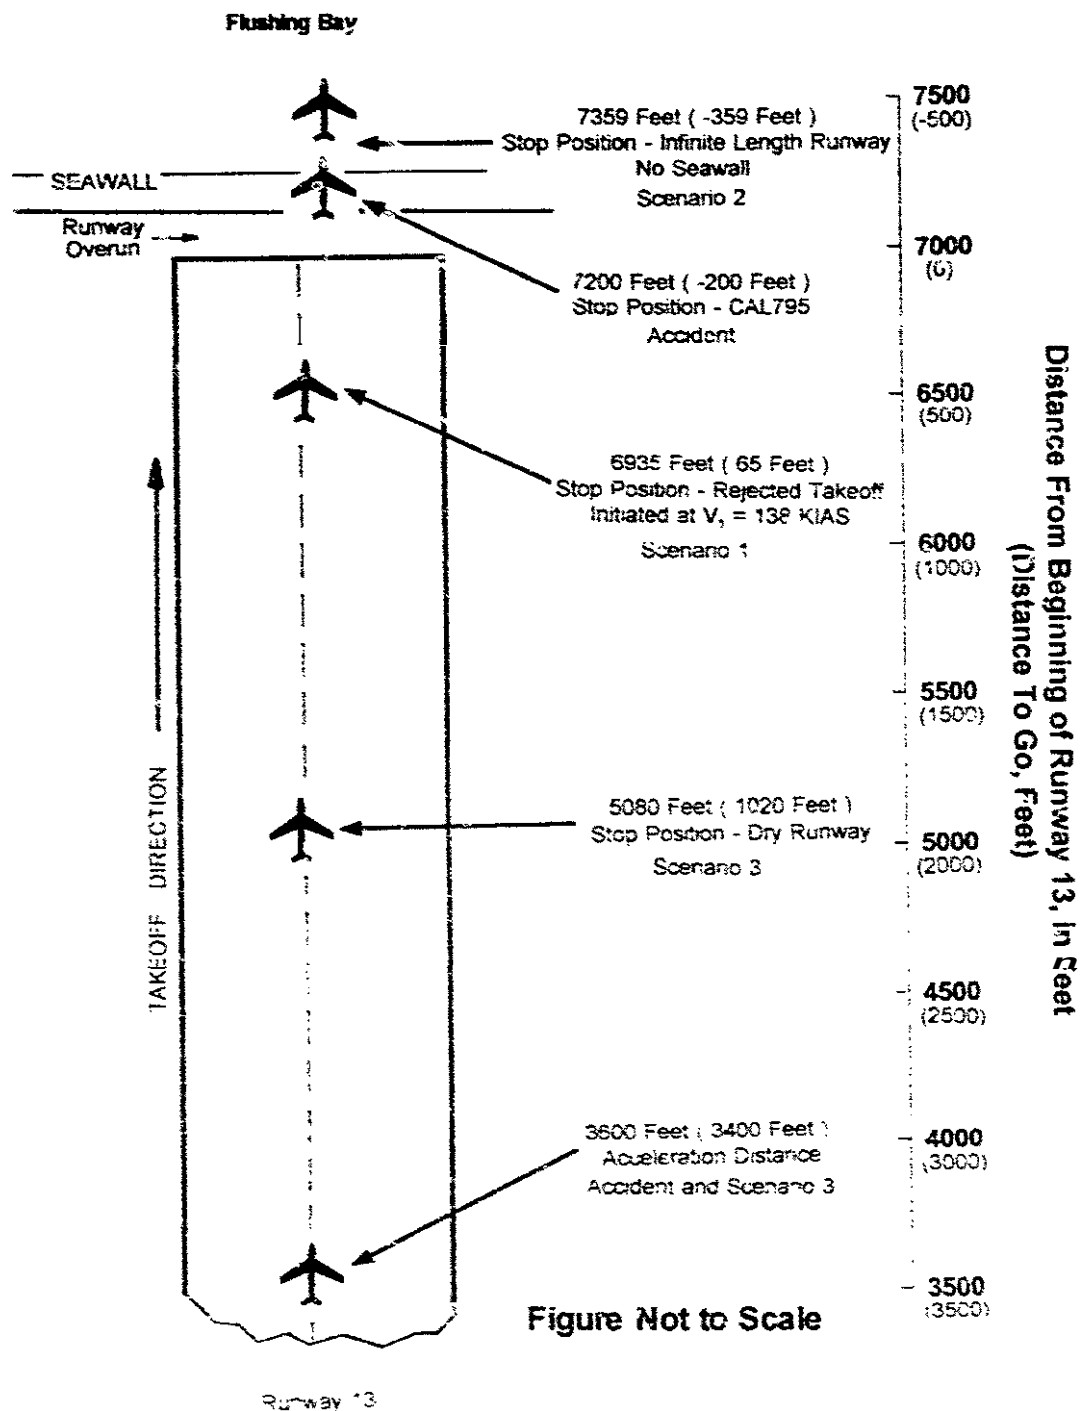
Figure 6.--Results of takeoff/stop scenarios.

The airplane performance study also revealed that the airplane should have been able to stop 1,320 feet from the end of the runway, if the runway surface were dry. (See figure 6, scenario 3). These computations assumed weight, thrust, and environmental conditions for the accident flight. The study also determined that the acceleration of the airplane, as compared to the nominal performance data for the airplane, was consistent with that for an uncontaminated runway, and the deceleration values were consistent with a slippery runway. (A *Mu* of 0.2 was used in these calculations).
