PB95-910404
NTSB/AAR-95/04
DCA95MA007

AIRCRAFT ACCIDENT REPORT

CRASH DURING EMERGENCY LANDING
PHOENIX AIR
LEARJET 35A, N521 PA
FRESNO, CALIFORNIA
DECEMBER 14, 1994

Abstract: This report explains the accident involving the Phoenix Air Learjet 35A that crashed while attempting an emergency landing at Fresno Air Terminal, Fresno, California, on December 14, 1994. Safety issues in the report focused on maintenance, inspection and quality assurance. Safety recommendations concerning these issues were made to the Federal Aviation Administration, Phoenix Air, and the Department of Defense.

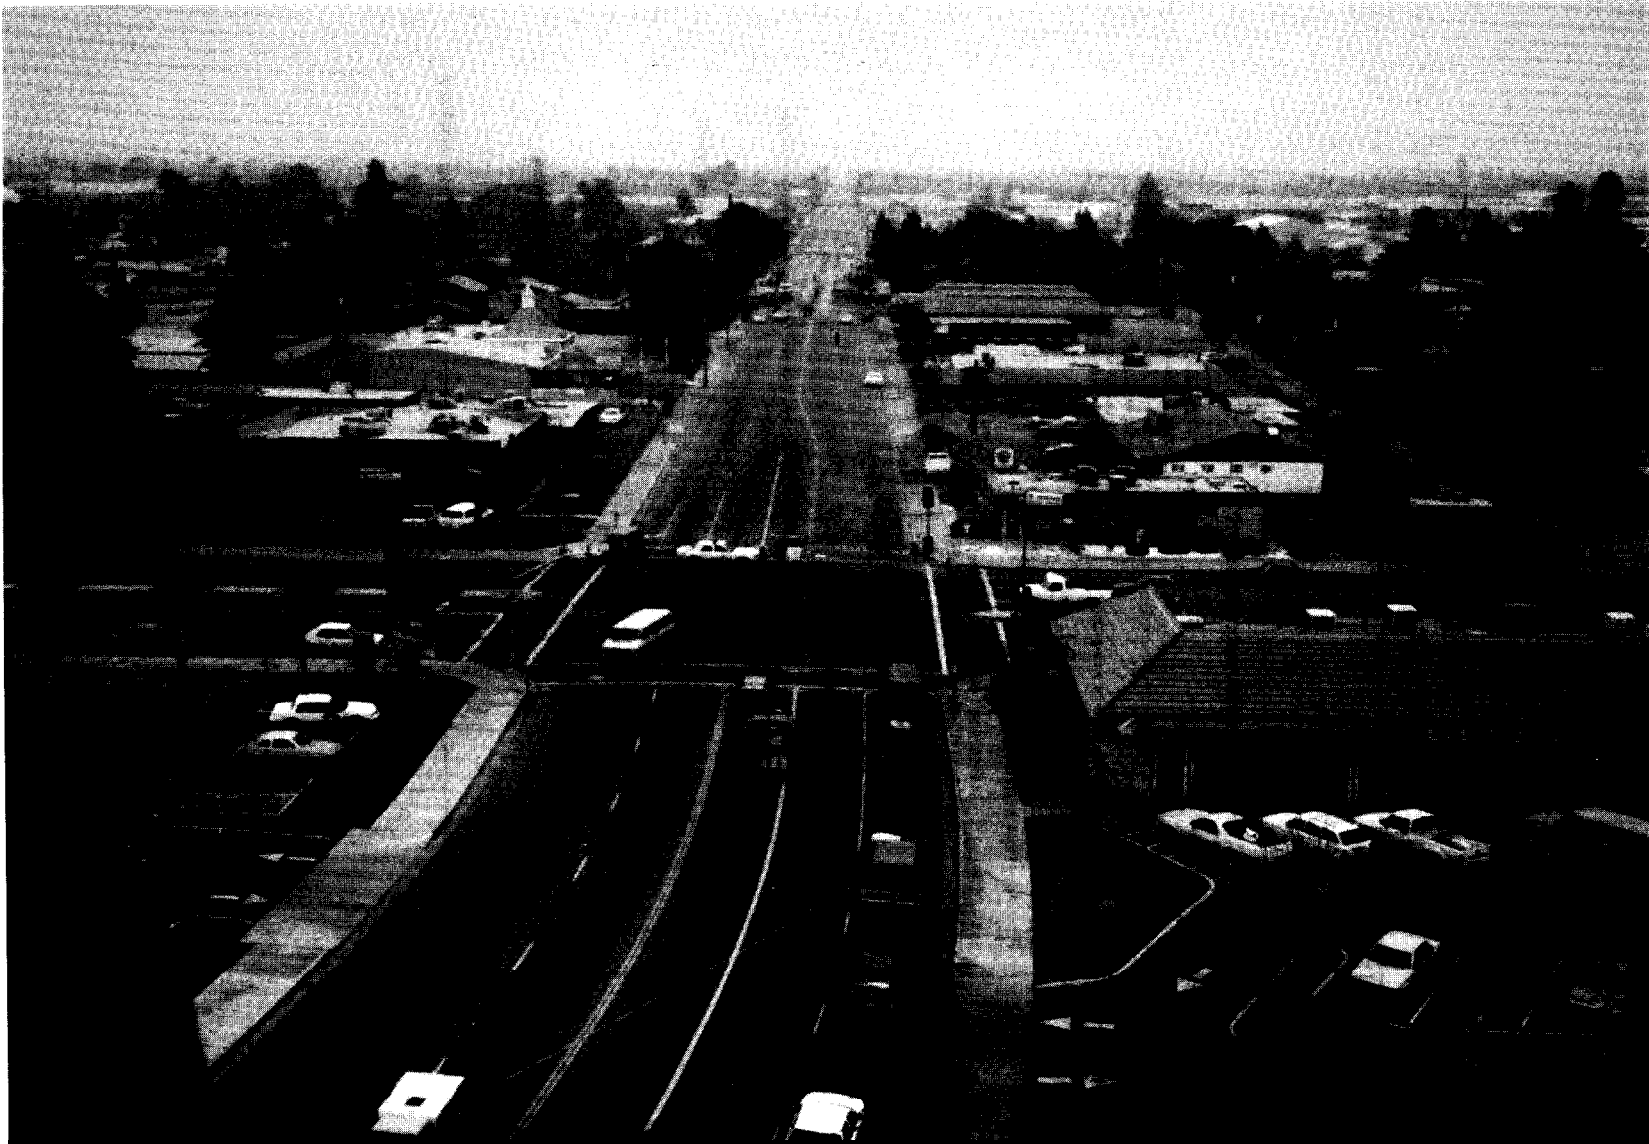
Figure 2a.--View to the west on E. Olive
looking approximately down the final flightpath.

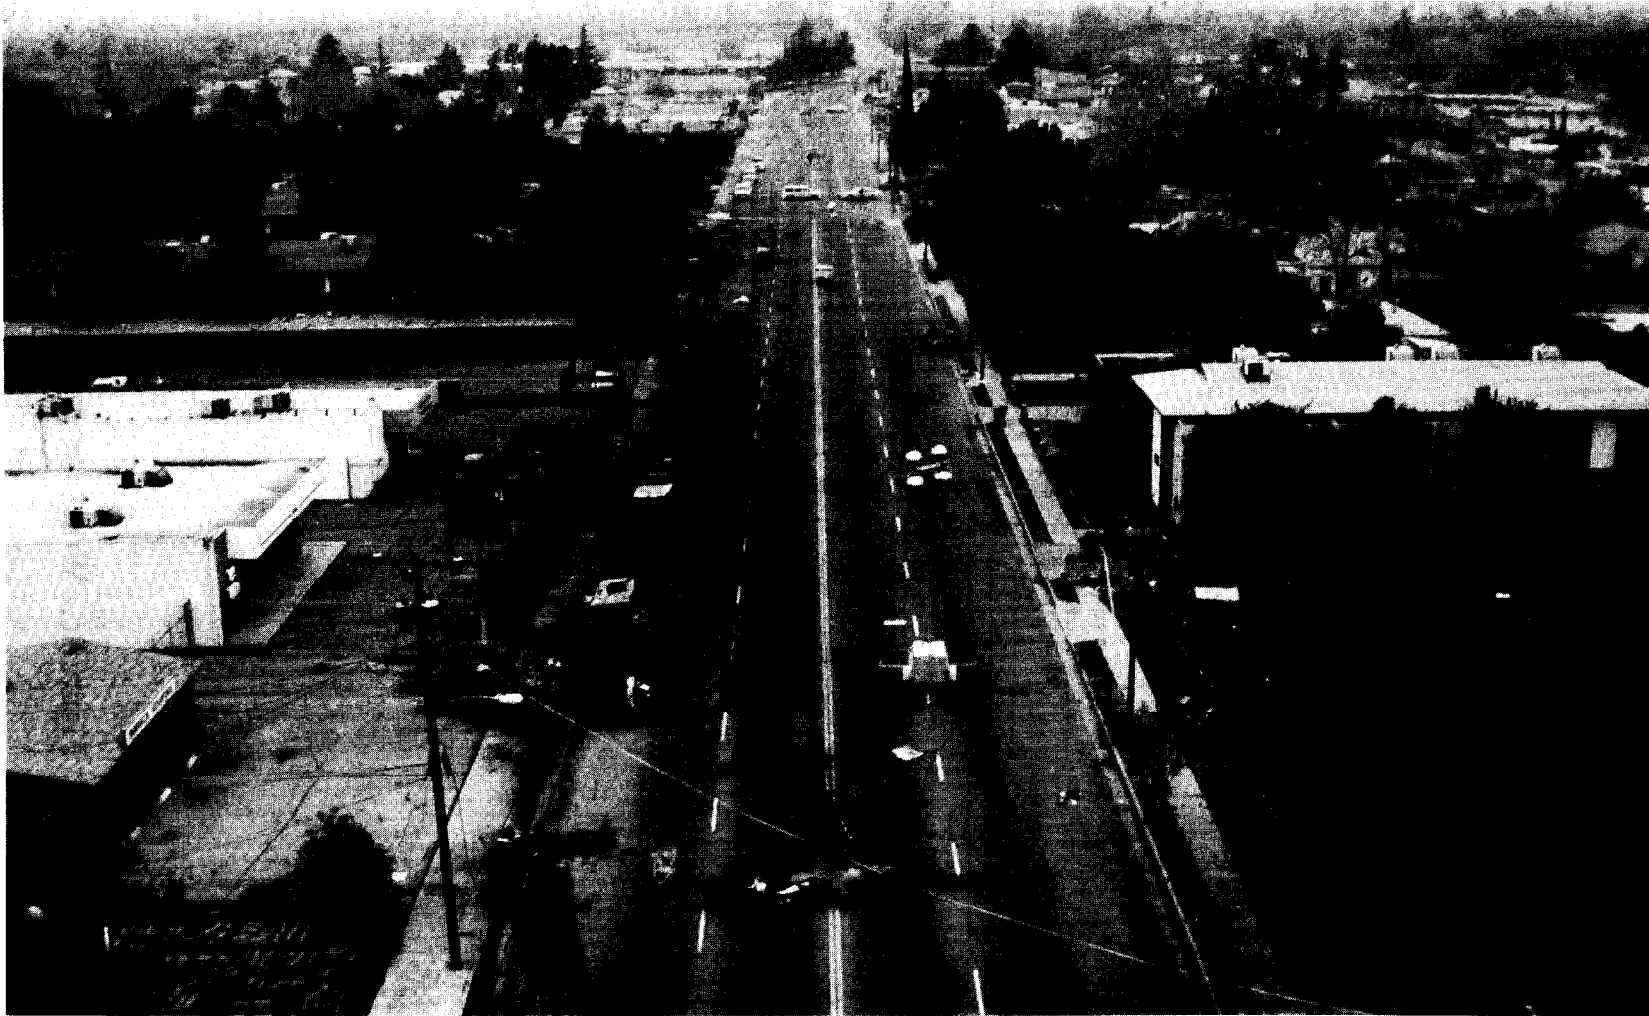
Figures 2b.--View to the east on E. Olive from immediately east of N. Sierra Vista. Last major portions of wreckage in wreckage path are near the bottom of the photograph.

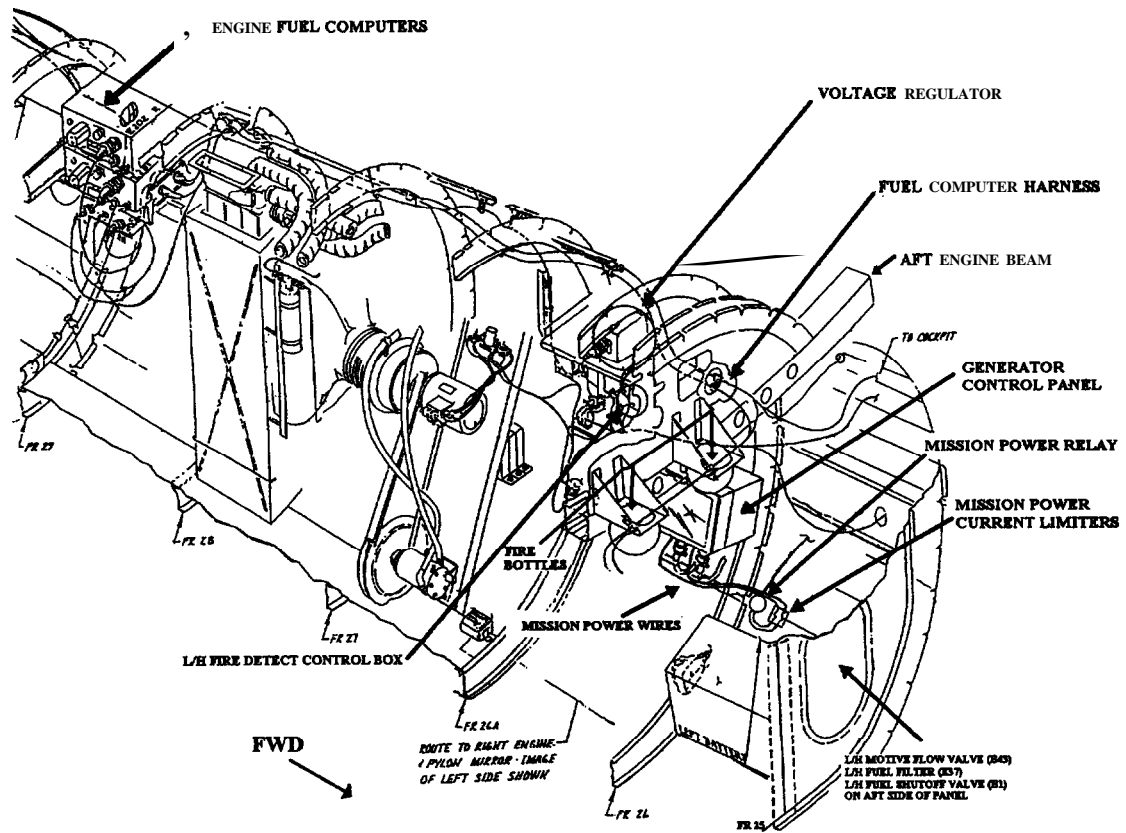
Figure 3a.--Components in tailcone.

The investigation found that in the actual mission equipment wiring of **N521PA**, the power wires were routed directly to the battery charging bus. (Figure 3a is a drawing of major components in the tailcone. Figure 3b shows the intended versus actual routing of the power wires in **N521PA**.)

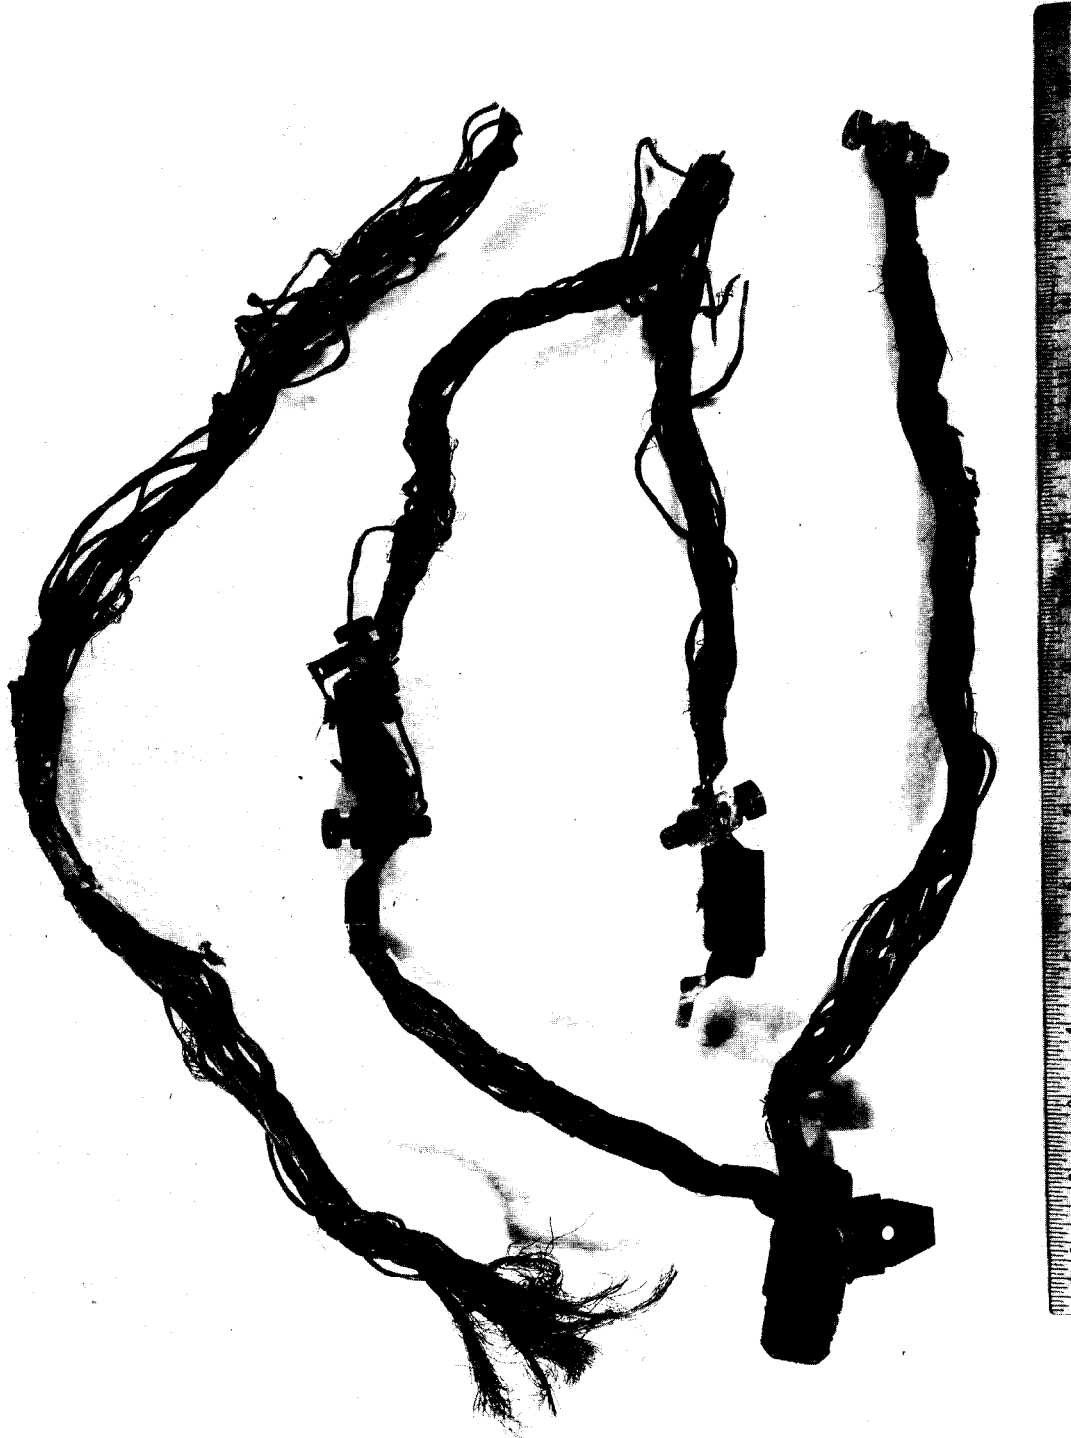
Portions of the wires, identified as part of the electrical power source for the special mission package, were size No. 0 awg and were found on E. Olive, near the wheel of an unburned vehicle. The wires had evidence of high heating prior to impact, including areas fused together for about 2 inches in length, and individual strands of the wires had a beaded appearance. (See figure 4.) Current limiters (fuses) were found attached to the nonwelded ends of one of the two sets of wires. In subsequent testing, the current limiters were found to provide electrical continuity (in the closed position).

Figure 4.--View of cables as received for examination.
