AIRCRAFT ACCIDENT REPORT

**UNCONTROLLED COLLISION WITH TERRAIN
AIR TRANSPORT INTERNATIONAL
DOUGLAS DC-8-63, N782AL
KANSAS CITY INTERNATIONAL AIRPORT
KANSAS CITY, MISSOURI
FEBRUARY 16, 1995**

**Adopted: August 30, 1995
Notation 6538A**

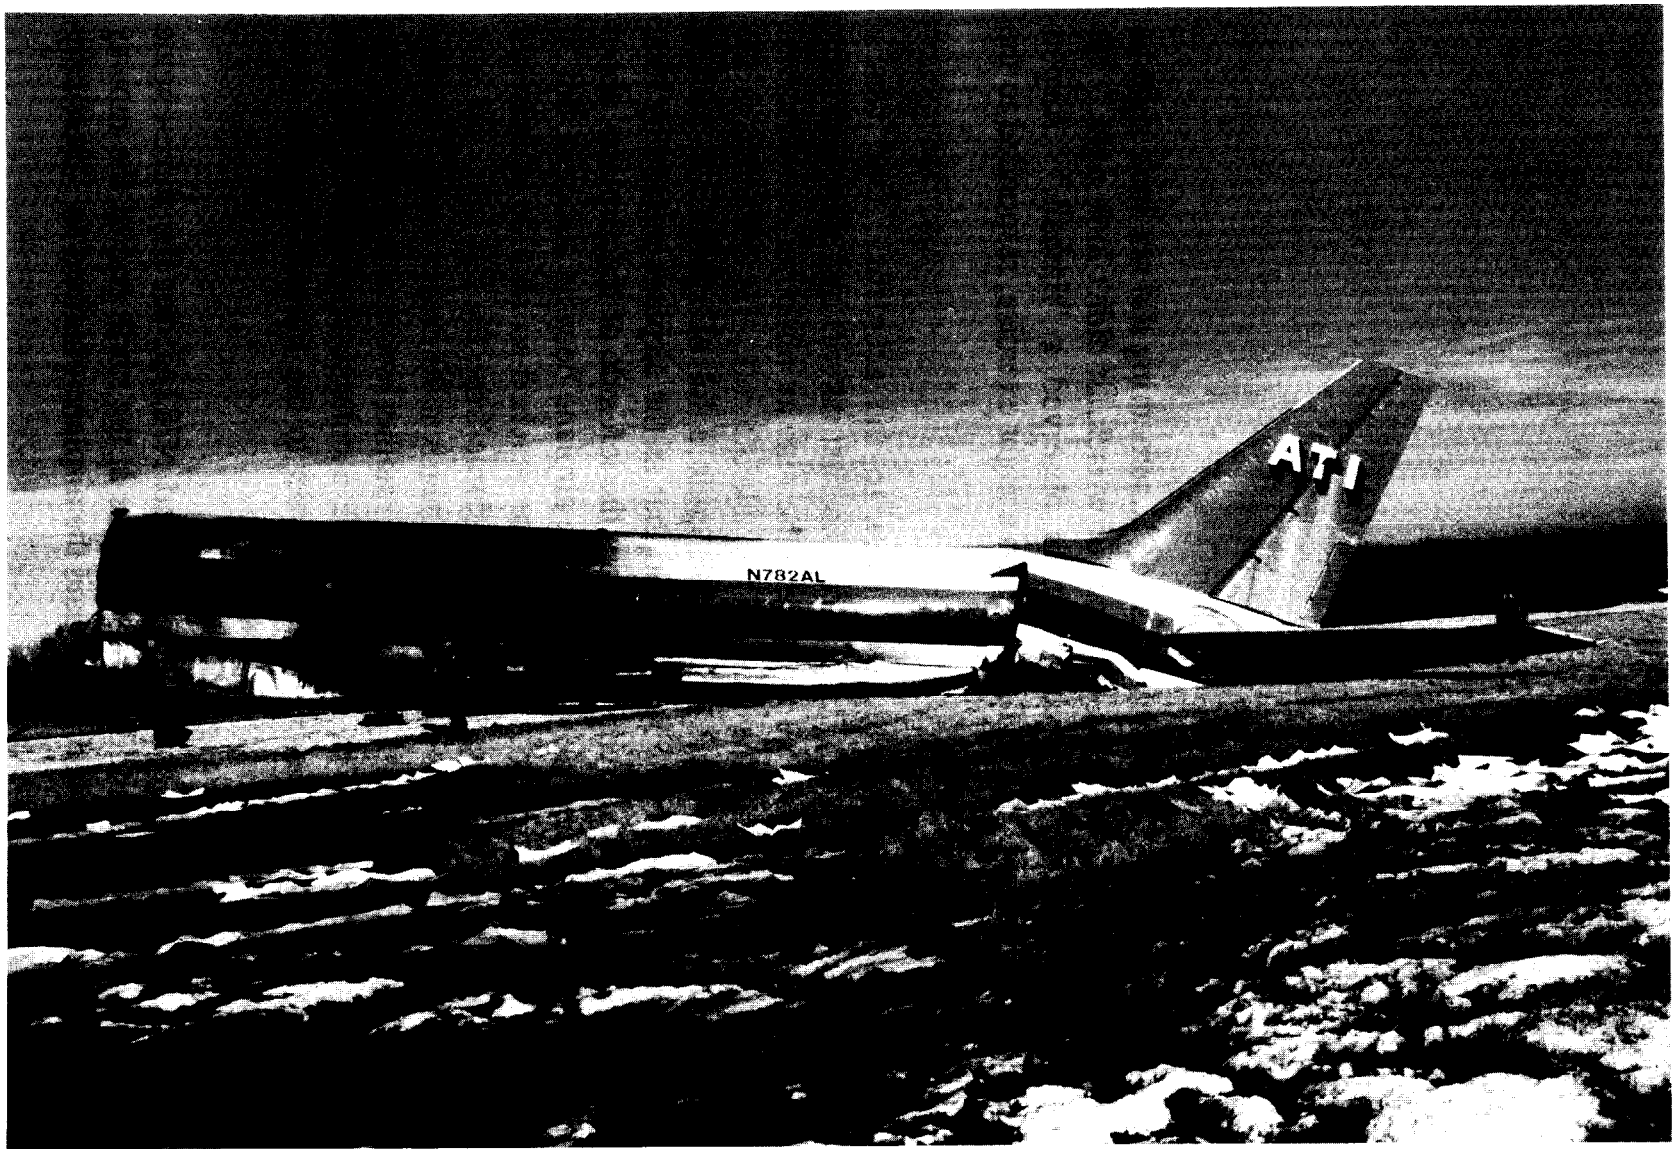
Figure 1.--Ground view of wreckage.

nose high attitude during rotation,” and he observed a “bright yellowish-orange ball of fire from the exhaust of the No. 2 engine.” He then saw the airplane enter a “slowly increasing left bank” just before impacting the ground. See figures 1 and 2.

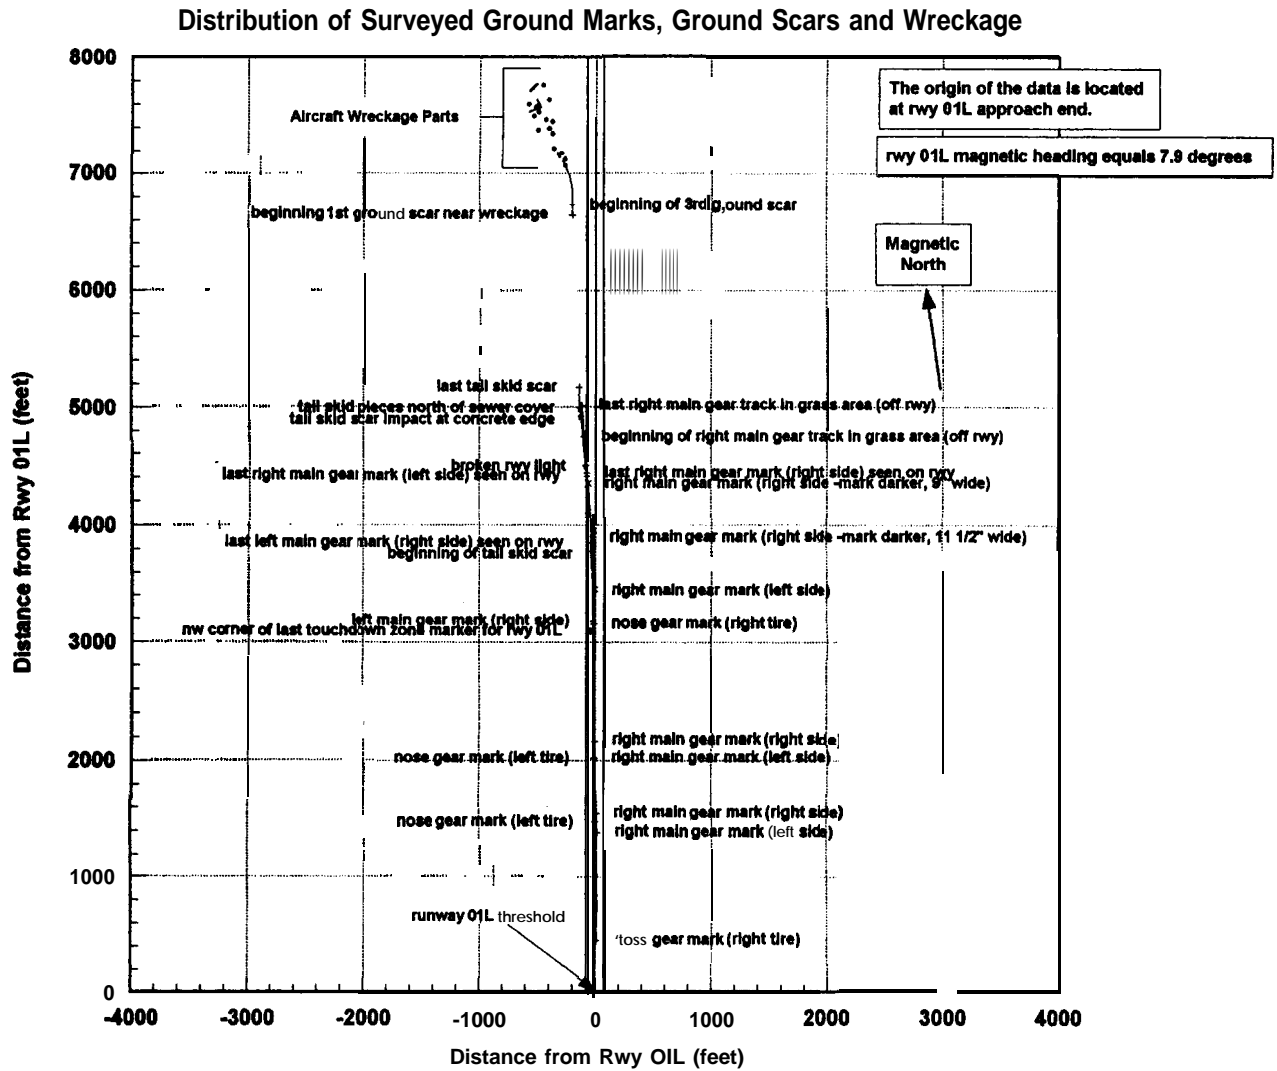
Figure 4.--Ground scars, ground marks, and wreckage.

Several ground impact scars, containing pieces of left wing, were observed near the main wreckage site. The first of these ground scars began 1,470 feet from the end of the tail skid scar. Fuel was spilled throughout the area of the initial ground scars, and most of the grass in this area was burned. A large trench began approximately 300 feet from the initial ground scar. The trench was generally oriented along a magnetic heading of 350 degrees, although it curved to the west slightly.

A large crater was located beyond the trench. Pieces of cockpit side window, a nose landing gear door, forward fuselage, a main cargo door latch assembly, and pieces of the No. 2 engine were found in and around the crater. A 10-foot section of the left wing tip was located near the crater. This piece had been heavily damaged by fire, and the outboard tip structure was mangled and bent. Also found just beyond the crater were a 19-foot-long piece of outboard left lower skin and most of the main cargo door. Examination of the door revealed that it was latched and locked. Pieces of red lens were found between the initial left wing
