PB95-910407  
NTSB/AAR-95/07  
DCA95MA006

## AIRCRAFT ACCIDENT REPORT

UNCONTROLLED COLLISION WITH TERRAIN  
FLAGSHIP AIRLINES, INC., dba AMERICAN EAGLE  
FLIGHT 5379, BAe JETSTREAM 2201, N918AE  
MORRISVILLE, NORTH CAROLINA  
DECEMBER 13, 1994

**Adopted: October 24, 1995  
Notation 6520A**

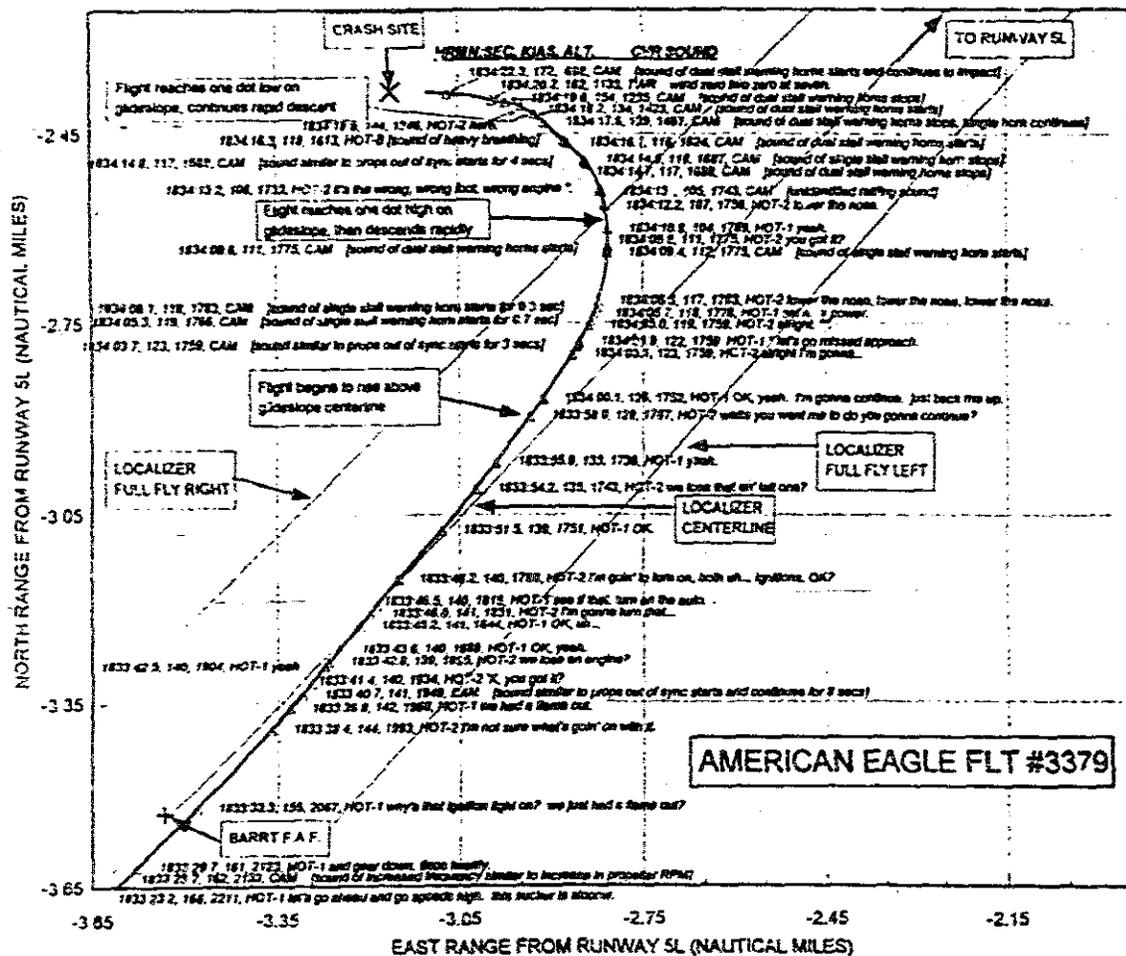
Figure 1.--Airplane ground track.

For the next several seconds, the airplane remained relatively level at approximately 1,800 feet, as the airspeed decreased from 140 knots to 122 knots, when the captain decided, "Let's go missed approach." In less than 2 seconds, at 1834:05.3, two momentary stall warnings occurred as the captain called, "Set max power," and the left turn rate increased. The first officer called, "Lower the nose, lower the nose, lower the nose," but the airplane remained at about 1,800 feet, and the airspeed continued to decay to approximately 119 knots as the left turn rate increased to about 5° per second.

At 1834:09.4, a stall warning horn started again, and was followed at 1834:09.6 by the dual stall warning horns. At this time, the airplane was still at 1,775 feet, and the airspeed had slowed to 111 knots. The first officer inquired, "You got it?," and the captain responded, "Yeah." The airspeed decreased to 103 knots at 1834:12, and the first officer said, "Lower the nose." At 1834:13.2, the first officer said, "It's the wrong, wrong foot, wrong engine." About this time, the rate of descent increased rapidly to more than 10,000 feet per minute. The rate of turn increased to about 14° per second at 1834:16, as the airspeed increased rapidly. There were several significant normal accelerations during this period. The airplane finally stabilized the last few seconds before impact at an airspeed of about 170 knots, a normal acceleration of 2.5 G absolute, and a heading of 290°.

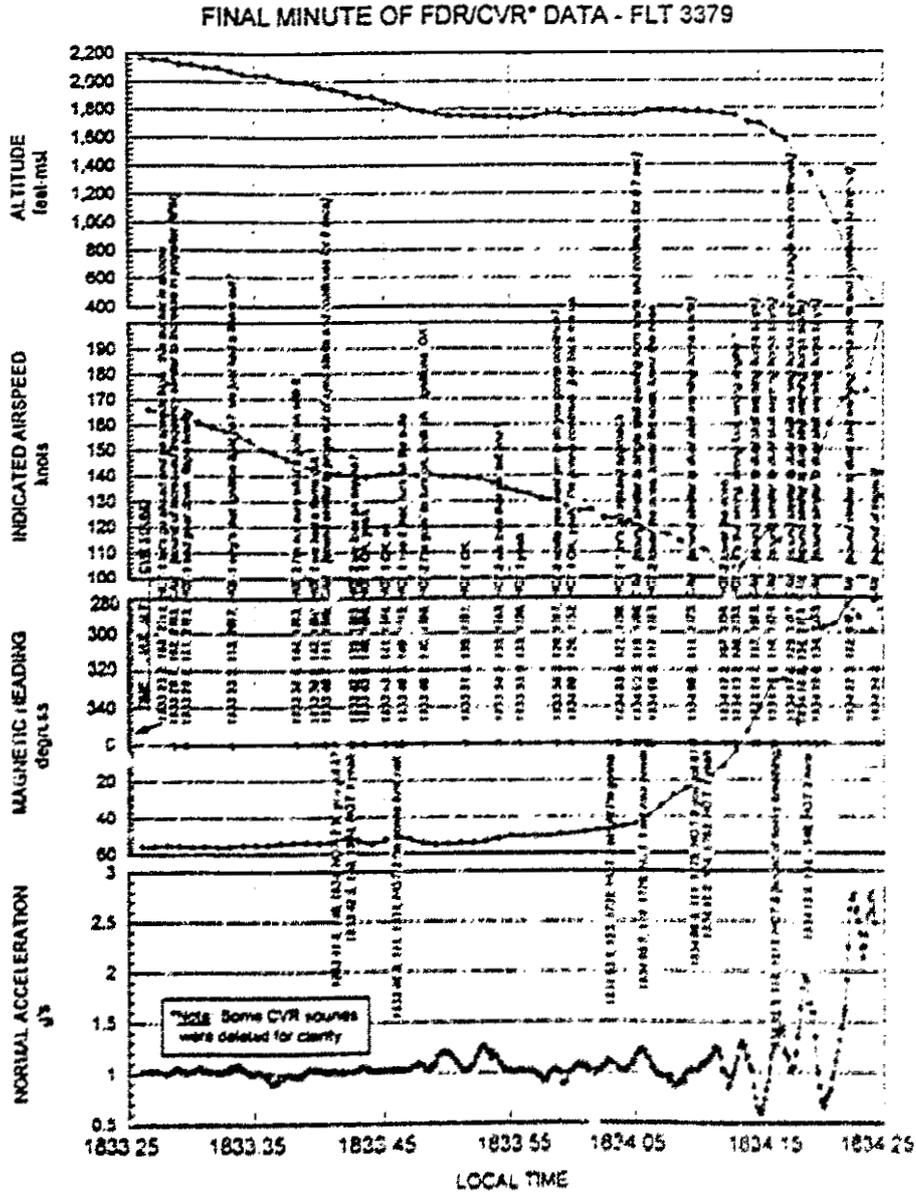
Figure 2. -FDR data.

The aircraft was equipped with a Loral Fairchild Model F800 digital flight data recorder (FDR), Part No. 17M703-274 (S/N 5379).<sup>12</sup> The FDR records pressure altitude, magnetic heading, indicated airspeed, vertical acceleration, and VHF [very high frequency] radio keying data on an elapsed time line for 25 hours before recording over the oldest data. The recorder was heavily damaged by impact forces, and the exterior casing had to be cut away to remove the crash-survivable memory module. This module was slightly damaged on the inside, but the tape was undamaged. The last 3.5 hours of data were transcribed to a disk file for processing. Figure 2 depicts the last minute of FDR VR data.
