NATIONAL TRANSPORTATION SAFETY BOARD

AIRCRAFT ACCIDENT REPORT

WHEELS-UP LANDING
CONTINENTAL AIRLINES FLIGHT 1943
DOUGLAS DC-9 N10556
HOUSTON, TEXAS
FEBRUARY 19, 1996

**Adopted: February 11, 1997
Notation 6804**

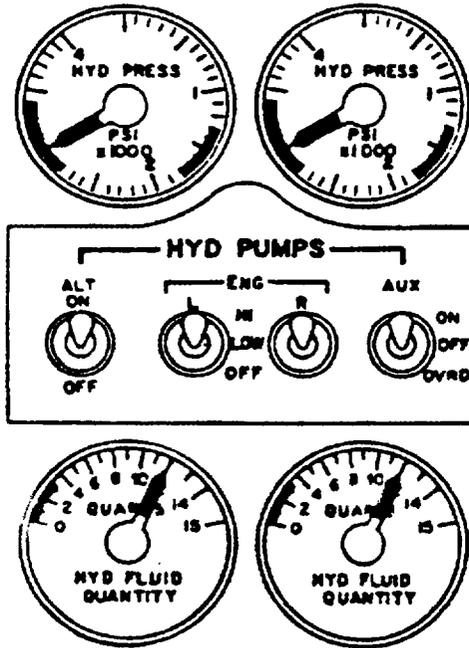
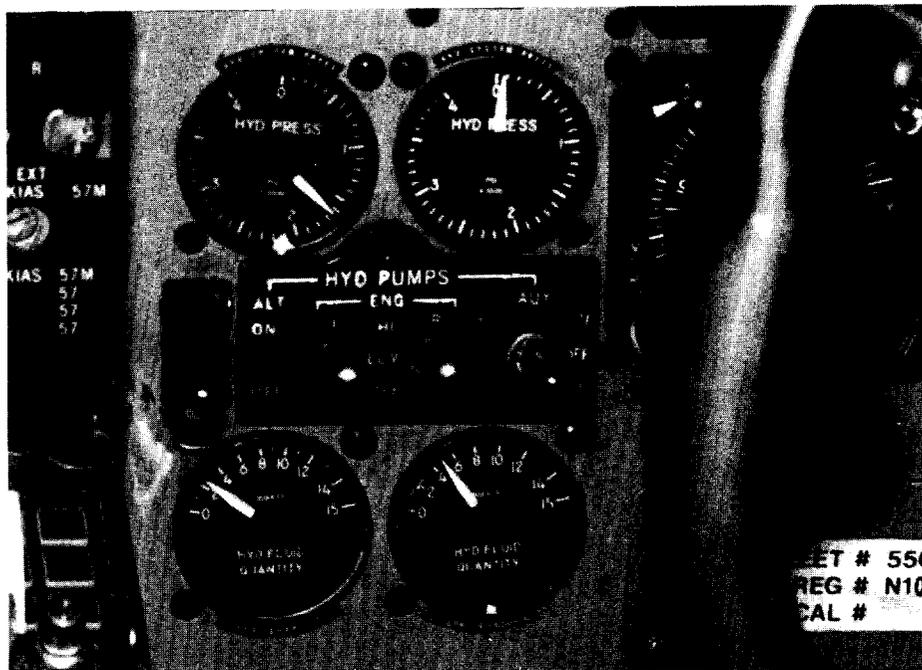
Figure 1 – Hydraulic switch panel.

Upper Illustration - Hydraulic switch panel in high pressure configuration.

Bottom Photo - Photo of accident airplane's hydraulic switch panel in low pressure configuration (see section 1.12).

Examination of the cockpit revealed that the landing gear handle was in the down position and the flap handle was set to 50°. The left and right engine-driven hydraulic pump switches were in the “LOW” position, and the ALT and AUX hydraulic pump switches were in the “OFF” position. The left hydraulic system gauge indicated 1,600 psi, and the right gauge indicated 0 psi (refer to figure 1). The safety wire on the GPWS flap override switch was found broken; however, the switch was not in the “OVRD” position.

The evidence indicates that the airplane's hydraulic system was not configured for landing. Because the hydraulic system remained in the low pressure mode, hydraulic pressure was not available to lower the landing gear and deploy the flaps. The flightcrew failed to detect this configuration error and continued its approach into Houston. Comments on the CVR and postaccident statements by the flightcrew indicate that both pilots recognized that the flaps did not deploy after the flaps were selected to 15°, but the flightcrew did not determine the cause of this problem or execute a go-around.
