**Safety Recommendation Report**

**Preventing Windshield Arcing, Smoke, and Fire on  
Bombardier DHC-8 Airplanes**

<b>Accident Number:</b>	ENG15IA024
<b>Operator/Flight Number:</b>	United Express flight 4776 (operated by CommutAir)
<b>Aircraft and Registration:</b>	Bombardier DHC-8-202, N363PH
<b>Location:</b>	Windsor Locks, Connecticut
<b>Date:</b>	June 5, 2015
<b>Adopted:</b>	March 11, 2016

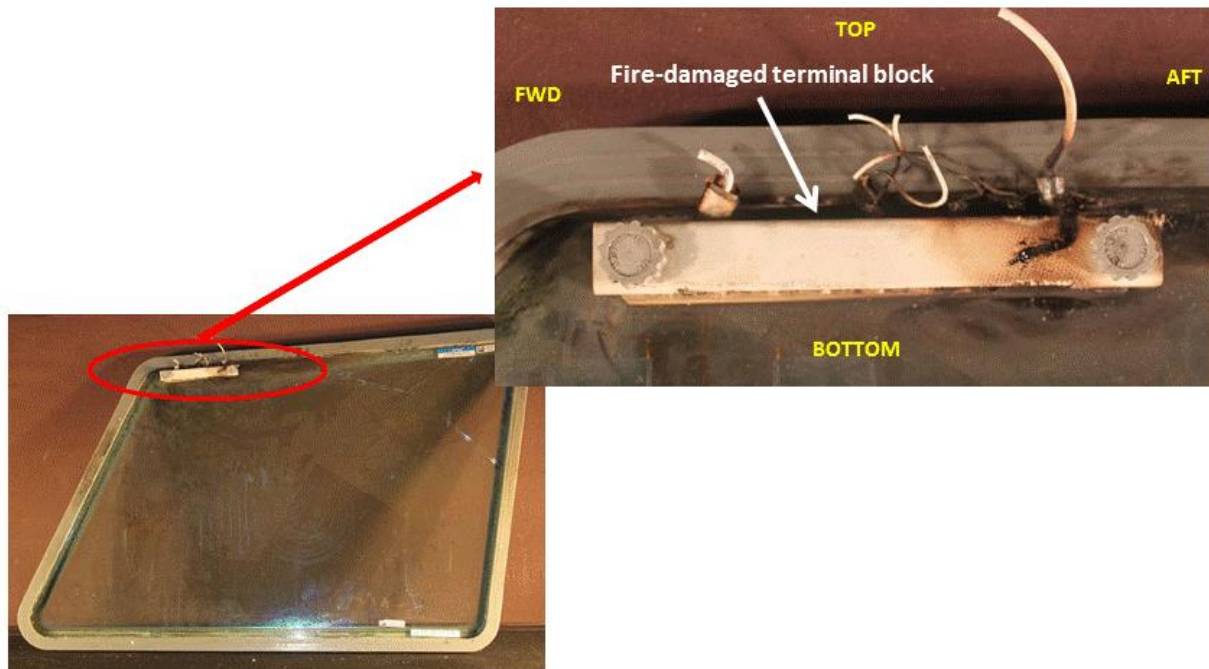
Although postincident examination of the windshield found typical signs of aging (described in more detail below) with evidence of moisture ingress into the laminate around the edges of the windshield, the discrepancies were within the manufacturer's published limits and did not contribute to the failure.<sup>2</sup> The fire damage was concentrated in an area between the upper edge of the terminal block and the lower edge of the windshield gasket where the power wire was routed (see figure). The power wire was melted through in this area but remained soldered to the terminal block, indicating an arcing failure of the power wire. The damage to the power wire precluded investigators from determining whether it was damaged before the incident.

**Figure.** Photographs showing the damaged windshield and inset of the fire-damaged terminal block.

Postincident examination of the airplane found that the windshield heat switch was in the normal (NORM) position, which would continue to provide power to the windshield heating system. Switching the windshield heat selector to off would have cut power to the circuit, eliminating the arcing and fire. As discussed below, at the time of the incident, neither CommutAir nor Bombardier had flight crew checklists, guidance, or training addressing what to do in the event of windshield arcing, smoke, fire, or overheating. The NTSB determined that the probable cause of the fire was “the arcing failure of the windshield heat power wire on the right windshield due to unknown reasons. Contributing to the severity of the fire was the lack of

The current design of the DHC-8 windshields provides for connection of the windshield heat power wires to the terminal block using a ring terminal, screw, and lock washer. These screw connections are susceptible to cross-threading, improper torque, loosening over time due to vibration, and incorrect hardware usage, all of which can lead to arcing at the terminal block. In 2003, Bombardier revised the DHC-8 aircraft maintenance manual (AMM) to provide information on the correct screw and washer part numbers for attaching the power and sensor wires to the windshield terminal blocks and in 2005 revised the AMM to include the proper installation torque values for the terminal block screws. In 2012, Transport Canada issued Civil Aviation Safety Alert 2012-01 recommending detailed inspection of the windshield terminal blocks for security, overheating, and wire routing and re-torqueing of the attaching hardware.<sup>6</sup> Although Bombardier has published several in-service activities report articles over the years on windshield arcing, smoke, fire, or overheating events, these events continue to occur. Where the cause of the arcing, smoke, or fire could be determined, many of the 94 reports found during the NTSB’s investigation cited a loose connection at the terminal block or incorrectly installed/missing hardware.

Redesign the windshield heat power connection for all Bombardier DHC-8 airplanes to provide a mechanically secure, low-resistance electrical connection. (A-16-3)
