## Safety Recommendation Report

### Unsafe Wiring Conditions in Piper Model PA-31T-Series Airplane Floor-Mounted Circuit Breaker Panels

<b>Accident Number:</b>	WPR16FA153
<b>Operator/Flight Number:</b>	Cal-Ore Life Flight
<b>Aircraft and Registration:</b>	Piper PA-31T, N661TC
<b>Location:</b>	McKinleyville, CA
<b>Date:</b>	July 29, 2016
<b>Adopted:</b>	January 5, 2017

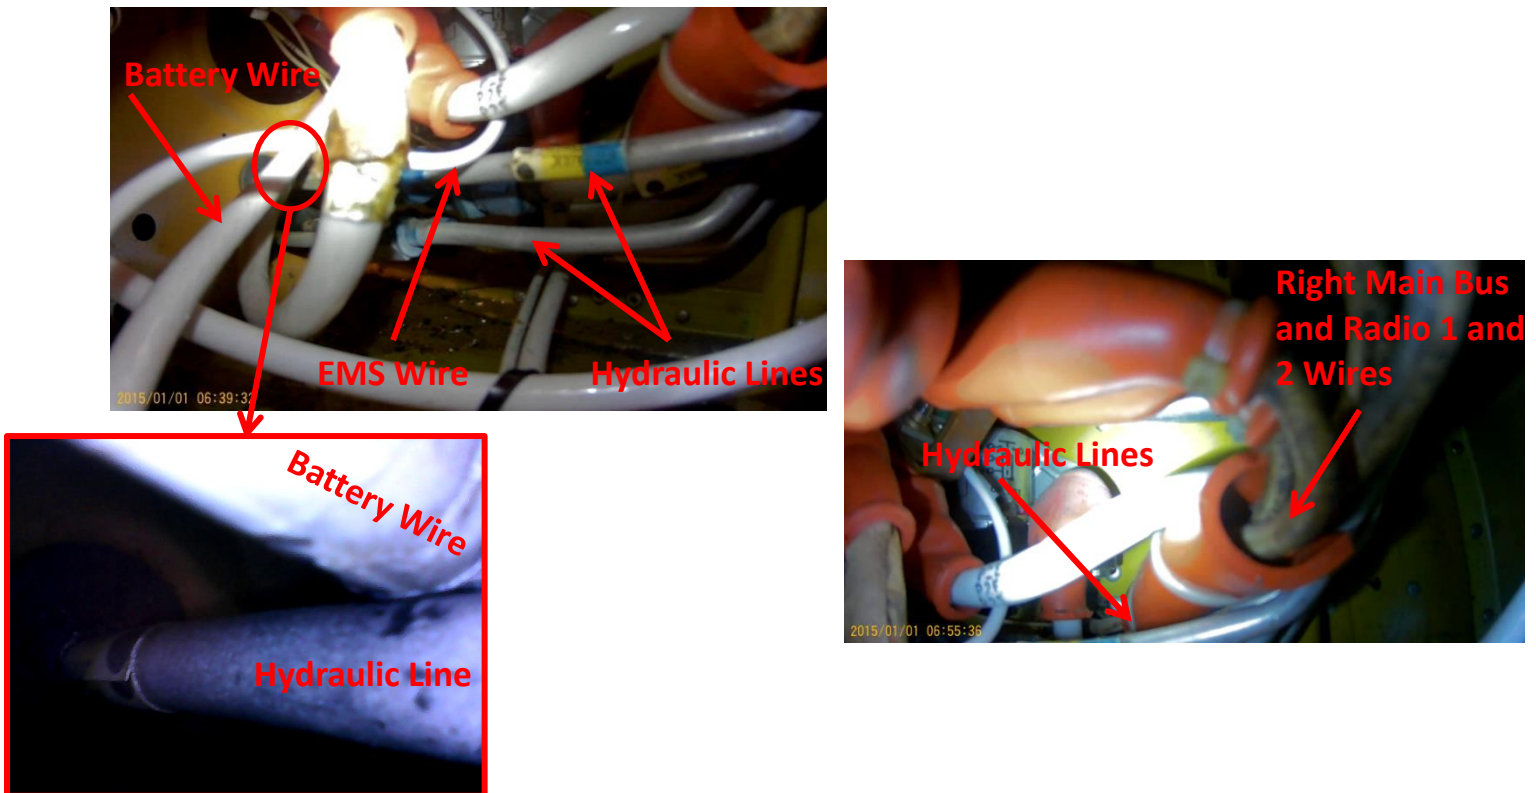
Advisory Circular (AC) 43.13-1B, "Acceptable Methods, Techniques, and Practices—Aircraft Inspection and Repair," advises against wires and fluid lines being in contact due to the risk of chafing, which can lead to thermal stress and arcing in an area where flammable liquids are routed.<sup>2</sup> This guidance material specifies a minimum 1/2-inch clearance between the wires and the fluid-carrying lines. During this investigation, the NTSB and the FAA examined the same area in six exemplar Piper model PA-31T-series airplanes and found instances on all six exemplar aircraft of unsafe conditions in which electrical lines and hydraulic lines were in direct contact (see figure).<sup>3</sup> Some of the wires in the exemplar aircraft showed chafing between the hydraulic line and the electrical wires, which, if left uncorrected, could have led to electrical arcing and subsequent fire.

**Figure.** Photographs showing contact between wires and hydraulic lines in exemplar Piper PA-31T-series airplanes.

The NTSB notes that, currently, about 317 Piper PA-31T-series airplanes are registered with the FAA. During annual inspections, the area below the circuit breaker panel is only accessible through a panel in the belly of the airplane. As shown in the figure, the number of electrical wires and hydraulic lines that are routed through the area further obscure an already confined space where visual sight lines are limited. Current maintenance procedures in AC 43.13-1B only specify a general visual inspection of the area to check “electrical wiring for security.” The difficulty of detecting this unsafe condition through visual means alone likely explains why it was not previously identified on all six of the exemplar airplanes examined during our investigation using a borescope and camera. We are concerned that current maintenance procedures do not provide adequate guidance for inspection in these areas, thereby allowing contact between electrical wires and hydraulic fluid lines to persist undetected.

On December 16, 2016, the FAA issued Special Airworthiness Information Bulletin (SAIB) CE-17-05 to alert owners and operators of these airplanes about this safety issue. The SAIB recommends that the condition of all wiring in the floor-mounted circuit breaker panel be inspected at the next scheduled maintenance visit using “a mirror, a suitable light source or other equipment (small cameras, borescopes, magnification, etc.) capable of providing equal or better resolution.” It also recommends that owners and operators repair or replace any damaged wires and ensure that proper clearance between wires and hydraulic lines is maintained.

Issue an emergency airworthiness directive (AD) that requires owners and operators of Piper PA-31T-series airplanes to take the actions recommended in Special Airworthiness Information Bulletin CE-17-05 immediately after the AD is issued. (A-17-1) Urgent
