National Transportation Safety Board

Safety Recommendation Report

Preventing Catastrophic Failure of Pratt & Whitney Canada JT15D-5 Engines Following Birdstrike or Foreign Object Ingestion

Accident Number:	ENG14IA013, ENG14IA011, and CEN09IA481
Operator/Flight Number:	Multiple
Aircraft and Registration:	Multiple
Location:	Multiple
Date:	Multiple
Adopted:	February 28, 2017

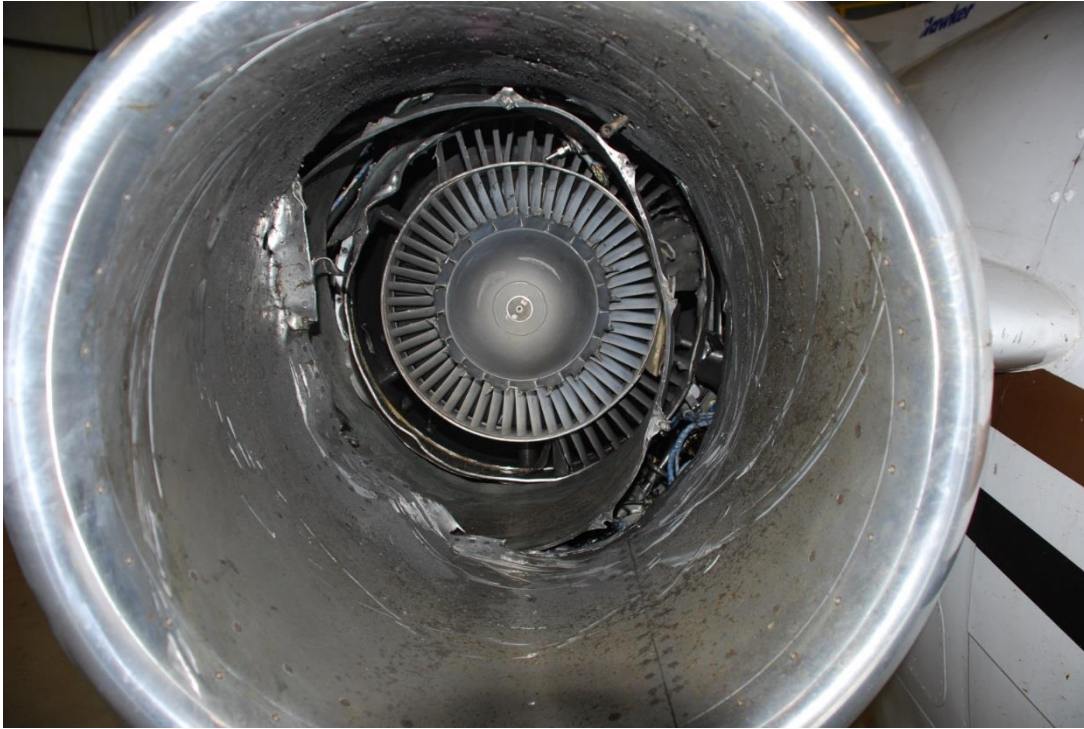
On May 13, 2014, about 1511 central daylight time, a Beechcraft Beechjet 400A, registration number N412GJ, equipped with two PWC JT15D-5 engines, experienced a fire in the No. 2 (right) engine following a birdstrike during takeoff roll at Sugar Land Regional Airport (SGR), Sugar Land, Texas. The flight crew successfully rejected the takeoff and discharged both fire bottles, which extinguished the fire. During an examination of the airplane, fuel was found leaking from the No. 2 engine cowling and from a puncture in the right wing fuel tank. The No. 2 engine fan blades were all fractured near the root. The No. 2 engine cowling had multiple penetrations and there was evidence of blade fragments impacting the inlet cowl forward of the fan (see figure 1).²

Figure 1. Photograph showing damage to the inlet cowl of the No. 2 engine on N412GJ.

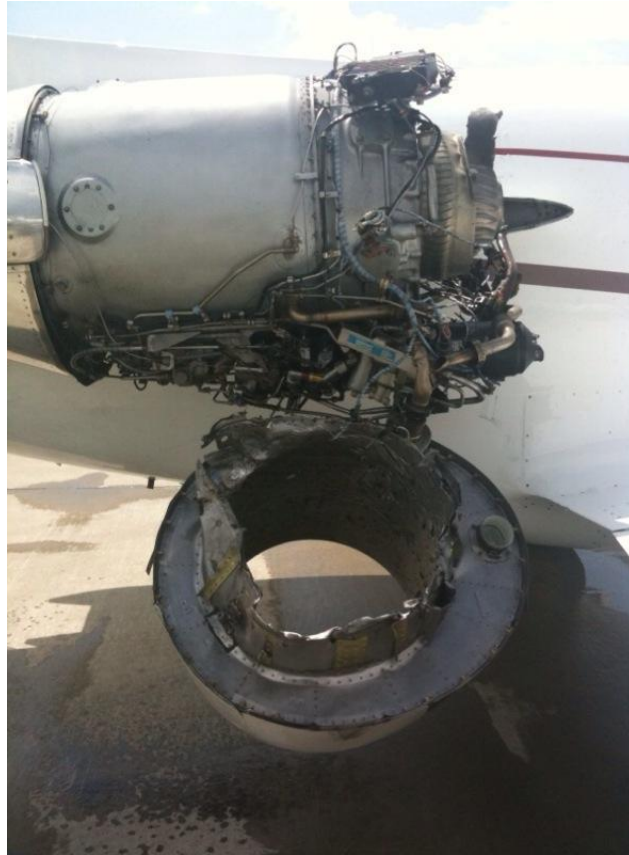
A similar event occurred at SGR in July 2009. In that incident, the No. 2 (right) PWC JT15D-5 engine on a Beechjet 400A, N679SJ, sustained damage and immediately lost all power after ingesting at least one bird during takeoff.³ The pilots successfully rejected the takeoff. Postincident examination of the airplane found all but one of the right engine fan blades fractured and that the inlet duct separated from the front of the engine (see figure 2).⁴

Figure 2. Photograph showing the inlet duct separated from the No. 2 engine on N679SJ.

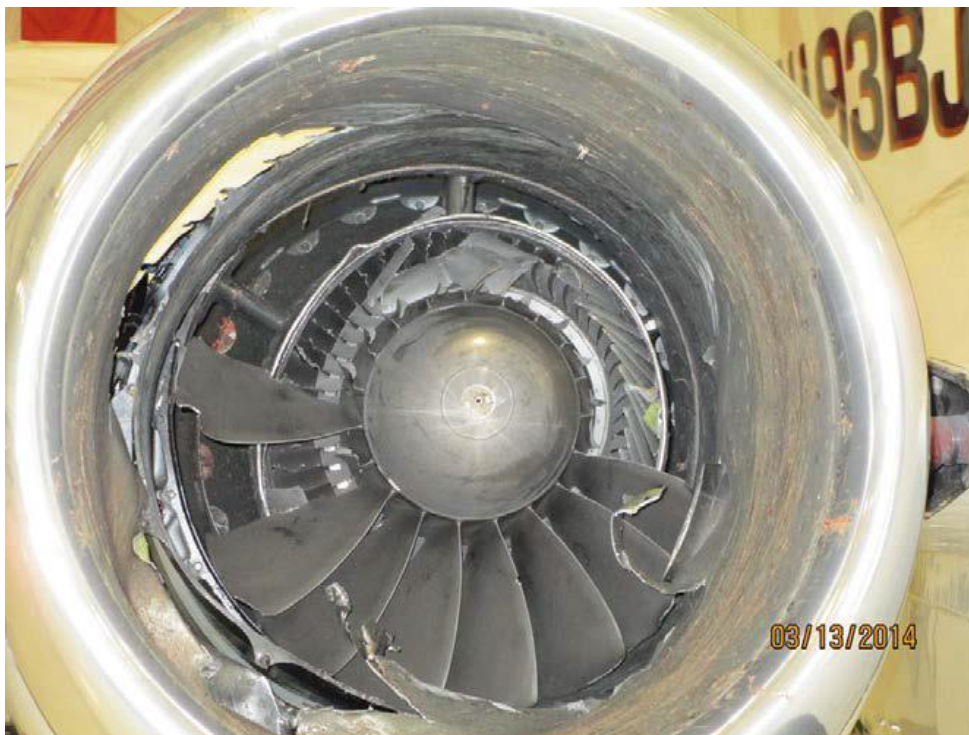
On March 13, 2014, about 1020 eastern daylight time, the No. 2 (right) PWC JT15D-5 engine of a Beechjet 400A, N193BJ, was damaged following a birdstrike shortly after takeoff from Greater Rochester International Airport, Rochester, New York.⁵ The flight crew declared an emergency and returned to the airport where they performed an uneventful landing. During an examination of the airplane, extensive damage to the No. 2 engine fan and inlet cowl was observed (see figure 3). The compressor cowl had multiple holes and the right wing had an impact mark forward of the engine fan case. Several weeks after the event, a blade fragment was found lodged in the roof of a building below the flightpath.⁶

Figure 3. Photograph showing damage to the inlet cowl of the No. 2 engine on N193BJ.
