# MIDAIR COLLISIONS IN U. S.

## CIVIL AVIATION - 1968

### A SPECIAL ACCIDENT PREVENTION STUDY

## NATIONAL TRANSPORTATION SAFETY BOARD

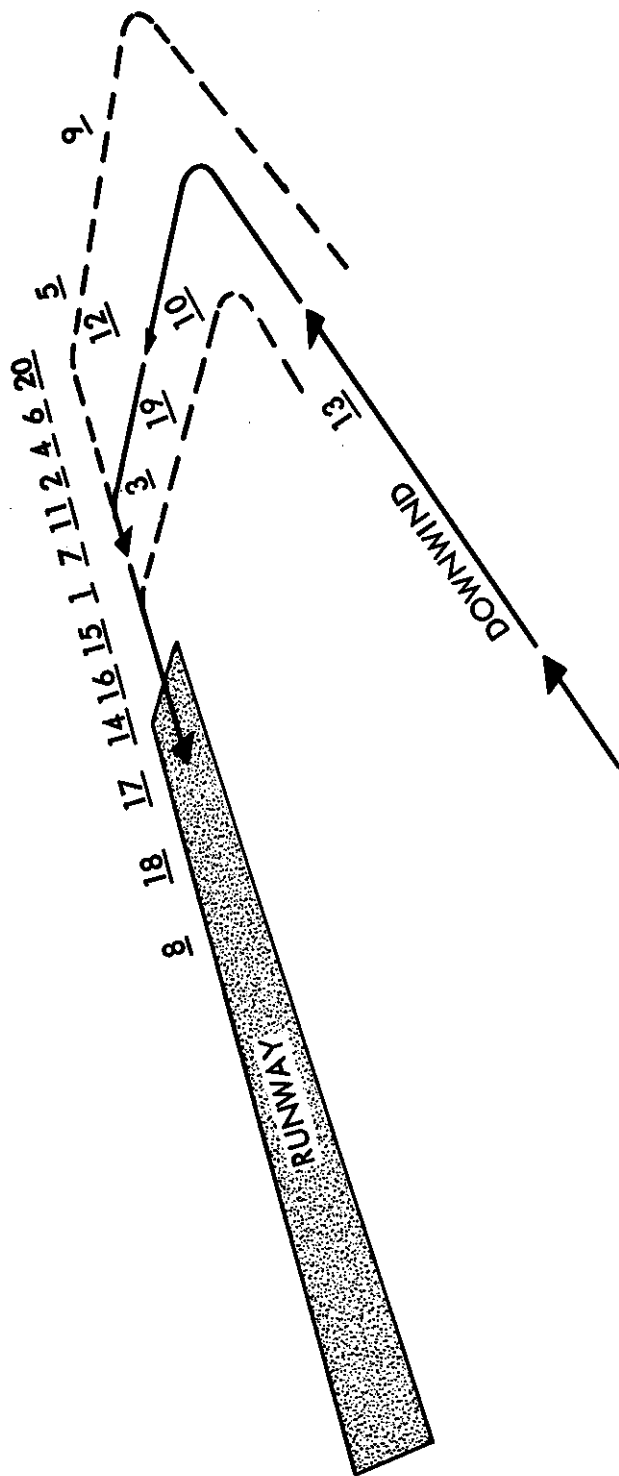
The area shown in Figure 9 is not only the area of greatest concentration of aircraft but also that part of the traffic pattern where a pilot is engaged in the most vulnerable and critical part of the flight--the landing. Increased attention is given to the landing gear, flaps, attitude control, and airspeed. He is concerned with wind speed and direction and possible traffic on the ground. He endeavors to position his aircraft at such an altitude and distance as to enable an approach best suited to the prevailing conditions. He may have to be attentive to instructions from air traffic control and be concerned with positioning his aircraft in the right sequence to land. At times the weather conditions may force him to divide his attention and consequently interfere with his piloting duties.

The airport pattern (Figure 9) conditions are such that aircraft of different configuration, flown by pilots of varying skill, close on each other without being seen by either pilot. Unlike the surface highway, there is no dividing line and a separate lane for the fast and the slow, but rather three dimensions with which to contend, and a journey that must end in a single lane.

Approximate Position of 20 Mid-Air Collisions that Occurred in the Down-Wind, Base-Leg and Final Approach.
