STUDY OF LESSONS TO BE LEARNED FROM ACCIDENTS ATTRIBUTED TO TURBULENCE

NATIONAL TRANSPORTATION SAFETY BOARD,
WASHINGTON, D.C.

15 DEC 1971

Doc
NTSB
AAS
71
01

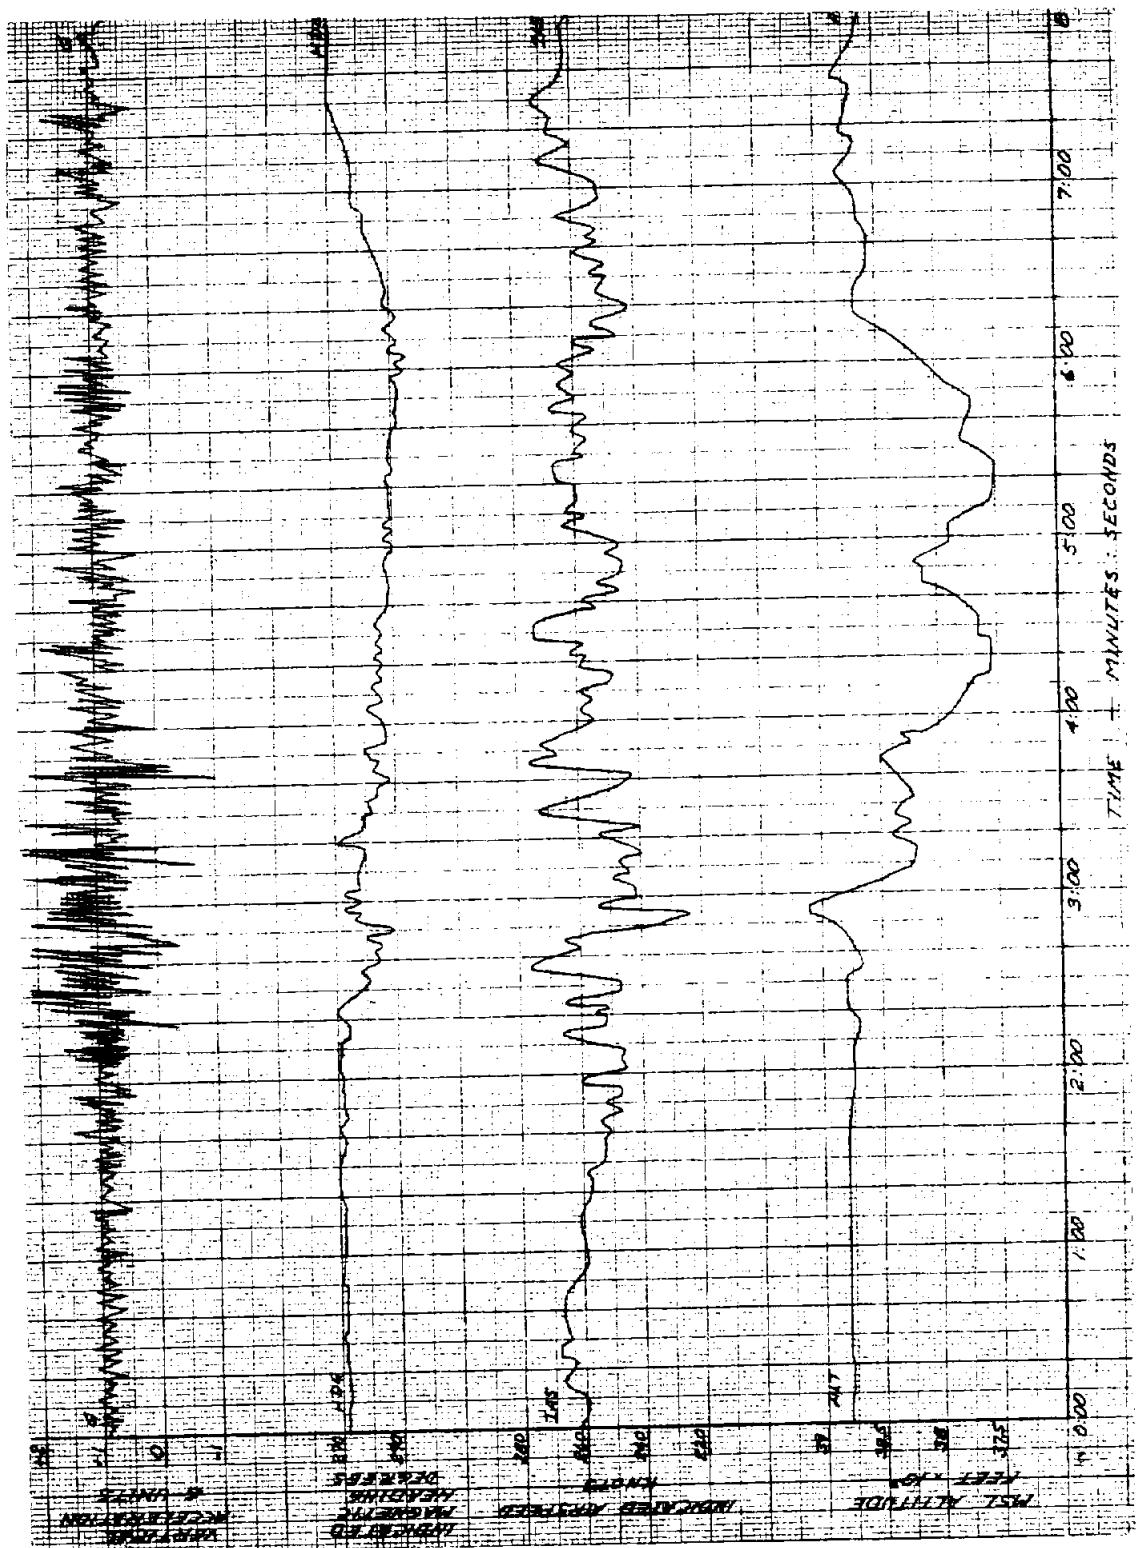
Figure 4 FLIGHT DATA RECORDER GRAPH
THUNDERSTORM PENETRATION

Fig. 4 is a reproduction of a portion of the flight data recorder graph associated with this accident. It can be seen that the maximum variance in vertical acceleration was from + 2.23 g's to -0.99 g or an incremental peak variation of 3.22 g's, while several variations of more than 2 g's are noted. During the worst of the encounter, airspeed fluctuated as much as 52 knots, the heading varied 20° and there were two successive altitude losses of almost 1,000 ft. Although the turbulence in this case has been categorized as severe, the variations in the parameters above, particularly the variation in vertical acceleration, meet the criteria for extreme turbulence.
