SPECIAL STUDY OF THE CARRIAGE OF RADIOACTIVE MATERIALS BY AIR

Adopted: April 26, 1972

NATIONAL TRANSPORTATION SAFETY BOARD Washington, D. C. 20591 REPORT NUMBER: NTSB- AAS-72-4 TECHNICAL REPORT STANDARD TITLE PAGE

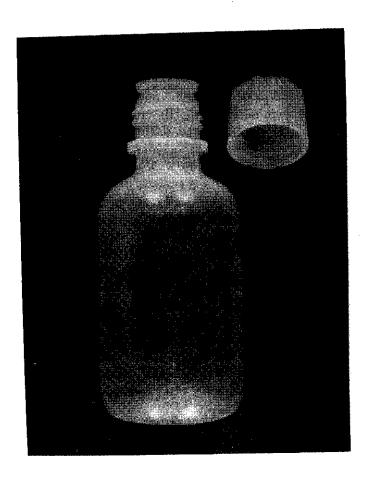
ATTACHMENT A-1

For example, the containment of the liquid isotope which leaked in that incident should have been assured by the requirements for the inner plastic bottle and for the gasketed closure of the lead-lined stainless steel secondary container (pig). However, in this case, it was determined that the mechanical manipulator used to install the top on the plastic bottle did not secure the top tightly enough to prevent leakage, and a section of the gasket under the plug top of the pig was missing. Thus, packaging designed to prevent release of its contents in accident conditions was not capable of preventing such release under conditions of normal transport.

Typical PRIMARY CONTAINER
Polyethylene bottle

SECONDARY CONTAINER "PIG" Stainless steel/lead lined Bio-Nuclear package # 40

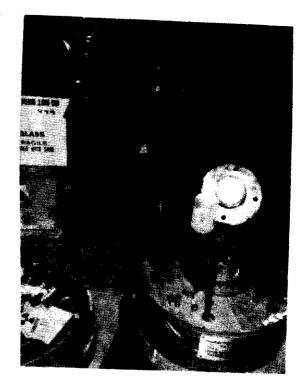
It is concluded that this incident occurred because of the improper packaging of a bulk liquid radioactive shipment in a poorly maintained reusable Type B container. A contributing factor was the transport by air with the package lying on its side.

CONTAINER #16 - Bio-Nuclear Neoprene gasket missing
