Special Study

JET BLAST HAZARDS

NATIONAL TRANSPORTATION SAFETY BOARD

REPORT NUMBER: NTSB-AAS-72-7

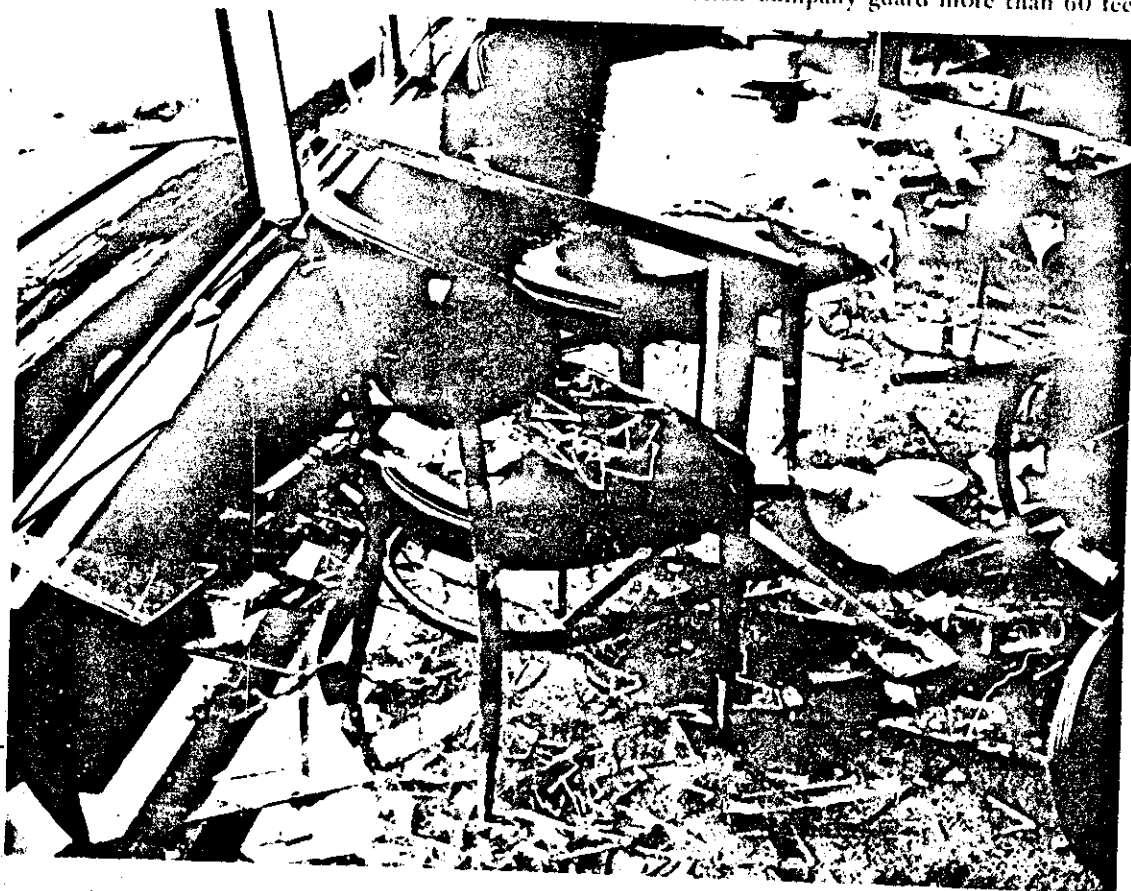
Three airline stewardesses having lunch at an airport restaurant were hospitalized after the windows of the restaurant were blown in by a jet leaving the gate area. The aircraft was required to make a short forward roll and a sharp turn to clear another aircraft parked at the adjacent gate. The ramp was covered with a layer of packed snow and slush. As the aircraft executed its turn out of the gate, the No. 2 rear mounted engine was 75-to-85 feet from the restaurant windows. The nosewheel began to slide during the taxi out, and the aircraft's

forward momentum was slowed down due to ramp conditions and the incline. When additional breakaway power was applied, the restaurant windows were blown in as well as the door of another airline's cargo building.

Restaurant Damage

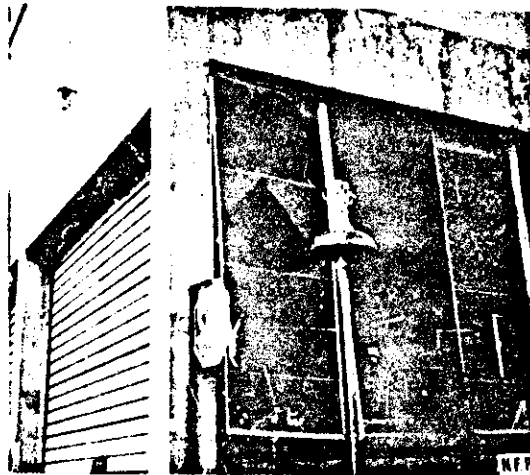
A jet blew an airport shack over when the pilot opened the throttles to start taxiing from a

Airport Building Damage

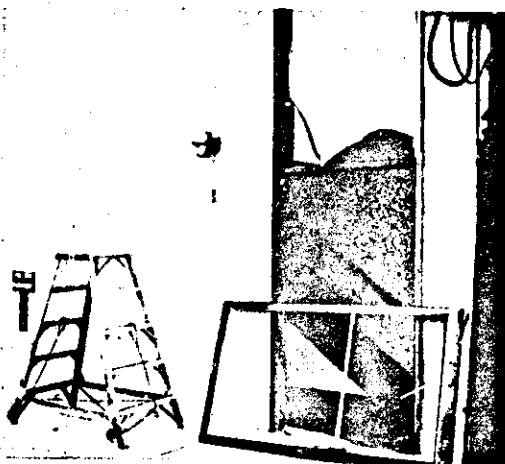
In still another case, a jet blast toppled a large shack while a tug was pushing a DC-8 back from a freight building. When the engines were revved up, the plane was just to the rear of the shack. The jet blast was directed towards the shack and

Airport Building Damage

parked position on the ramp. A woman inside the shack suffered injuries and was hospitalized.

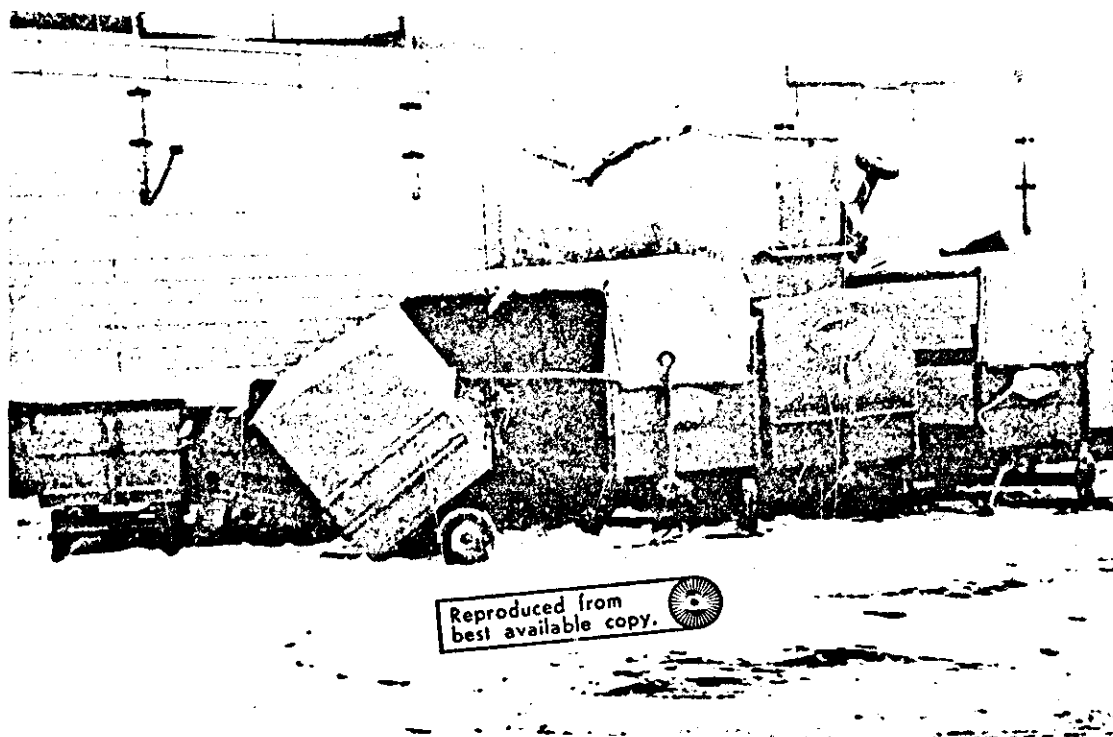
Baggage Cart Upsets

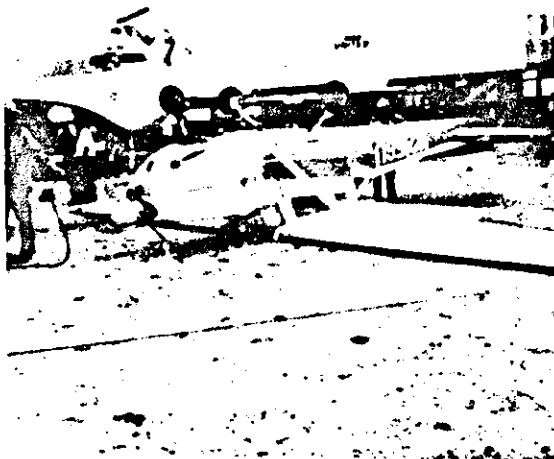
Taxiing behind large jets in terminal areas can be very hazardous. For example, the pilot of a light aircraft was taxiing to a tiedown area after landing. As he taxied past a large maintenance hangar, his aircraft was upset by a Boeing 707 which was being runup by check crew mechanics. The 707 was positioned in front of a blast fence in an assigned runup area. The No. 2 engine was running at 95 percent power, and No. 3 at 75 percent power.

Just before the accident, the ground mechanic lookout attempted to advise the runup crew of the approaching aircraft. However, due to a

Overtuned Aircraft

headset failure, which affected the mouthpiece, the lookout was unable to communicate with the runup crew in the cockpit. As the lighter plane taxied behind the 707, it flipped over on its back.

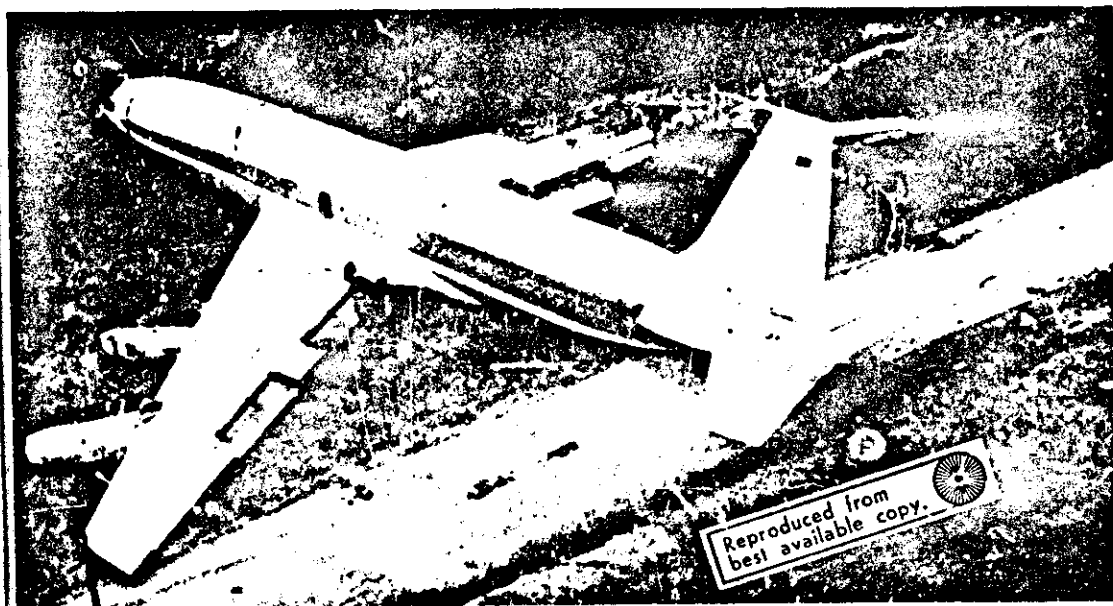
The aircraft passed behind the twin-jet at the speed of approximately 135 knots. As the twin-jet applied power in an attempt to get out of the mud, the jet-blast perpendicular to the takeoff plane's path caused a short-duration compressor stall in the No. 4 engine. Although the stall resulted in a loud report and the jet blast apparently moved the flight controls, the performance capabilities of the aircraft were not affected. However, the first officer, convinced that a collision had occurred, elected to abort the takeoff. The aircraft ran approximately 421 feet. The main landing gear was sheared, and the aircraft was extensively damaged by ground slide and fire.

Damaged Transport Aircraft
