1. Report No. NTSB-AAS-74-3	2. Government Accession No.	PB 238 269	
4. Title and Subtitle Special Study - Safety Aspects of Emergency Evacuations From Air Carrier Aircraft		5. Report Date November 13, 1974

SAFETY ASPECTS OF EMERGENCY EVACUATIONS FROM AIR CARRIER AIRCRAFT

**NATIONAL TRANSPORTATION SAFETY BOARD
Washington, D.C. 20591
REPORT NUMBER: NTSB-AAS-74-3**

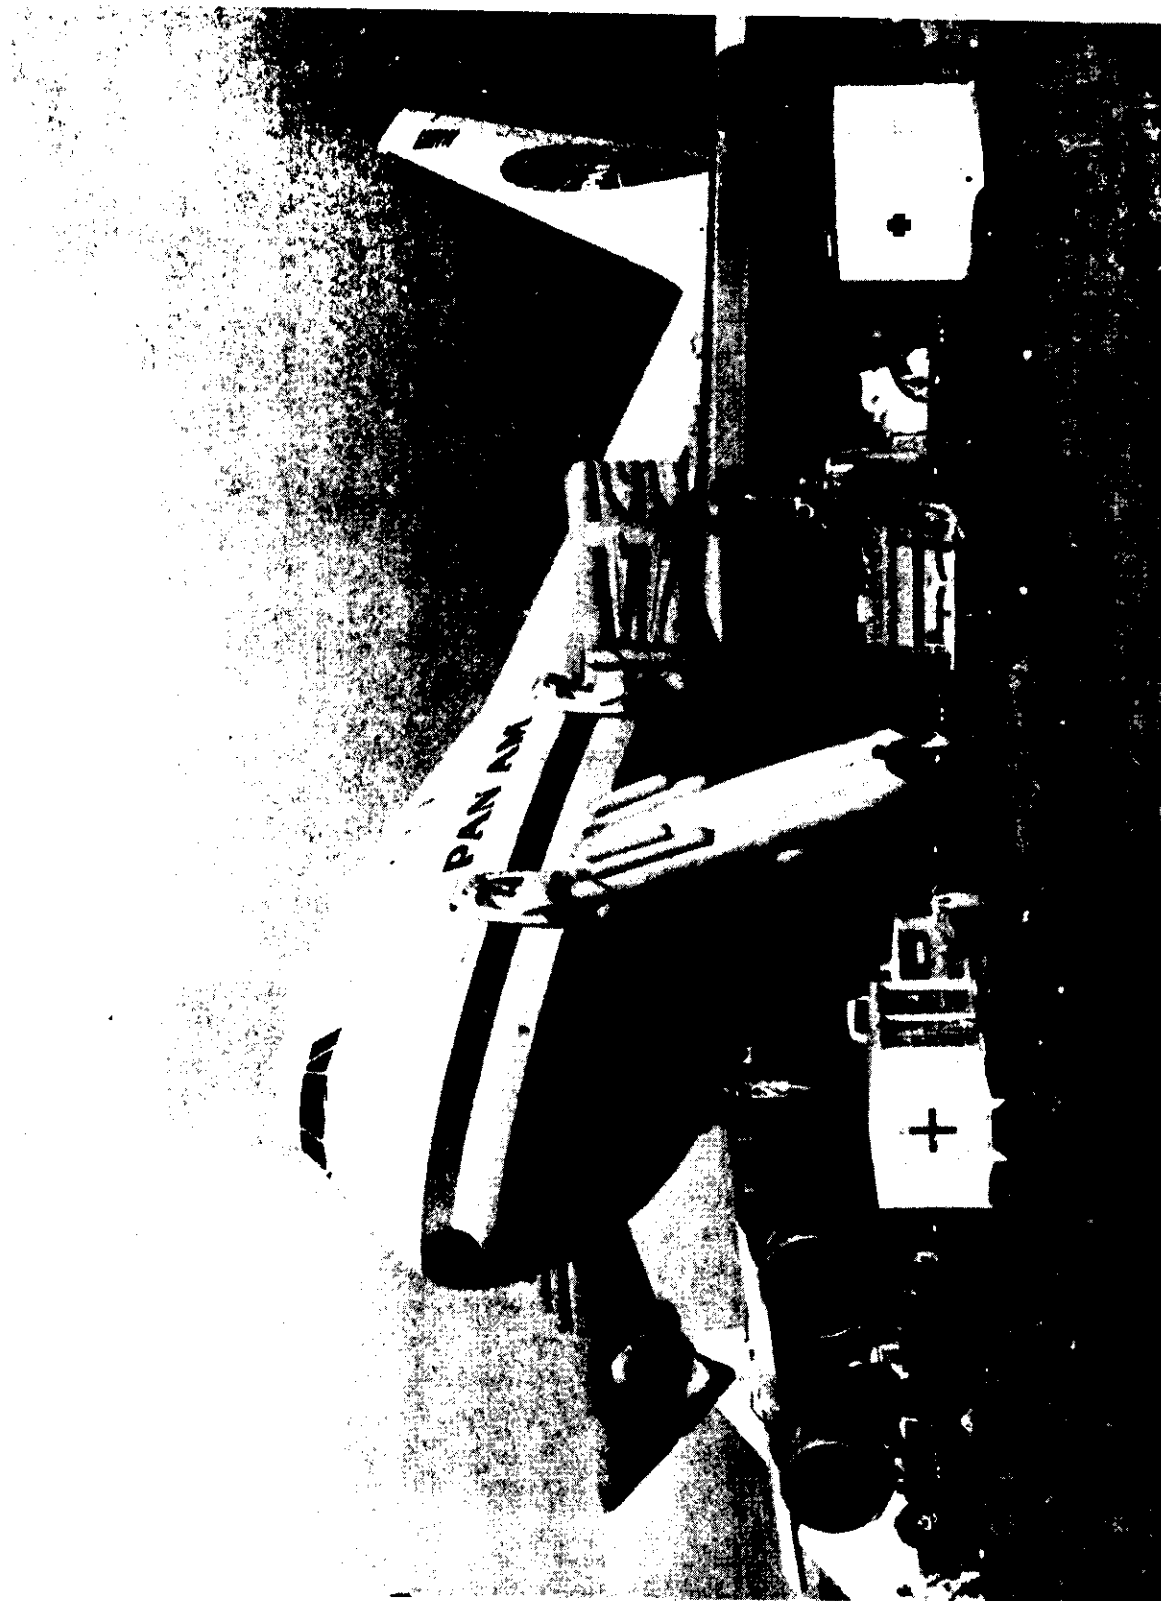
Weather. -- Although weather may affect the success of an evacuation in many ways, the effects of wind on evacuation slides is one of the most serious problems. The direction and velocity of the wind at an evacuation site may cause the emergency evacuation slides to deploy and inflate improperly. Improper slide deployment and inflation can severely limit the number of usable exits, as in the Pan Am 747 accident. (Case History No. 9.) Figure 1 depicts the effect of adverse wind on emergency escape slides (No. 2 on left side and No. 1 on right side.) The winds affecting the Pan Am 747 slides were about 25 knots; such wind velocities are not uncommon in normal landing situations. The longer slides on wide-bodied aircraft make them more susceptible to wind displacement.

Following the Pan Am 747 accident, the Safety Board was informed that the design of the slides was being reviewed to determine if the effects of wind on slides could be reduced. The Federal Aviation Regulations (FARs) have not been revised and wind remains a potential problem.

Figure 1. Wind effect on Pan American escape slide deployment

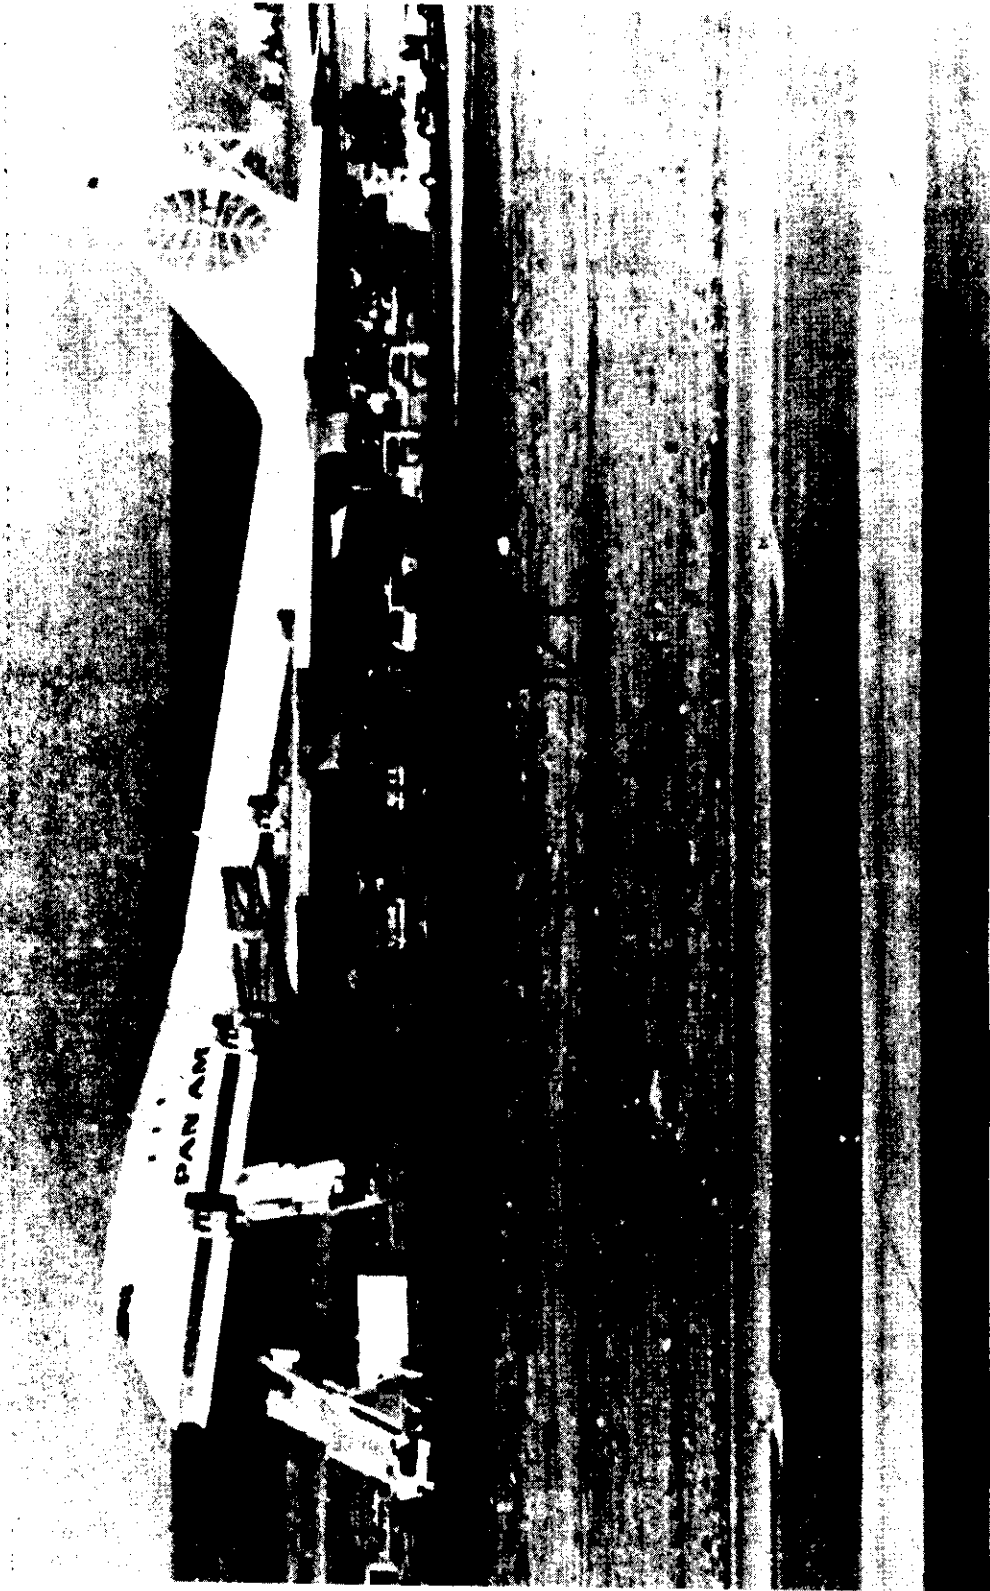
Figure 2. The Pan American 747 nose-high attitude

3. The attitude of wide-bodied aircraft following an accident may render exits unusable. Nose-high and tail-high attitudes can cause some slides to be nearly vertical.

Since the design of slides on wide-bodied aircraft does not provide for large attitude variations, and changes to the current designs do not appear forthcoming, the possibility that exits will be unsafe or unusable because of attitude variations will continue to be a problem for evacuating passengers. Crewmembers should be made aware of this possibility so they can redirect passengers to usable exits, if necessary.

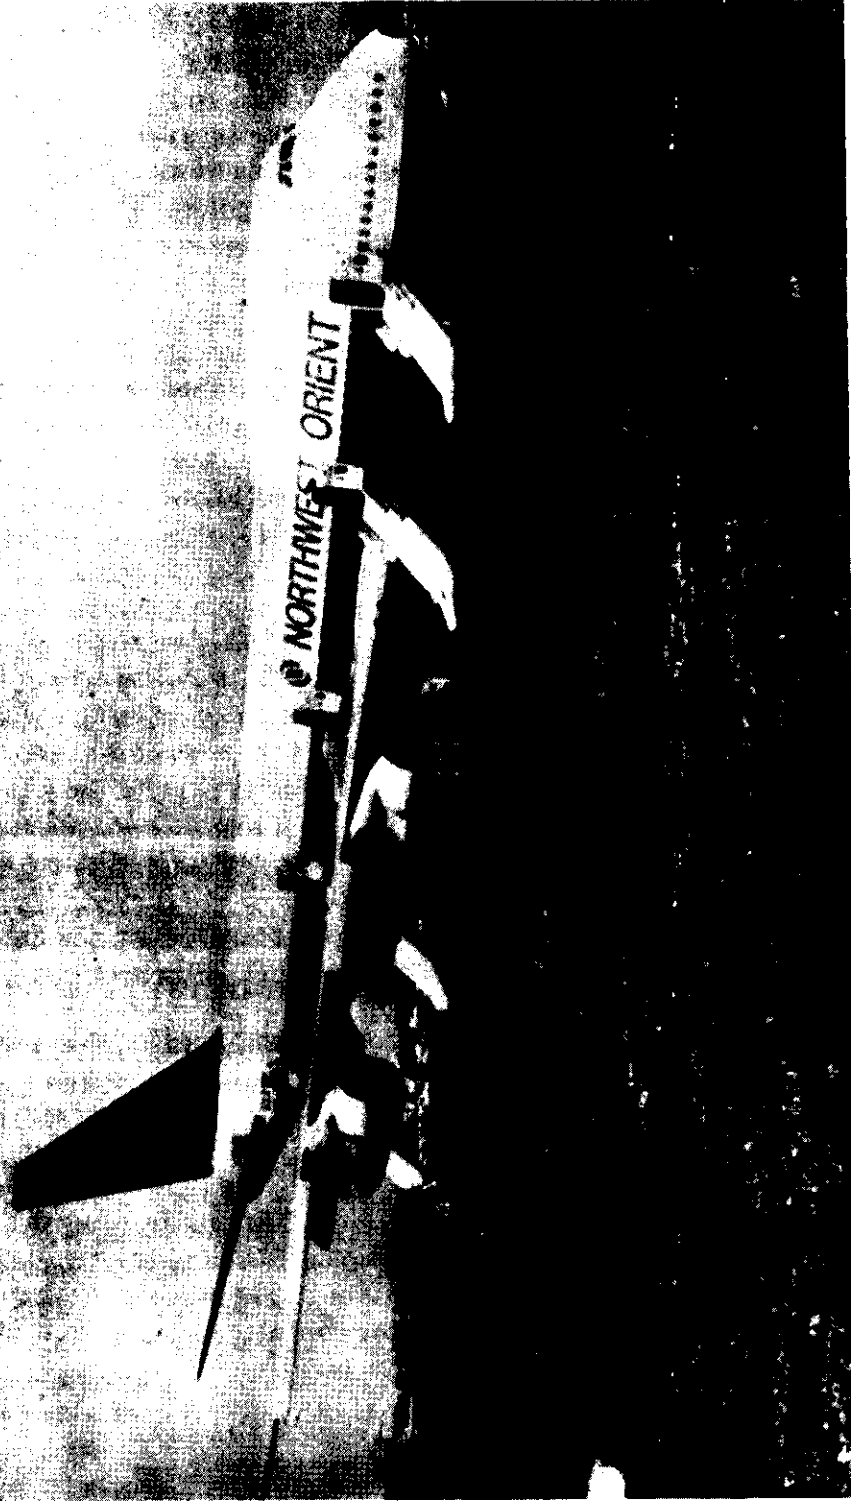
Figure 3. The Northwest 747 tail-high attitude

- The aircraft came to rest in a tail-high attitude, rendering the rear exits unusable.
- There was no specific order given to evacuate the aircraft.
- Damage to the floor and galley in the first-class section obstructed passengers proceeding toward the forward cabin doors.

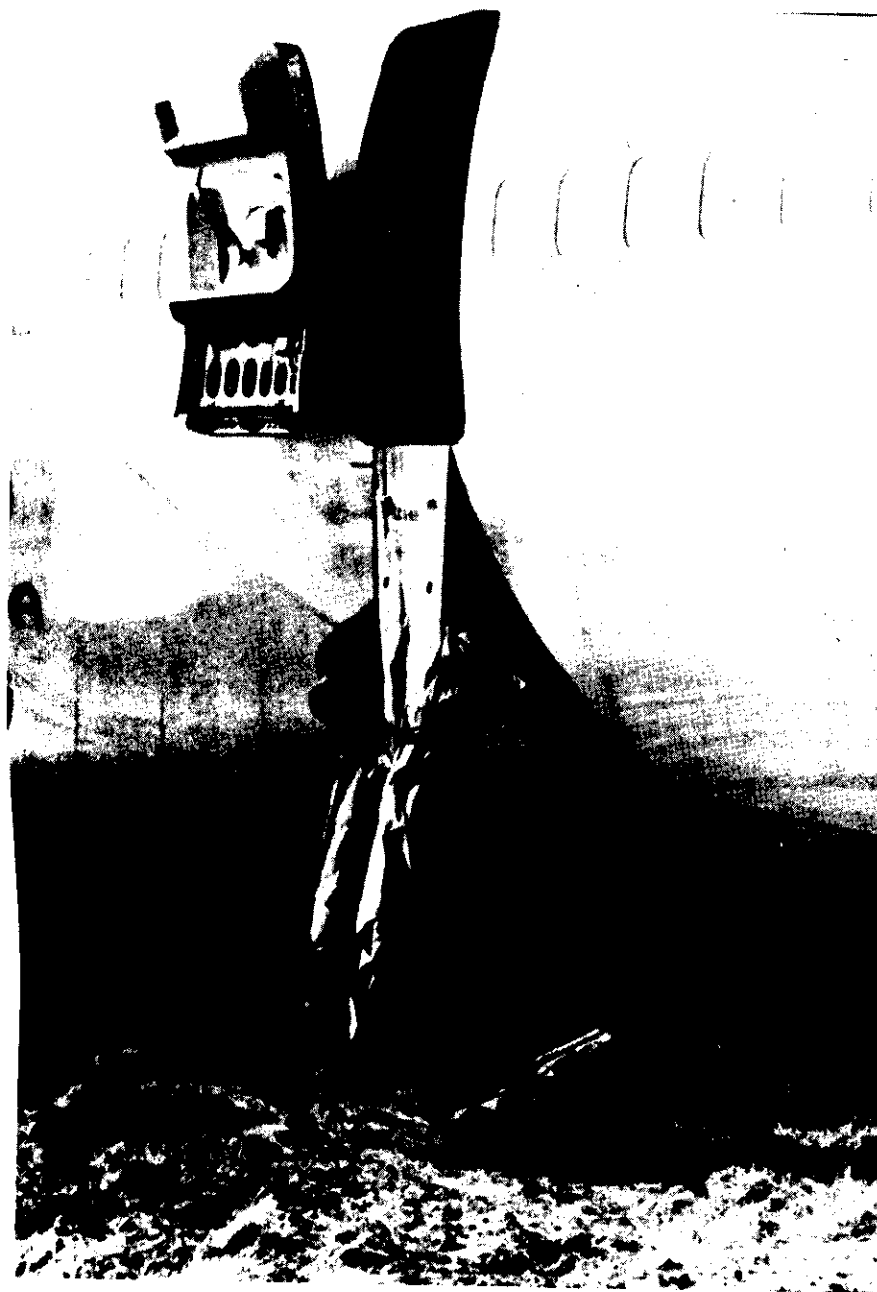
In the Pan Am 747 accident, one exit was rendered unusable because the entire emergency slide pack broke loose from the door to which it was mounted. (See Figure 4.) The same problem occurred in the Icelandic DC-8 accident when a slide pack broke loose at impact. The crash forces of both accidents were survivable.

Figure 4. Evacuation Slide Failure, Pan American 747

- An emergency evacuation slide pack broke loose from one of the doors.
- There was less than a full load of passengers onboard.
- Some evacuation slides failed to inflate and deploy properly because of mechanical problems and surface winds.

(As a result of these problems, the Safety Board has recommended that the FAA review the slide pack mounting design, gas generator retention design, and wheel-well mounted gas generator retention design of the B-747. The recommendation was aimed at improving the design and reliability of these components. The Boeing Company issued a service bulletin regarding these problems, but no rulemaking has been initiated.)

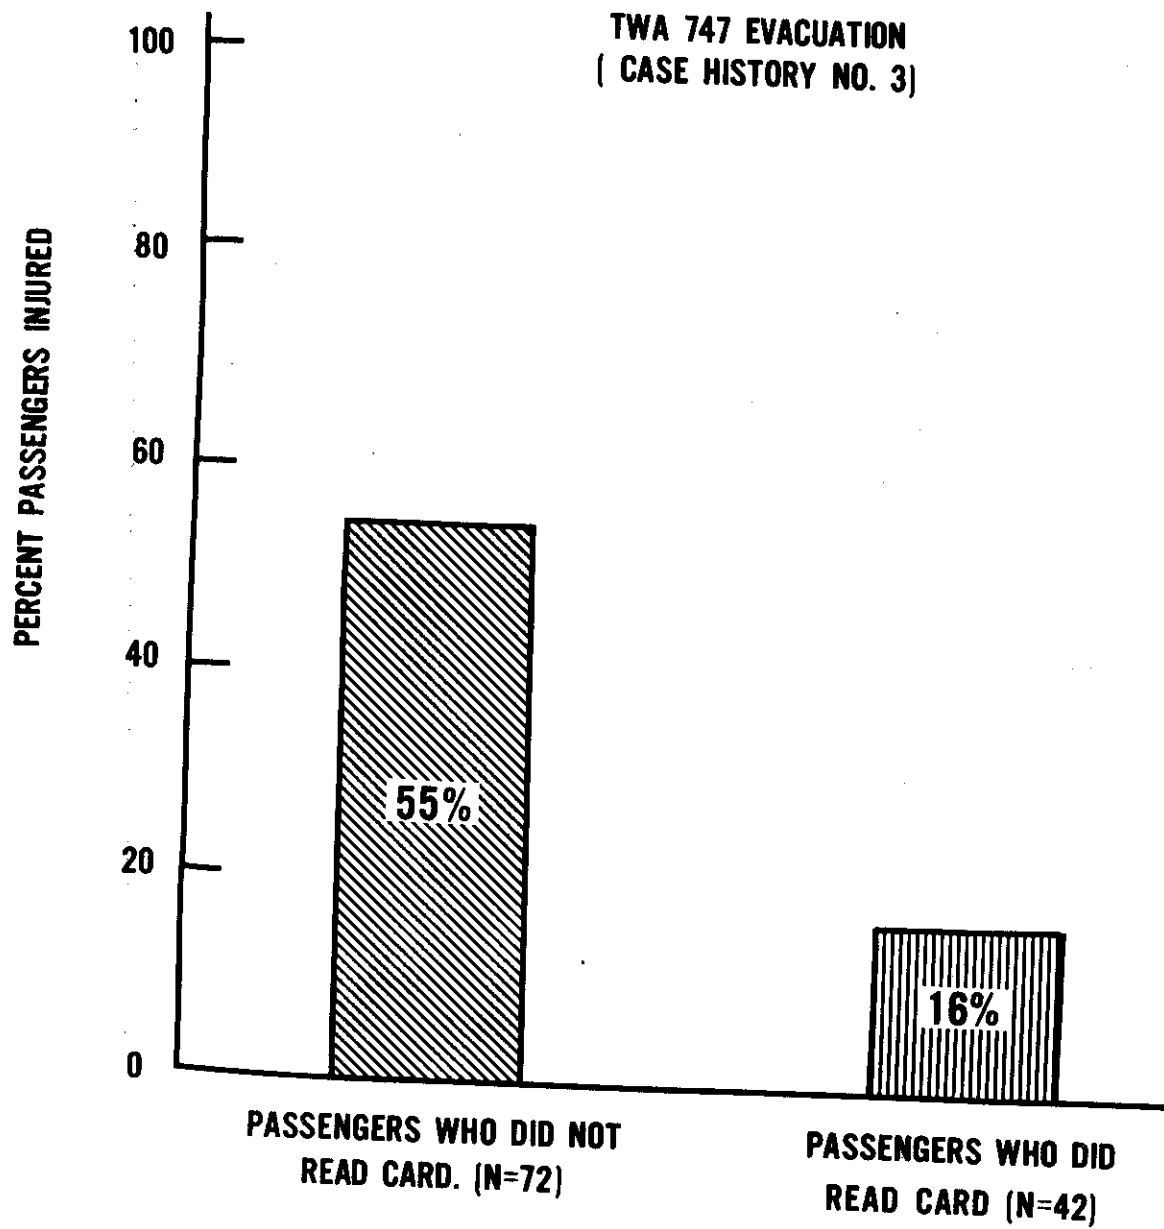
The questionnaires revealed that of the 114 persons responding, 72 had not read the safety information card. Of the 72 passengers who had not read the card, 40 persons were injured by evacuation-related causes. By contrast, of the 42 persons who had read the card, only 7 received evacuation-related injuries. Although these constitute a very limited sample, these data indicate that the percentage of passengers injured who had not read the safety information card was three times as great as that for those passengers who had read the card. (See Figure 7.) These data suggest that passengers who are not attentive to safety information are much more susceptible to being injured during an evacuation.

Figure 7. Comparison of Evacuation Related Injuries and Knowledge of Safety Information Card
