# SPECIAL STUDY **TURBINE ENGINE ROTOR DISK FAILURES**

ADOPTED: DECEMBER 18, 1974

NATIONAL TRANSPORTATION SAFETY BOARD Washington, D.C. 20594

REPORT NUMBER: NTSB-AAS-74-4

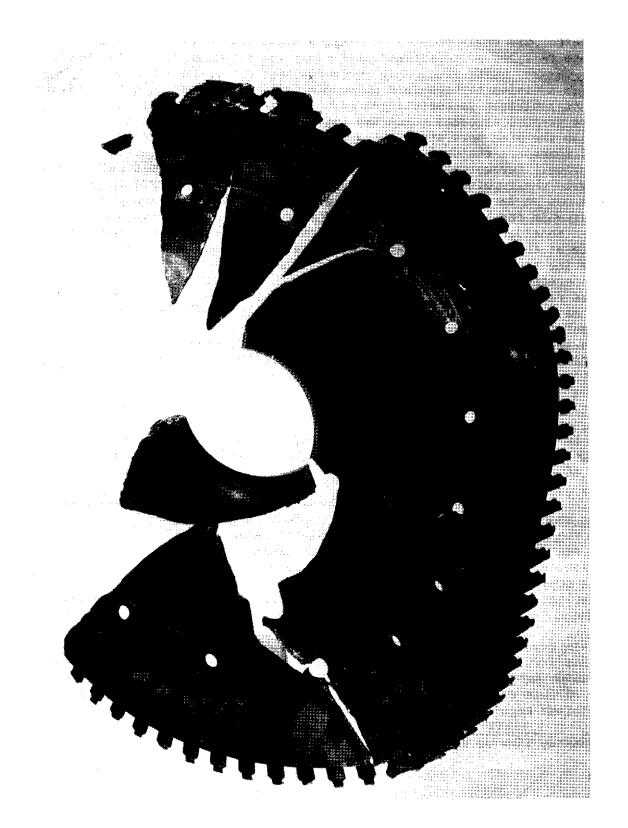
When a rotor disk fails, large masses of disk segments which possess large amounts of kinetic energy (see Photograph No. 1), are liberated from the main disk assembly. The resultant velocities of these liberated disk segments or other debris, are sufficient to cause extensive penetration and shrapnel damage to the fan, compressor, or turbine cases. Other powerplant components also may be damaged, such as engine cowlings and pylons of the affected engine or an adjacent or remotely installed engine.

Photograph No. 1 Typical separated disk segments.

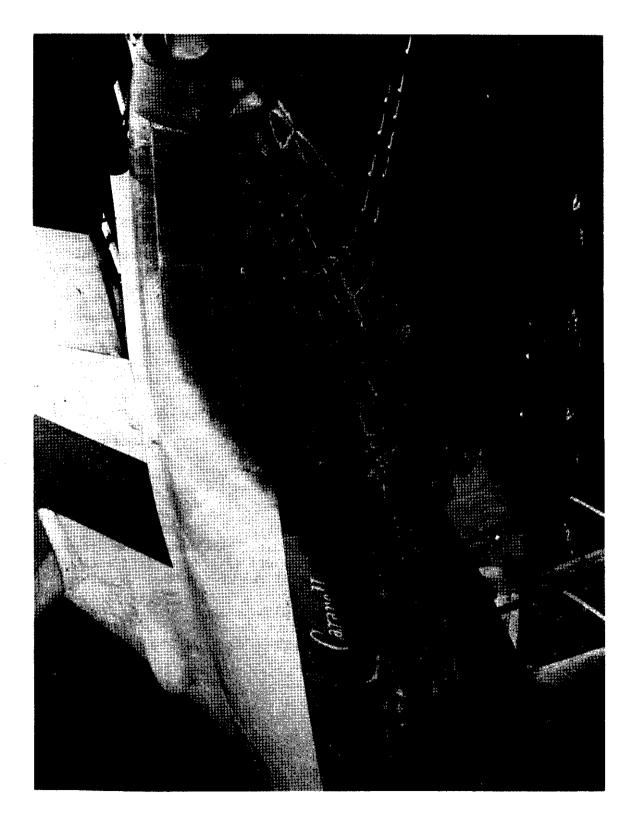
Photograph No. 2. Burned aircraft empennage section caused by a disk separation.

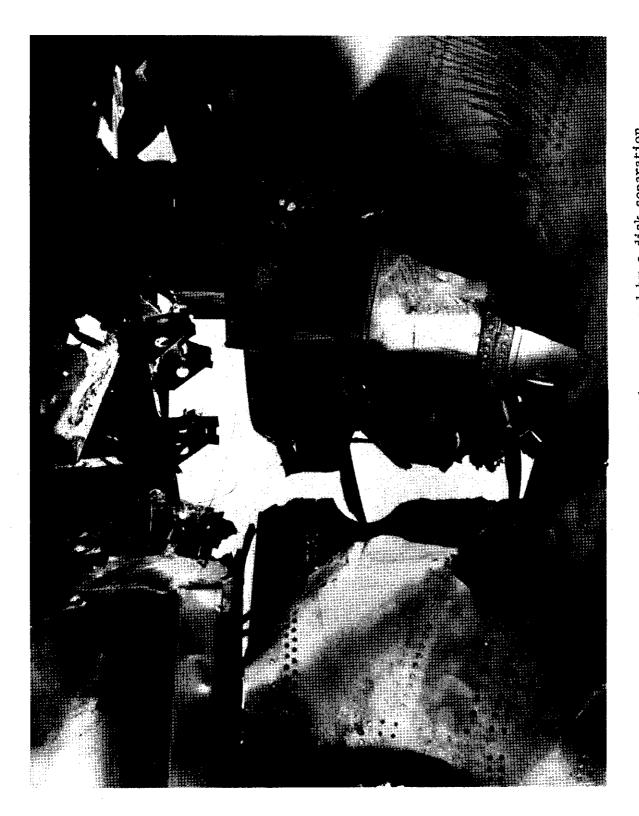
Wide bodied jet pylon damage caused by a disk separation. Figure No. 4.
