# NATIONAL TRANSPORTATION SAFETY BOARD

**CABIN SAFETY IN LARGE  
TRANSPORT AIRCRAFT**

NTSB-AAS-81-2

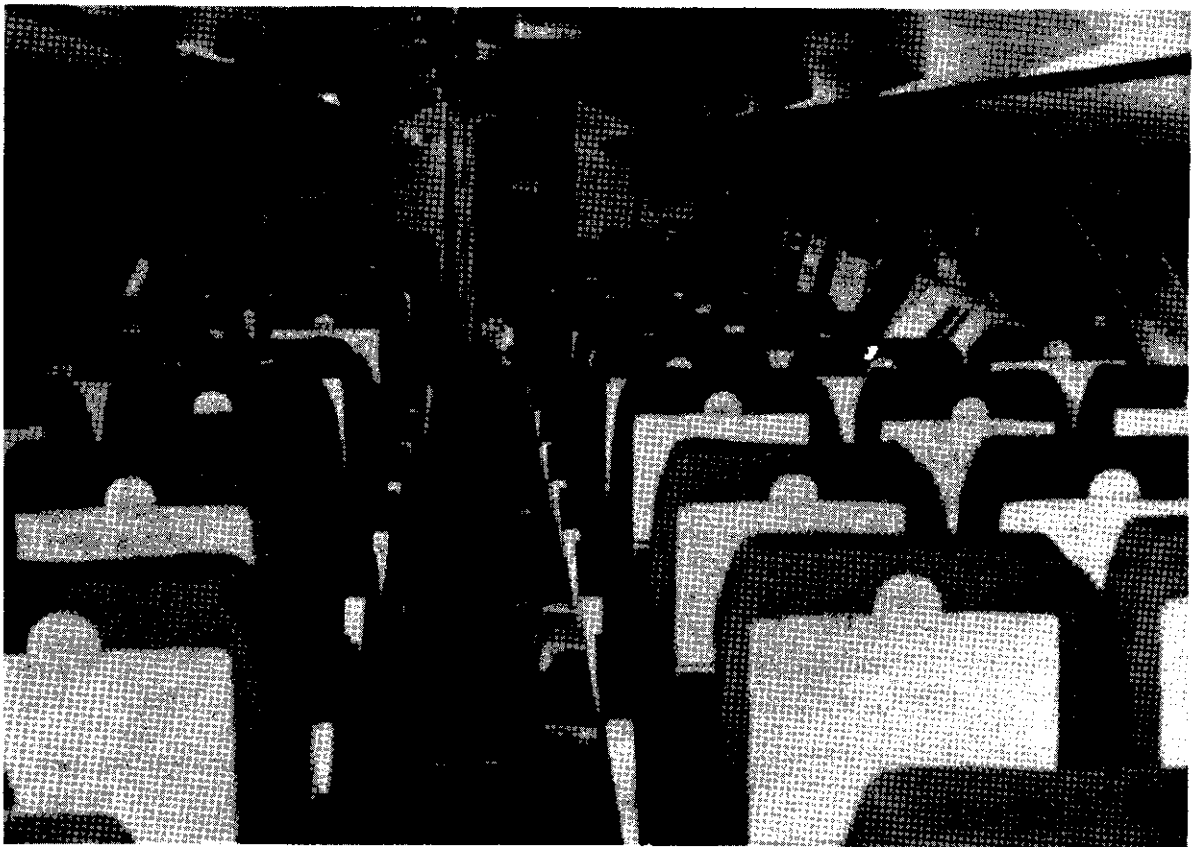
Failed overhead racks or bins also blocked movement in the cabin by cutting off access to and from aisles and overwing exits. (See figure 3.) Figure 4 shows hazards created by failed passenger service units.

Figure 4.--View toward the forward portion of the aircraft.  
(Note the passenger service units  
hanging over the A and E seats in each row.)

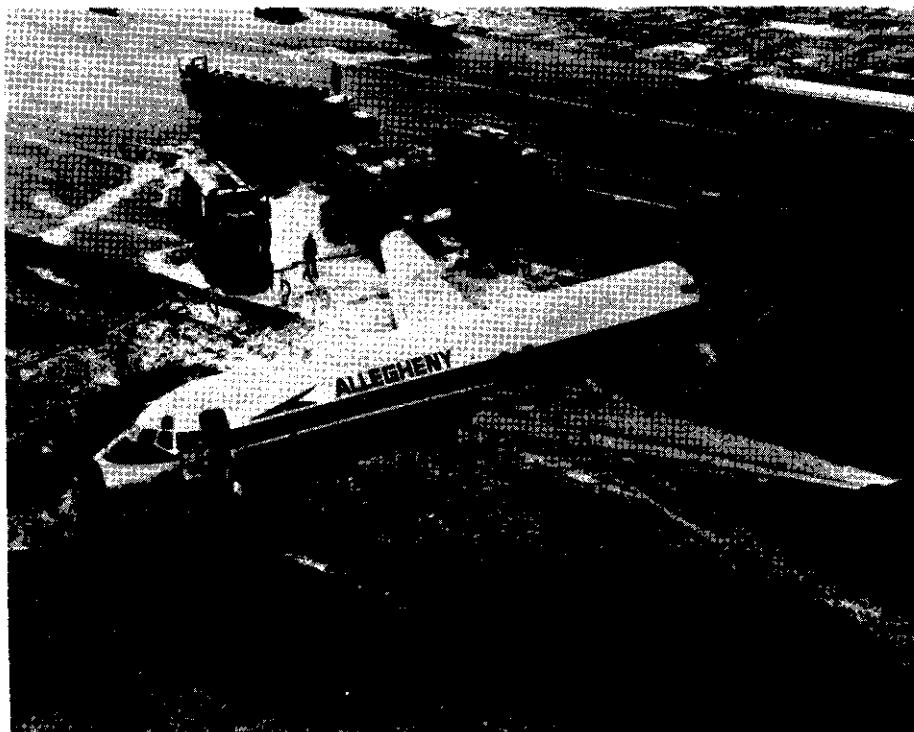
The bottom of the fuselage was damaged severely. The skin was torn and abraded, frames were crushed, stringers were damaged along the entire length of the fuselage, and the floor above the landing gears was buckled upward. The wings remained intact and connected to the fuselage; there were no fuel leaks from the wing tanks. (See figure 6.)

Figure 6.--View of fuselage exterior.

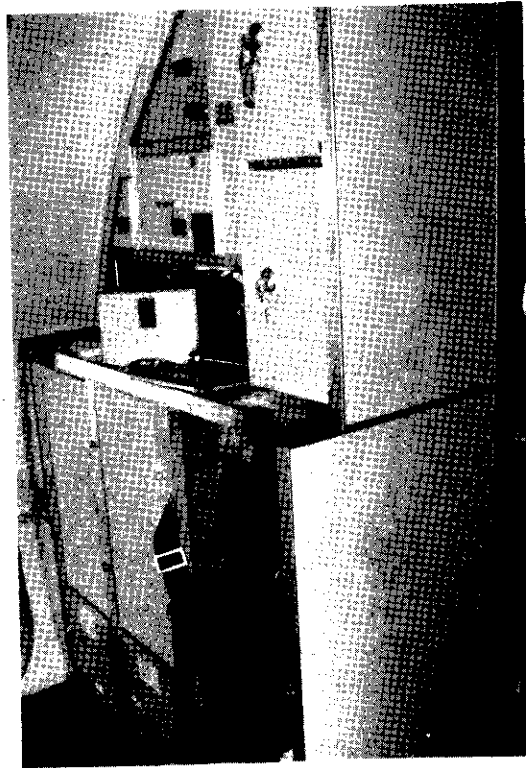
Passenger and crew statements included the following observations. The seat failures occurred at impact and caused passengers to be thrown into adjacent seats, or pinned them between seats, between the floor and seats, and between seats and side walls. Failed seats were thrown into the aisle and against other seats, hampering the flow of passengers to the exits. As many as 12 passengers were immobilized by injuries or trapped by failed seats and were still in the aircraft when firemen arrived. In addition, overhead storage racks spilled their contents into the aisles. Some passengers encountered baggage and garments in the aisle during evacuation, and some stopped to retrieve possessions before leaving the aircraft. One flight attendant, whose seat failed incapacitating her with a spinal fracture, recalled seeing two coffee pots and liquid on the floor. (See figures 7 and 8.)

Figure 7.--No. 2 galley.  
(Note flight attendant's keys and failed trash  
trolley restraint strap fastener.)

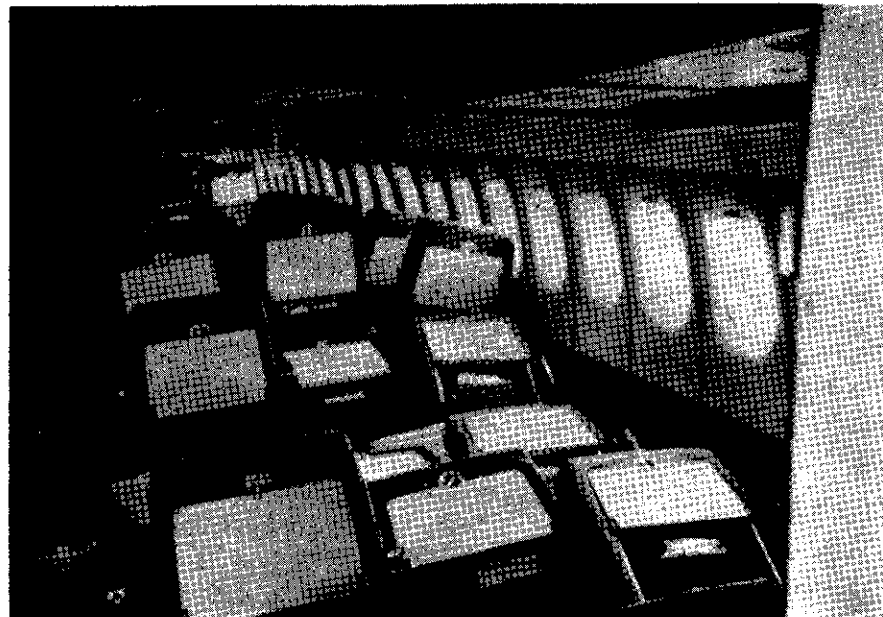
Figure 8.--View of passenger seats forward from row 20.

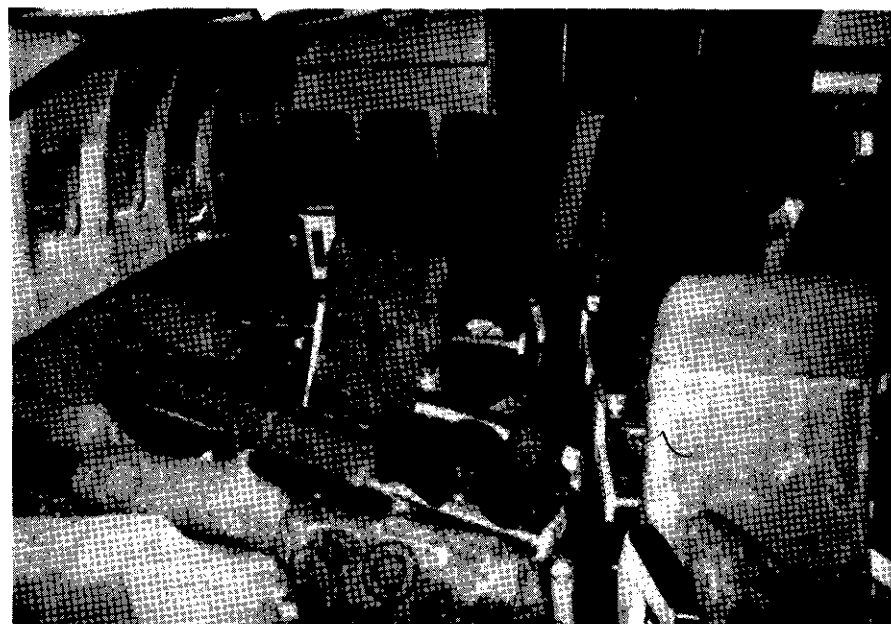
Documentation of the seat failures throughout the cabin indicated forces acting downward and to the left, confirming statements by the passengers. Failures occurred mainly in the seat legs; others occurred in arm rests, seat-to-floor attachments, and the seat tracks. (See figures 10 and 11.)

Figure 10.--Interior view to aft of cabin.

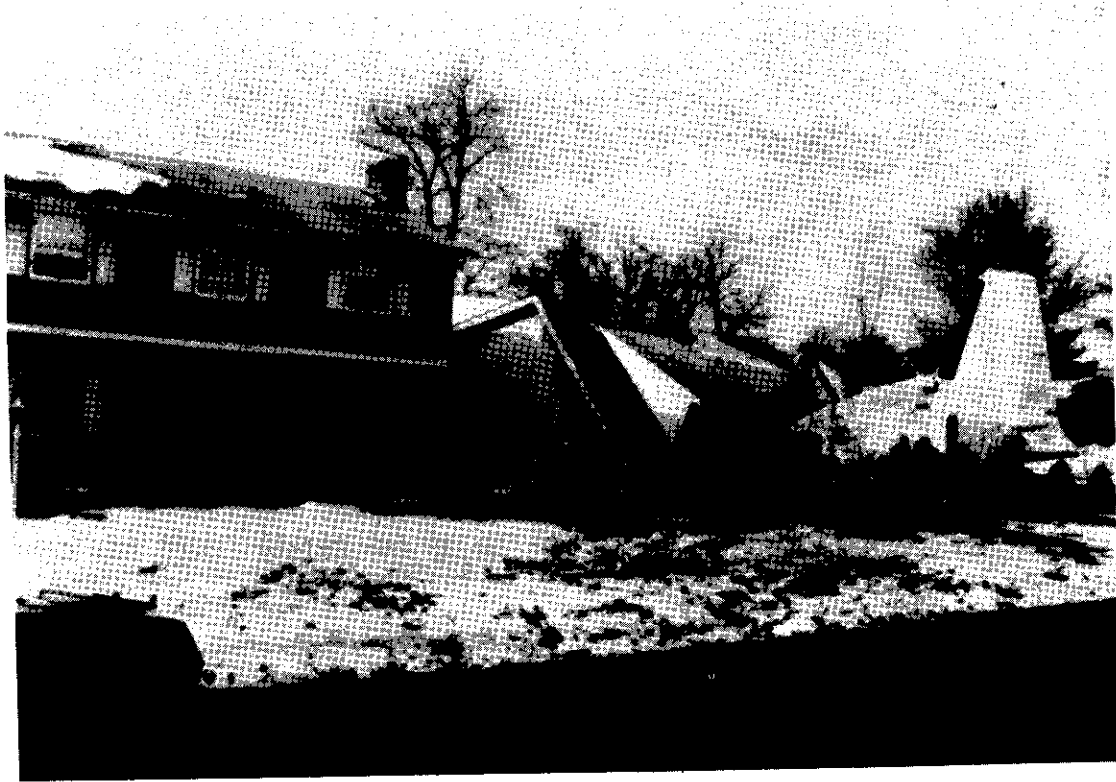
Figure 12.--Aircraft lodged in house.

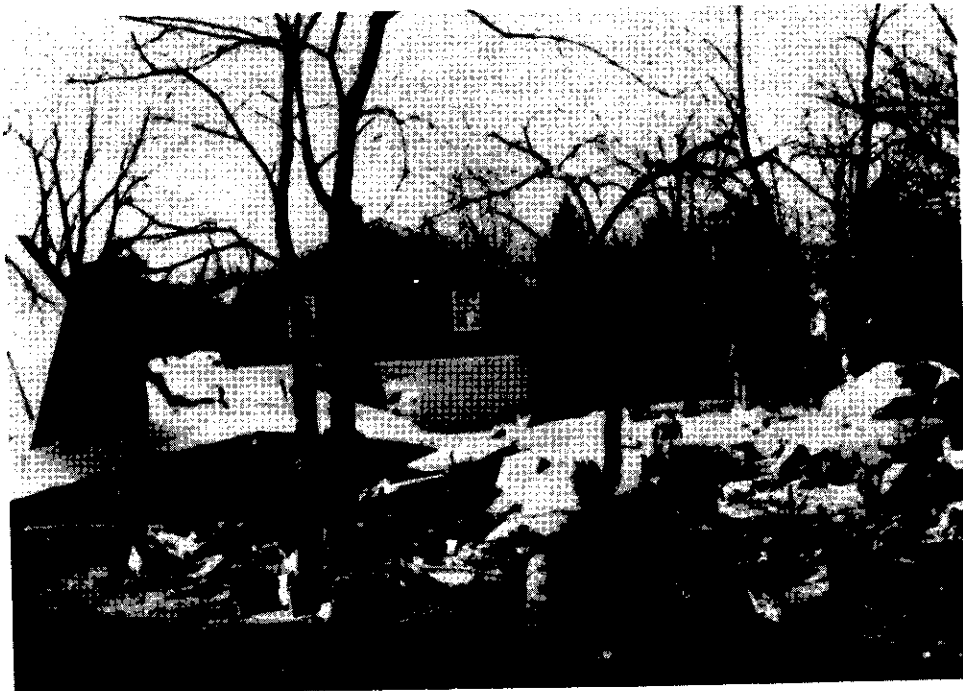
Figure 13.--Aircraft after house was torn away.
