THE PHENOMENON OF AIRCRAFT AQUAPLANING

CIVIL AERONAUTICS BOARD  
WASHINGTON, D.C. 20428

Bureau of Safety  
Civil Aeronautics Board

October 1963

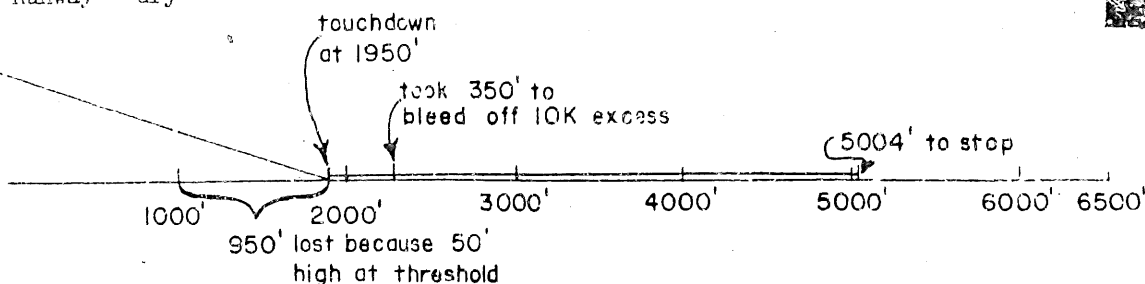
FIG. 1

The determination of minimum runway length is based on crossing the threshold at 50 feet, at reference or boundary speed, and on a dry runway. In order to conform to the computed minimum runway, the pilot must meet the above conditions of speed and altitude over the threshold. In adverse weather this is not always possible. A Boeing 720B aircraft is used in the following example to indicate what can happen when some of the parameters are varied slightly. (See Figure 1)

Aircraft - Boeing 720B

Constants - Will use:  
brakes, speed brakes,  
full reverse to 60K  
on each landing

- #1 Over threshold:  
Alt. - 50'  
Speed - ref. + 10K  
Runway - dry

- #2 Over threshold:  
Alt. - 100'  
Speed - ref. + 20K  
Runway - dry

- #3 Over threshold:  
Alt. - 100'  
Speed - ref. + 20K  
Runway - wet

#3. Stopping distance will depend on: Tire condition, type of runway depth of water, amount of head wind, delay in applying reverse thrust, etc. Shortly after aquaplaning begins (3 sec.) anti-skid system is deactivated and aircraft is in full skid condition.

In the light of the above considerations, it is urged that each air carrier establish a wet runway factor as well as landing techniques for adverse weather, and publish this information in the Flight Manual for each type aircraft. This information should also be taught formally at pilot training sessions. Some of the carriers do verbally discuss landing on wet, slippery runways at pilot training sessions and publish bulletins at different times concerning this problem. However, this is not considered adequate coverage of the subject. The information needs to be available to the pilot in written form for ready reference at those times when conditions conducive to aquaplaning are found to exist upon arrival over the destination airport.

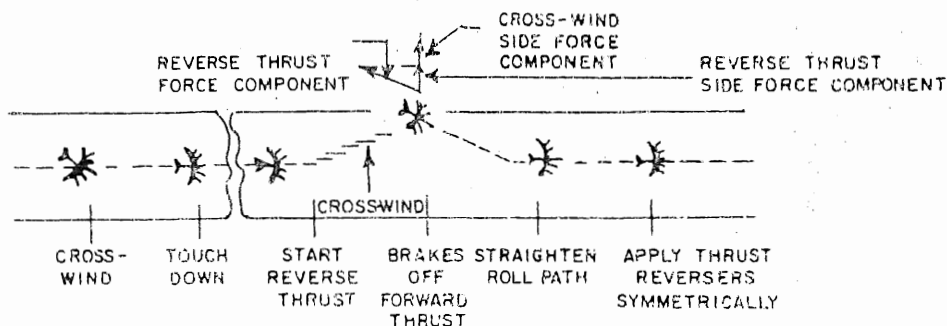
Propeller or thrust reversers are relied upon to provide additional deceleration during landings. When a headwind or no wind condition exists on a runway, reversing is very effective. However, if the landing is made under crosswind conditions, reversing can actually be a detriment. (See Appendix 1, Accidents 3, 5, Incidents 4, 11, 14, 15) An aquaplaning aircraft tends to weathervane in a crosswind and if reversing is applied while the aircraft is in this cocked position to the runway, it will actually assist the crosswind in moving the aircraft off the side of the runway. (See Figure 2) This is actually what occurred in the accident referred to earlier on page 3. When an aircraft becomes cocked to the runway it may become necessary to add forward thrust to alleviate the situation and return the aircraft to the runway centerline. (See Figure 2) This requires additional runway, further diminishing the buffer provided by the CARs when a minimum length runway is used.

FIG. 2 - During cross-wind landing side thrust from thrust reversers, once airplane is canted to centerline, plus cross-wind can drive airplane off runway. To correct path, return all engines to forward thrust at low power to return to center, use differential braking to straighten roll path then reverse thrust to stop. (Extracted from December 1960 Boeing Airliner)

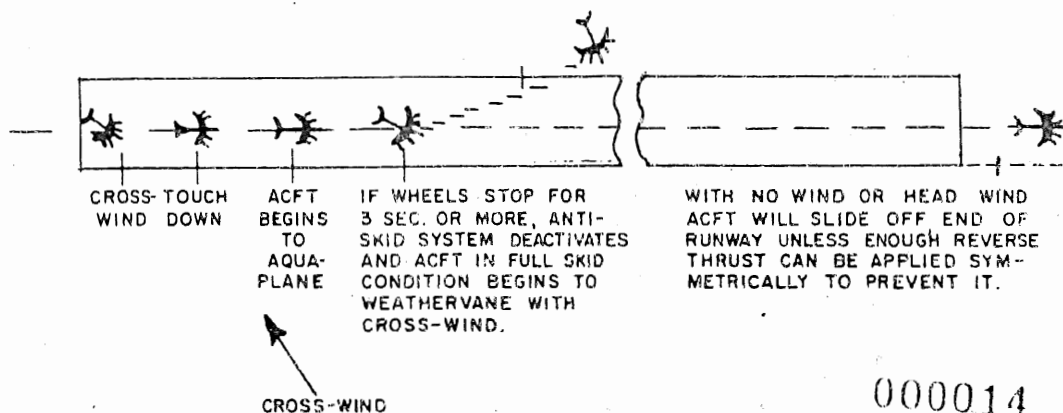
One other interesting point that was learned during this study is that as the wheel aquaplanes it comes to a complete stop. If this condition lasts more than three seconds the anti-skid warning system is deactivated. This means that at that point, the aircraft is in a full skid condition. (See Figure 3)

FIG. 3 - Touchdown is made on a wet runway. The aircraft begins to aquaplane almost immediately. The wheels stop turning either from brake action or spin down from the aquaplaning effect. If this condition lasts more than 3 seconds the anti-skid equipment becomes deactivated. The aircraft is now in a full skid.

WITH CROSS-WIND AND IN FULL SKID COND. ACFT WILL WEATHERVANE AND ACFT WILL DRIFT OFF RUNWAY
