*Accident
on 25 July 2000
at "La Patte d'Oie"
in Gonesse (95),
to the Concorde,
registered F-BTSC,
operated by Air France*

INTERIM REPORT (15/12/2000)

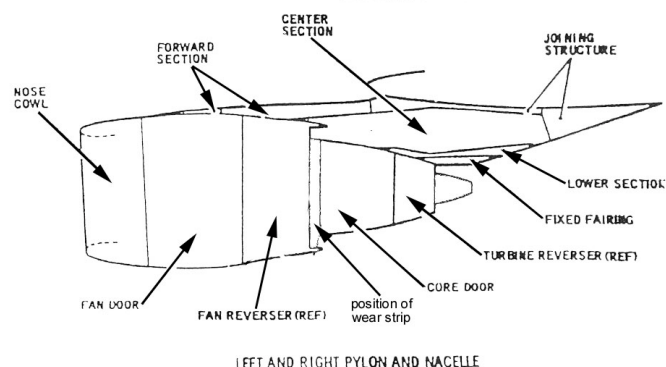
The metal strip found on the runway after the accident (see Preliminary Report, § 12.1.3) appeared to be of a type used in aviation but not belonging to the Concorde. A search was therefore undertaken to identify the aircraft which it could have fallen from. This search was concentrated on the aircraft which had taken off from the same runway after 13 h 00. In addition, work on several types of aircraft led to a belief that the part could be a wear strip from a CF6-50 engine thrust reverser cowl.

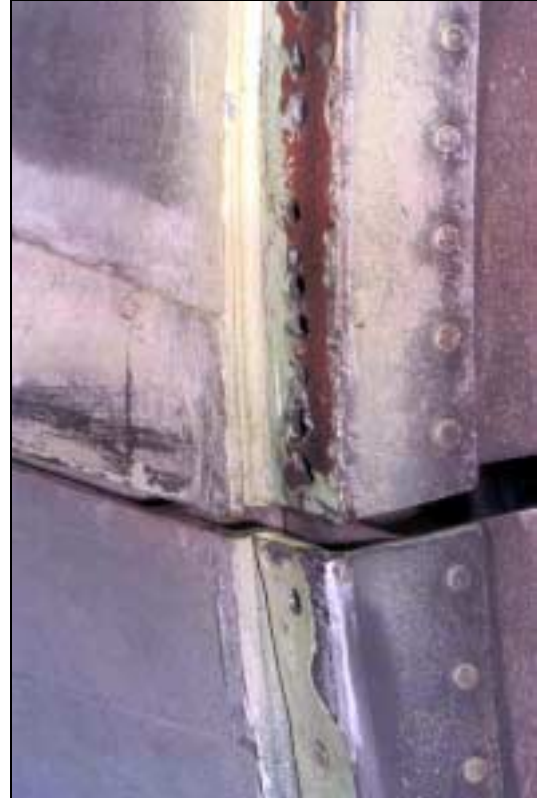
a) Rear reverser cowl structure

- The lower left wear strip, about 44 cm long, was missing. The closed core cowl door normally rests on the front part of the wear strips ;
- The fitting had been painted with green epoxy primer ;
- In the missing part's position, the fitting had been coated with red type RTV106 mastic ;
- There were no traces of RTV 106 on the other parts of the fitting ;
- There were no traces of RTV 106 on the wear strips still in place ;
- There were numerous paint run marks on the fitting and on the wear strips. The paint partially spread over onto the fan cowl door ;
- In the position of the missing part, the fitting still had several rivets in place;
- the fitting was drilled with thirty-seven holes, some of which had spaces less than twice their diameter between them.

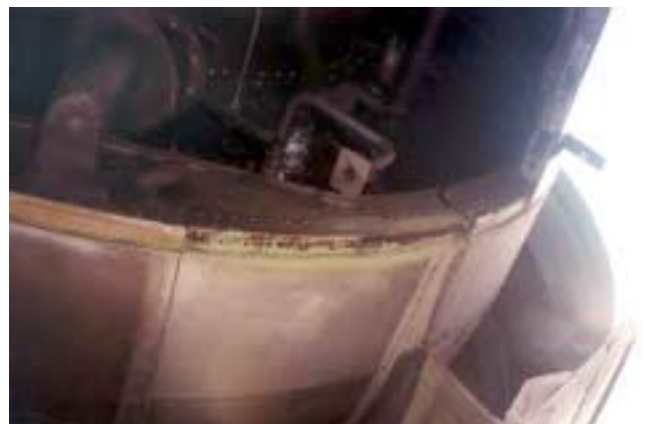
c) Lower right wear strip

- a rivet was missing on the strip. The strip was twisted and allowed play of 6 mm in relation to the fitting ;
- the rivet at the tip was broken off, the part remaining on the fitting prevented the strip from sticking to the fitting, which prevented correct closing of the cowl;
- in comparison with an original part, this strip was too long.
