*Accident
on 25 July 2000
at “La Patte d’Oie”
in Gonesse (95)
to the Concorde
registered F-BTSC
operated by Air France*

Interim report (10/07/2001)
f-sc000725ae2

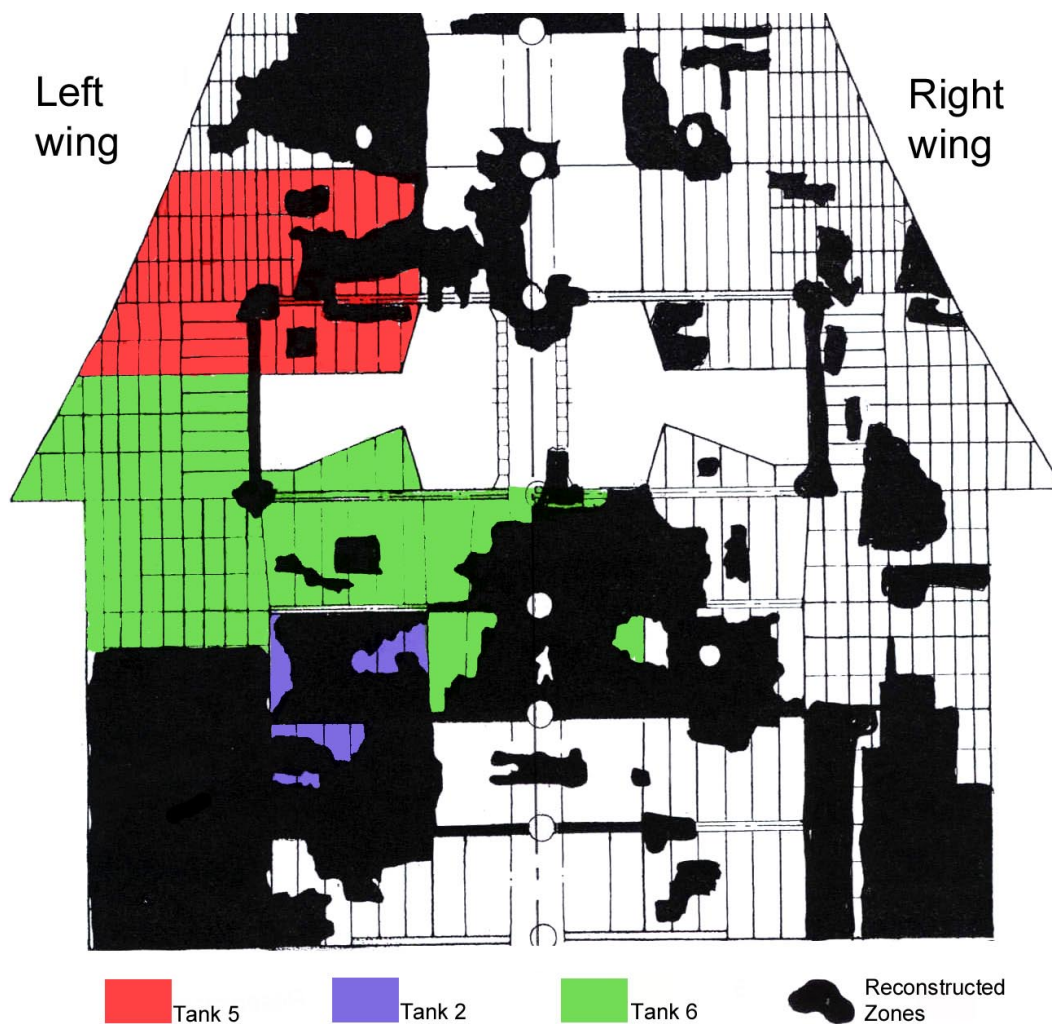
It was impossible to reconstruct the surfaces located near the landing gear well, nor the majority of the right wing.

Figure 14: Computerised representation of the upper wing

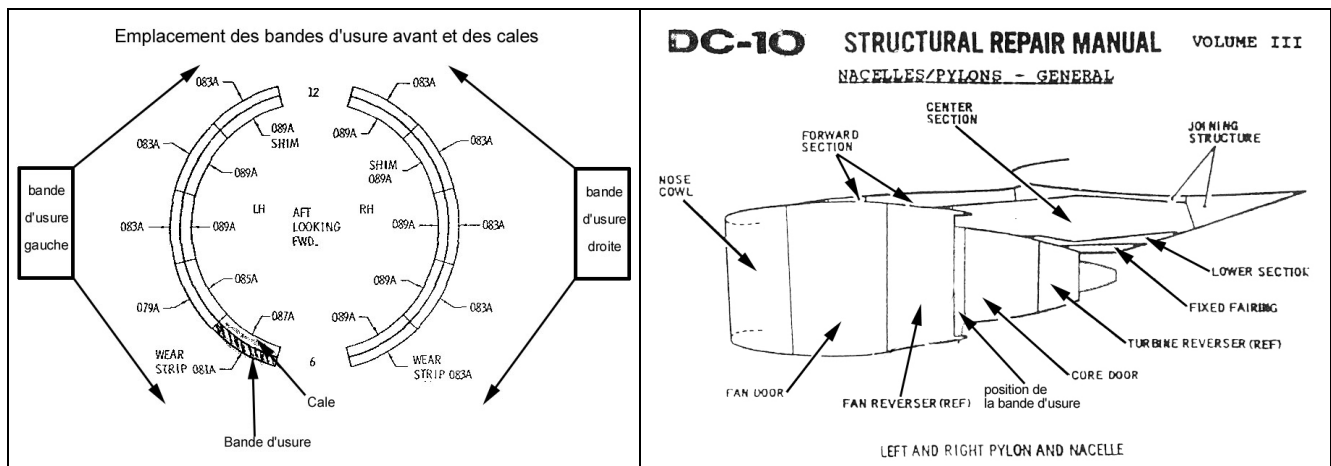
The metallic strip found on the runway after the accident appeared to be an aviation part that did not belong to the Concorde. A search was therefore undertaken to identify the aircraft from which the part had fallen. This search was focused on the aircraft that had taken off from the same runway after 13 h 00. In addition, research on several types of aircraft showed that the part could be a wear strip from a CF6-50 engine fan reverser cowl.

Figure 17: Diagram showing the positions of the wear strips

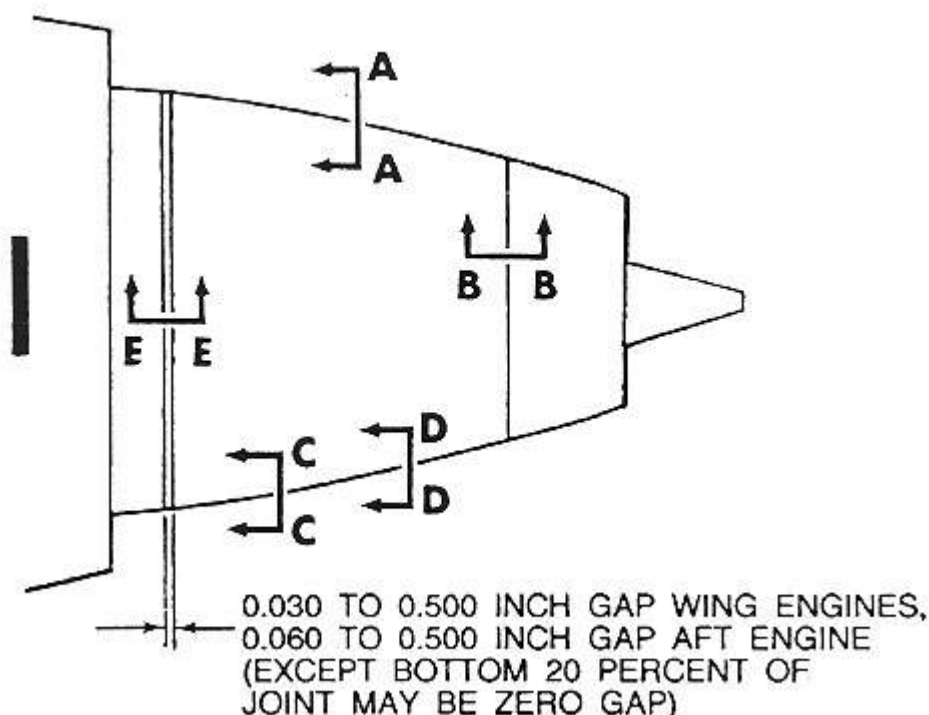
Figure 21: Play between the core door and the fan reverser cowl

During the investigation, it was noticeable on various aircraft that the play measured with engines stopped could exceed these values without touching the width of the wear strip. However, with the engine running, particularly when under takeoff thrust, the pressure inside the cowls is very high. Their deformation may then allow loss of a wear strip no longer attached to its support.

The play between the core door and the fan reverser cowl must be between 0.030 inch (0.7 mm) and 0.5 inch (12.7 mm) as shown hereafter:

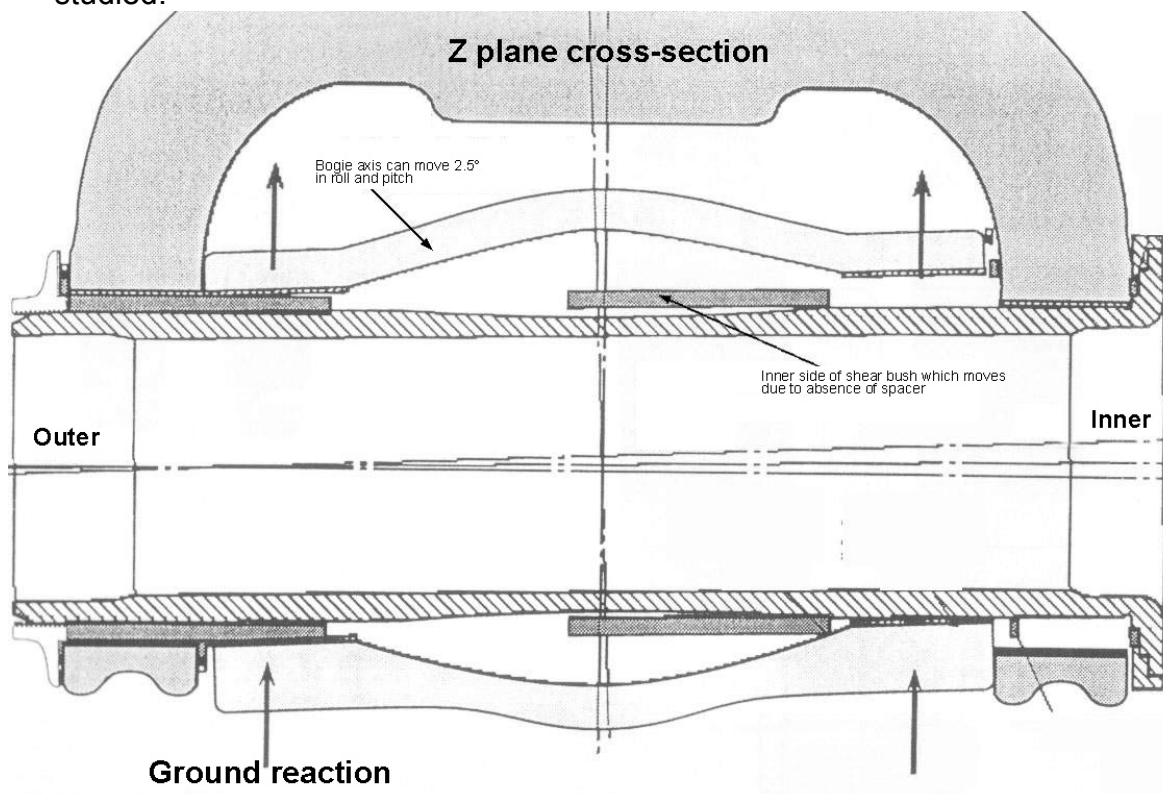
Figure 26 : Landing gear without spacer

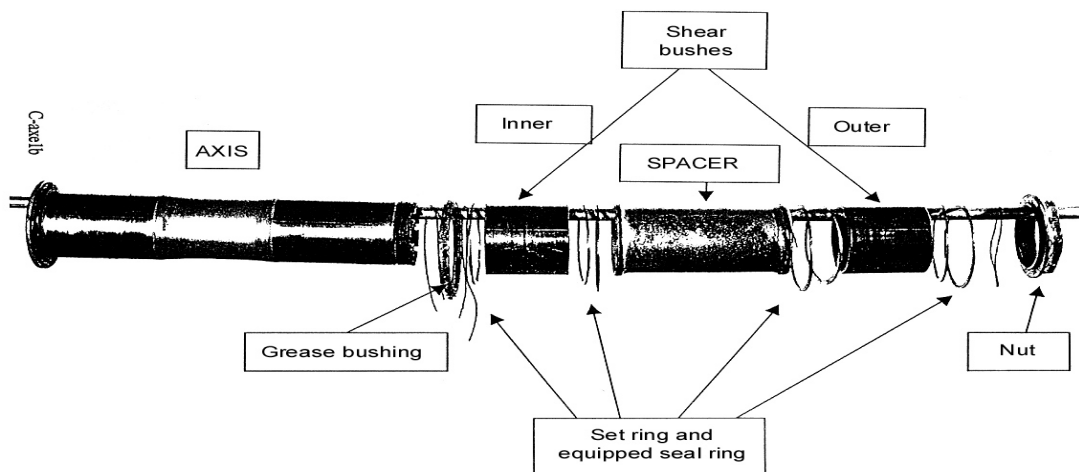
During reinstallation, the shear bushes were positioned directly in their receptacle on the drum, before the axle was reinstalled. This made it impossible to detect the absence of the spacer on the new bogie.

Figure 27 : Right landing gear: bogie beam fittings

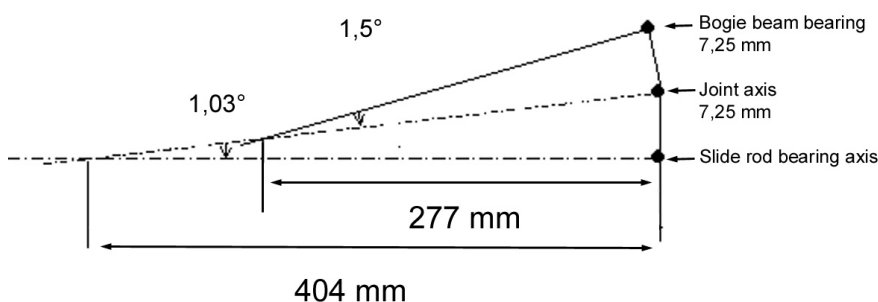
Maximum displacement of the geometrical axis of the bogie beam results from the combination of the two movements described above, which corresponds to 14.5 mm at the radius, thus a cone angle at the apex of 5° , the tip of the cone being located at the centre of the outer bearing.

Figure 29: Effect of the absence of the shear bush on bogie geometry
