NATIONAL TRANSPORTATION SAFETY BOARD
WASHINGTON, D.C. 20594
AIRCRAFT ACCIDENT/INCIDENT REPORT
BRIEF FORMAT
U.S. CIVIL AVIATION

NATIONAL TRANSPORTATION SAFETY BOARD ACCIDENT FILE CONTENTS		PAGE <u>1</u> OF <u>28</u> PAGES		
TRANSPORTATION MODE <input checked="" type="checkbox"/> AVIATION <input type="checkbox"/> HIGHWAY <input type="checkbox"/> PIPELINE <input type="checkbox"/> INTERMODAL <input type="checkbox"/> MARINE <input type="checkbox"/> RAILROAD		NTSB FILE NO. ANC78-F-A005 <i>ef</i>		
IDENTIFICATION OF ACCIDENT 6 Nautical Miles on 220° True Bearing from Anchor Point, Alaska 12-19-77 Fairchild Hiller FH-1100, N18845

DATE OF THIS REPORT 12/21/77	SIGNATURE OF OPERATOR Donald M. Lee	FOR NTSB USE ONLY	
NTSB ACCIDENT NO. ANC78FA005	REVIEWED BY NTSB OFFICE LOCATED AT ANCHORAGE, AK.	NAME OF INVESTIGATOR JON L. OSGOOD	DATE REPORT RECEIVED 12/21/77

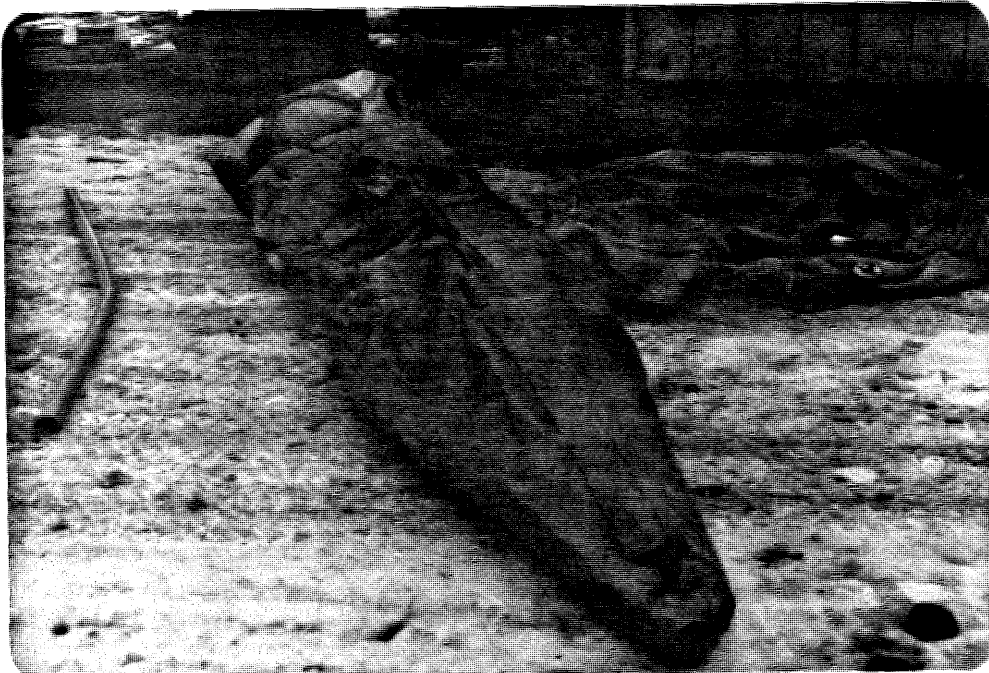
- #1. This photo shows all that was recovered from Helicopter N-18845. The EAM-5 five man life raft was partially filled with water when found. When the right float was retrieved from Cook Inlet it was buckled and folded in the center. Several small pieces of plexiglass fell from the fold in the canvas when it was laid out on the deck of the U.S. Coast Guard Cutter Sedge. The metal float tube (left side of photo) was just barely attached to the end of the float as it was pulled from the water.

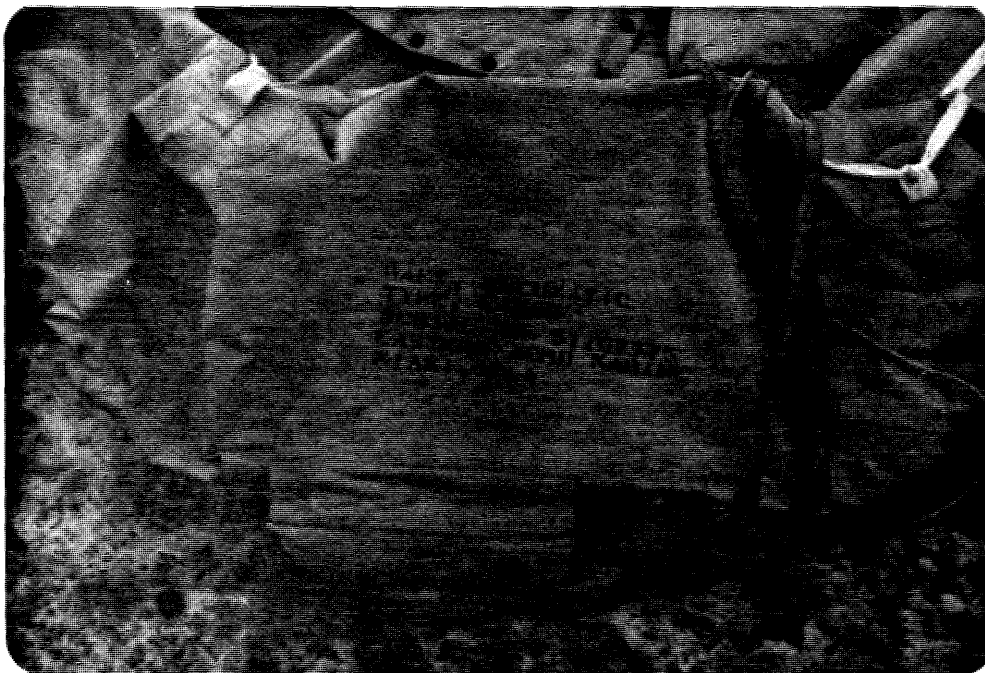
- #2. Closeup of identifying numbers on the emergency life raft. This serial number matches the number of the raft inspected by Eagle Enterprises, Inc., in Anchorage, Alaska, on 10-12-77, which was placed in N-18845.

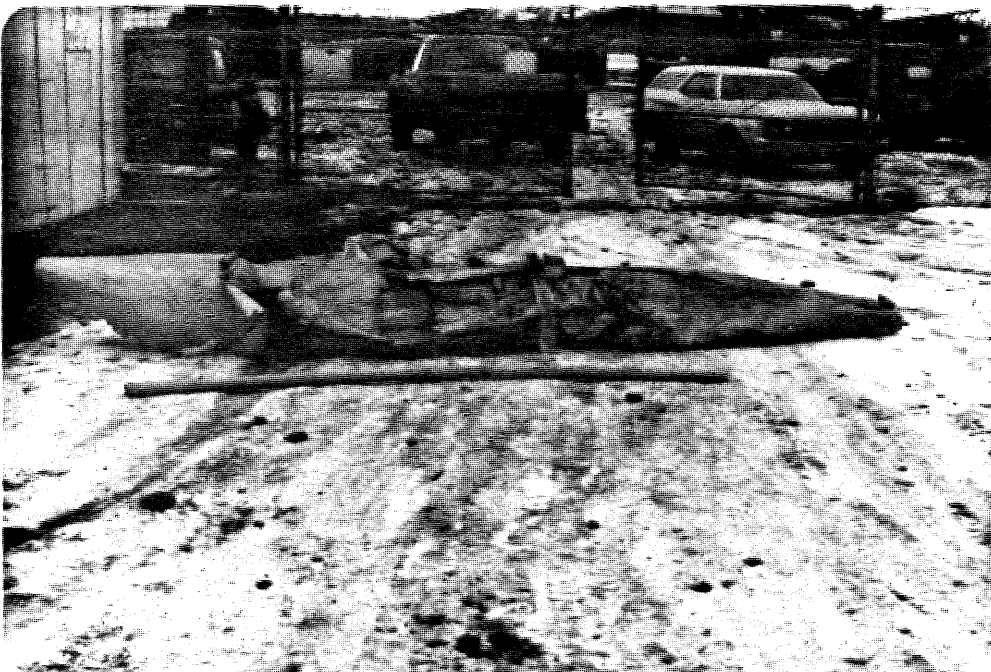
The aircraft is missing. The only portion of N18845 that was recovered was the right pontoon and several small pieces of plexiglass that were caught in a fold of the floats canvas. A metal tube which runs inside a canvas sleeve on top of the float was bent approximately 18°. The bend was near the aft portion of the tube which would indicate the aircraft impacted the water in a relatively nose high attitude. Deformation to the float and metal tube also indicate impact to be relatively level in relation to the roll axis of the helicopter. Impact velocity can not be accurately determined; however, due to the absence of any impact injuries on the passenger, this would indicate impact velocities between minor and moderate. Either the pilot or the passenger was able to inflate the emergency raft and then the passenger was able to get in it.

#3. Photo showing inboard side of right float and metal float tube.

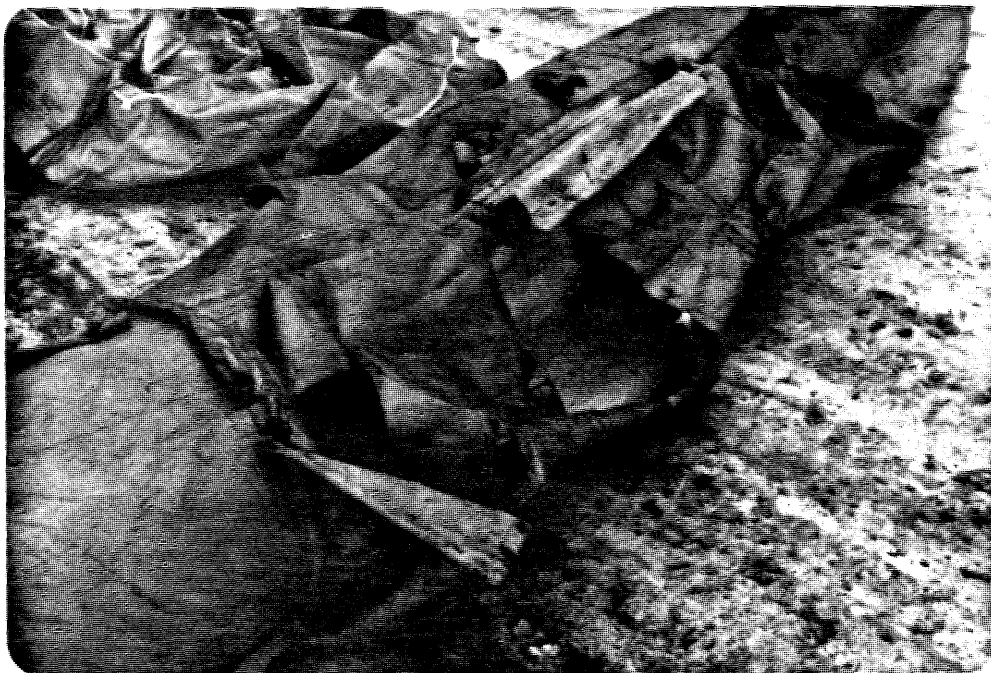
#4. Closeup of mid-section of inboard side of right float.

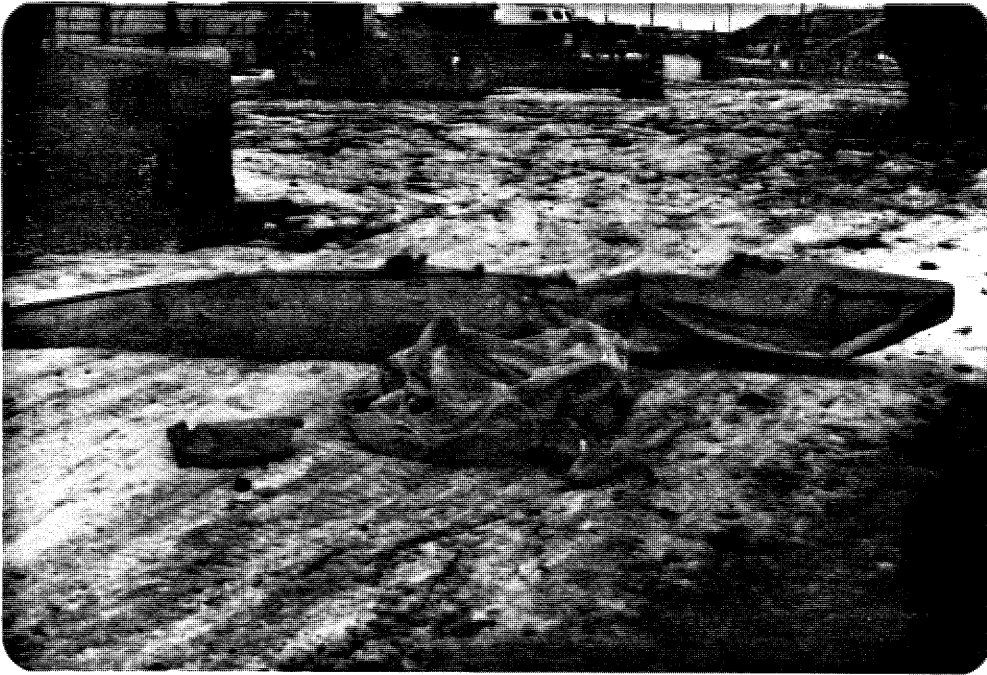
#5. View showing outboard side of right float.

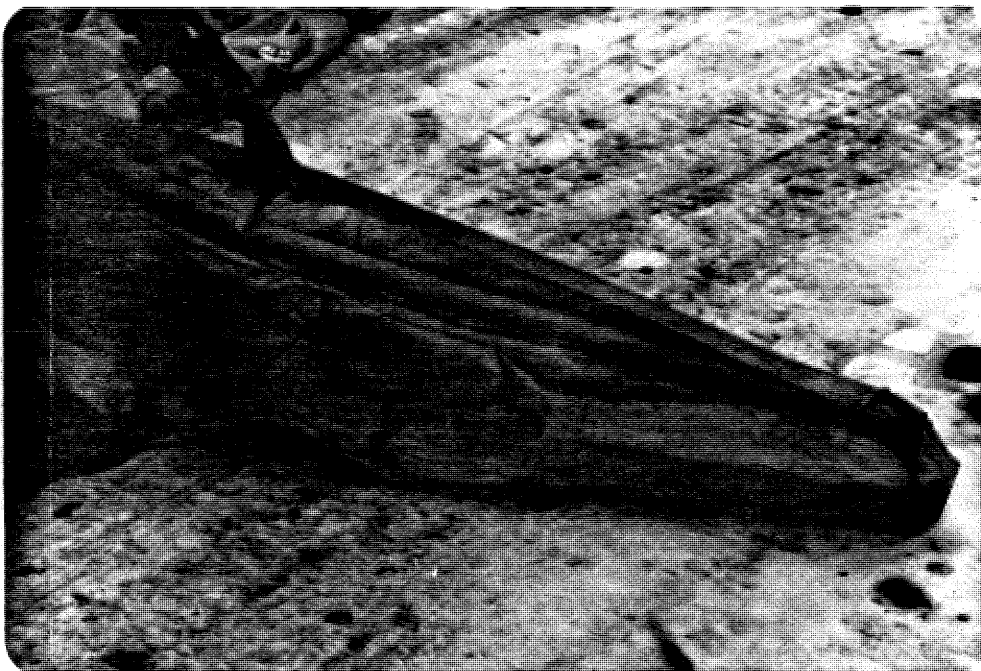
#6. View showing where metal float tube is normally positioned inside of canvas sleeve running down the top of the float. Note where bend in tube and tear in canvas sleeve match up. This would indicate the helicopter impacted relatively nose high.
