National Transportation Safety Board

**FACTUAL REPORT**

NTSB ID: ATL04FA038

Aircraft Registration Number: N4482S

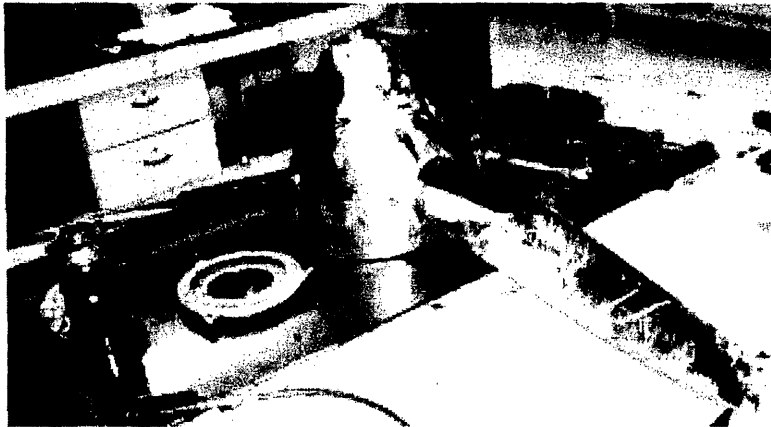
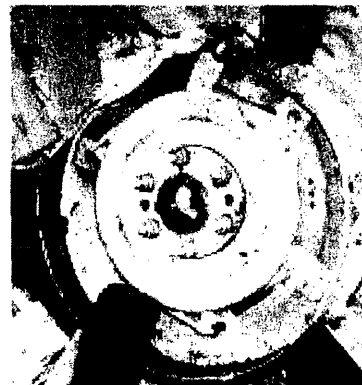
The left propeller had significant blade bending and twisting. Normally this, plus torsional fracture of the engine shaft, suggests power ON at impact. However, some of the harsh damage is likely attributable to the manner of impact, as evidenced by edgewise bending near the shank of blade L3. Also, blade L1 was straight with little damage, which suggests that the left propeller was not at high power (except that possibly the crankshaft fractured and the propeller separated prior to L1 blade impact).

The spinner dome had not been removed. The engine shaft was fractured near the propeller mounting flange. The engine flange had not been removed from the propeller.

The pitch change mechanism was seized and cycling of the mechanism was not possible. The air valve was broken and it did not retain its air charge.

The engine shaft was fractured about 1/2 inch aft of the propeller mounting flange. The engine shaft had spiral cracks around the fracture surface. The propeller attachment bolts and propeller mounting flange were unremarkable.

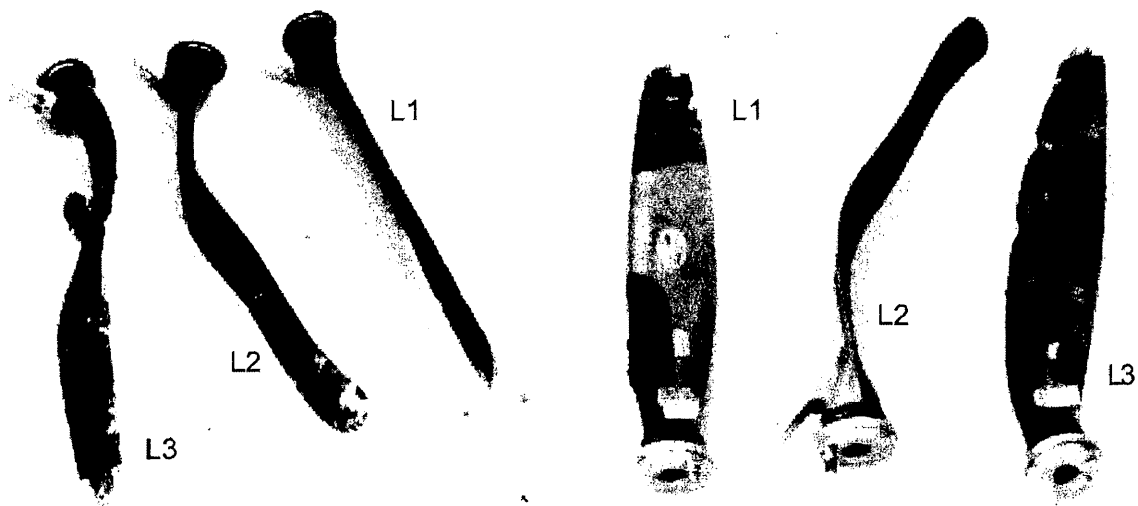
L2 blade was bent aft about  $30^\circ$  at mid-blade. It was bent slightly forward at 2/3 radius. The outer two inches of the tip was bent aft and twisted toward low pitch.

L3 blade was bent forward approximately  $20^\circ$  at 1/4 radius. It was bent aft and twisted toward low pitch at mid-blade. There were very deep gouges in the leading edge. There was rotational scoring on the camber side. The blade had a chordwise aft bend near the shank. There was rotational marking (appeared to be roof tar) on the outer 12 inches of the blade on the camber side.

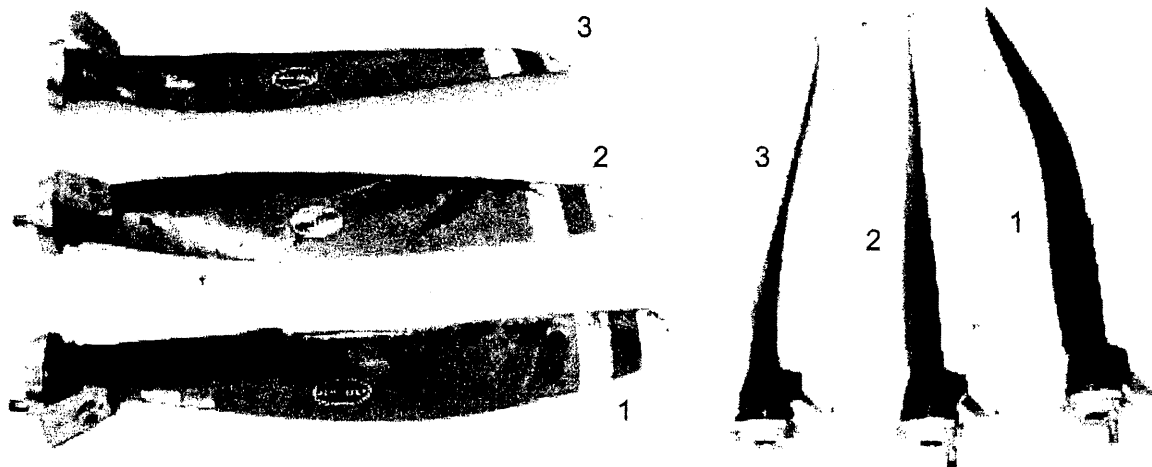
All three blade had traces of what appeared to be roofing tar on the camber side of the blades. # 3 blade pitch change knob was fractured. # 1 and # 2 blade pitch change knobs were intact. All three blade counterweights were intact.

# 1 blade had rotational scoring on the camber side with leading edge damage in the tip area. It was mildly bent aft about  $10^\circ$  at mid-blade.

# 2 blade appeared to be undamaged except for the presence of black tar on the camber side.

# 3 blade was slight bent forward at 1/3 radius. The outer two inches of the tip was curled aft. The tip had rotational scoring on the camber side with leading edge damage.
