NTSB ID: LAX98FA106 Alrcraft Registration Number: N257NW

Occurrence Date: 03/05/98 Most Critical Injury: FATAL

Aircraft Manufacturer	Model/Series	Type of Aircraft
Piper	PA-31-350	Airplane

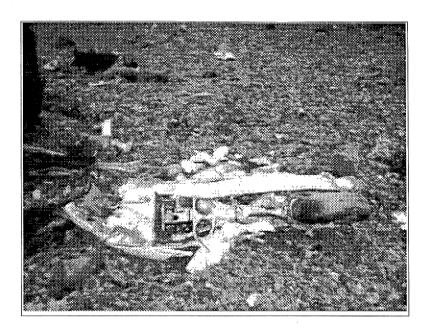
Photo 01: View of Nose Gear with Nose Gear Door (NTSB)

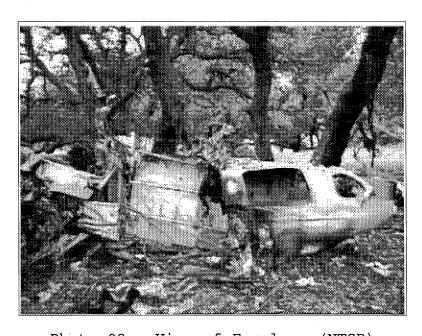
The cabin and fuselage section came to rest inverted about 75 feet forward of the tail section. It exhibited extensive crushing and fragmentation. Numerous fragments could be seen along the debris path extending forward from the tail section. Evidence of a ground fire was found that had consumed portions of the

Photo 02: View of Fuselage (NTSB)

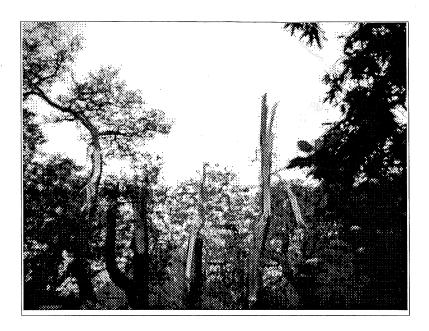
The trees on the northwest end of the accident site exhibited a series of broken limbs of up to 10 inches in diameter. The width of the initial swath through the trees was consistent with the tip-to-tip wingspan of the aircraft.

Photo 03: Initial Impact Point Looking in the Direction of Approach (NTSB)

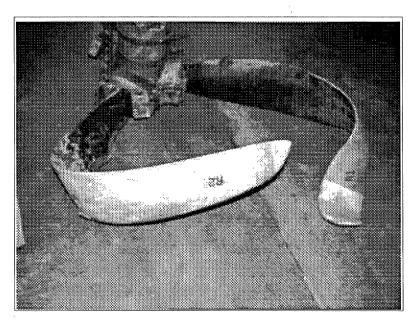
The right 3-bladed constant speed propeller was found near the main fuselage with all 3 blades attached to the hub. The propeller was separated from the engine and the propeller hub was fractured. A portion of the hub remained attached to the crankshaft flange. All three blades were equipped with de-icing boots.

The three blades exhibited various combinations of S-bending, torsional twisting, midspan bending and curling with leading and trailing edge damage. Of the three blades, two were turned in the hub while one was found at low pitch.

Photo 04: View of Right Propeller (NTSB)

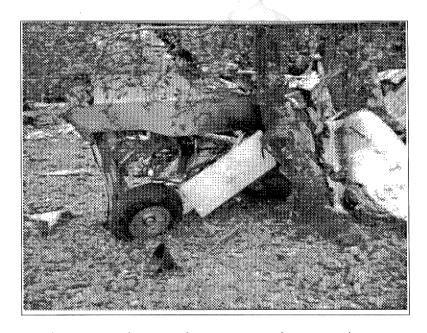
The inboard section of the right wing with the engine nacelle still attached and right main landing gear partially extended was found leaning against a tree. The nacelle exhibited evidence of ground fire.

Photo 05: View of Right Wing and Main Landing Gear (NTSB)

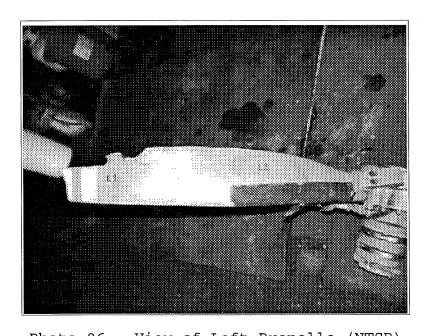
The left 3-bladed constant speed propeller was found along the left side of the debris path with 1 blade detached. The separated blade was found in the vicinity of the initial impact point. The propeller was separated from the engine and the propeller hub was fractured. A portion of the hub remained attached to the crankshaft flange. All three blades were equipped with de-icing boots.

Photo 06: View of Left Propelle (NTSB)
