C I V I L A E R O N A U T I C S B O A R D
ACCIDENT INVESTIGATION REPORT

Adopted: April 15, 1957

TRANS WORLD AIRLINES, INC., LOCKHEED 1049A, N 6902C, AND
UNITED AIR LINES, INC., DOUGLAS DC-7, N 6324C,
GRAND CANYON, ARIZONA, JUNE 30, 1956

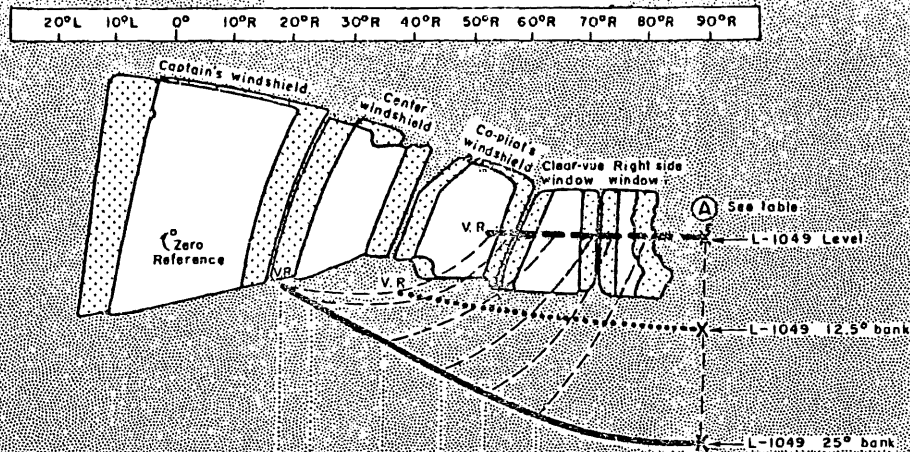
VIEW FROM CAPTAIN'S SEAT

Cloud diameter - Miles	-	10	5	2	1	△
Approx. time to collision - Seconds	60	50	38	27	21	12
Approx. distance between aircraft - Miles	54	4.8	3.3	2	1.5	.8

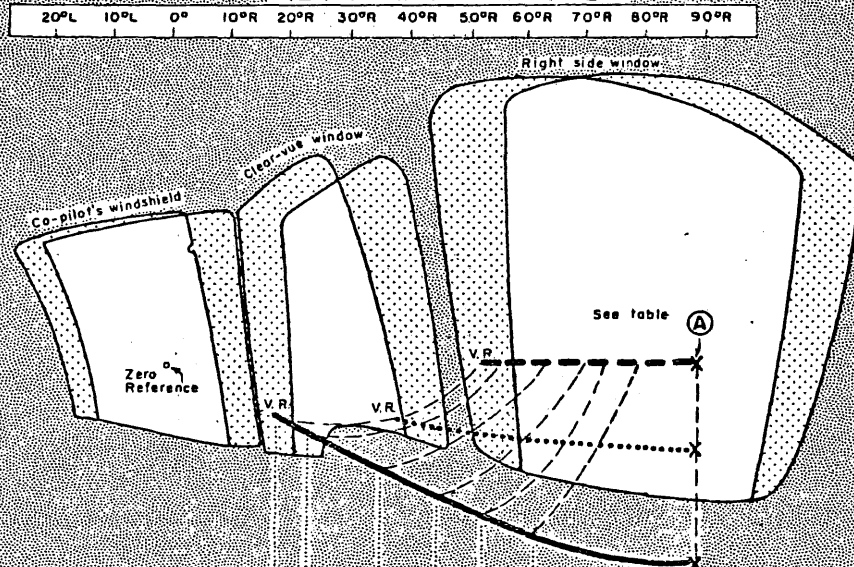
VIEW FROM CO-PILOT'S SEAT

Cloud diameter - Miles	-	10	5	2	1	△
Approx. time to collision - Seconds	60	50	38	27	21	12
Approx. distance between aircraft - Miles	54	4.8	3.3	2	1.5	.8

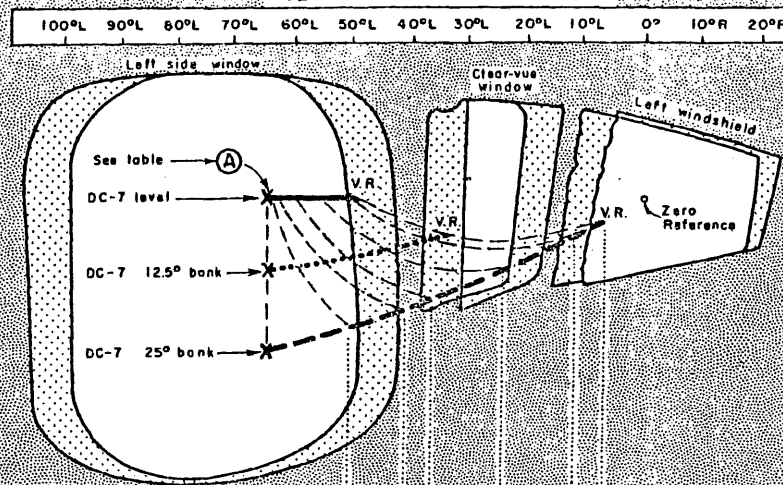
VIEW FROM CAPTAIN'S SEAT

Cloud diameter — Miles	1	2	5	10	—
Approx. time to collision — Seconds	12	21	27	38	50
Approx. distance between aircraft — Miles	.8	1.5	2	3.3	4.8

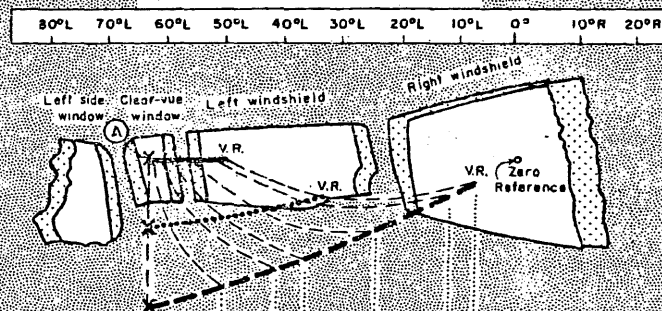
VIEW FROM CO-PILOT'S SEAT

Cloud diameter — Miles	1	2	5	10	—
Approx. time to collision — Seconds	12	21	27	38	50
Approx. distance between aircraft — Miles	.8	1.5	2	3.3	4.8
