Aviation Investigation Report

In-Flight Fire Leading to Collision with Water

Swissair Transport Limited
McDonnell Douglas MD-11 HB-IWF
Peggy's Cove, Nova Scotia 5 nm SW
2 September 1998

Report Number A98H0003

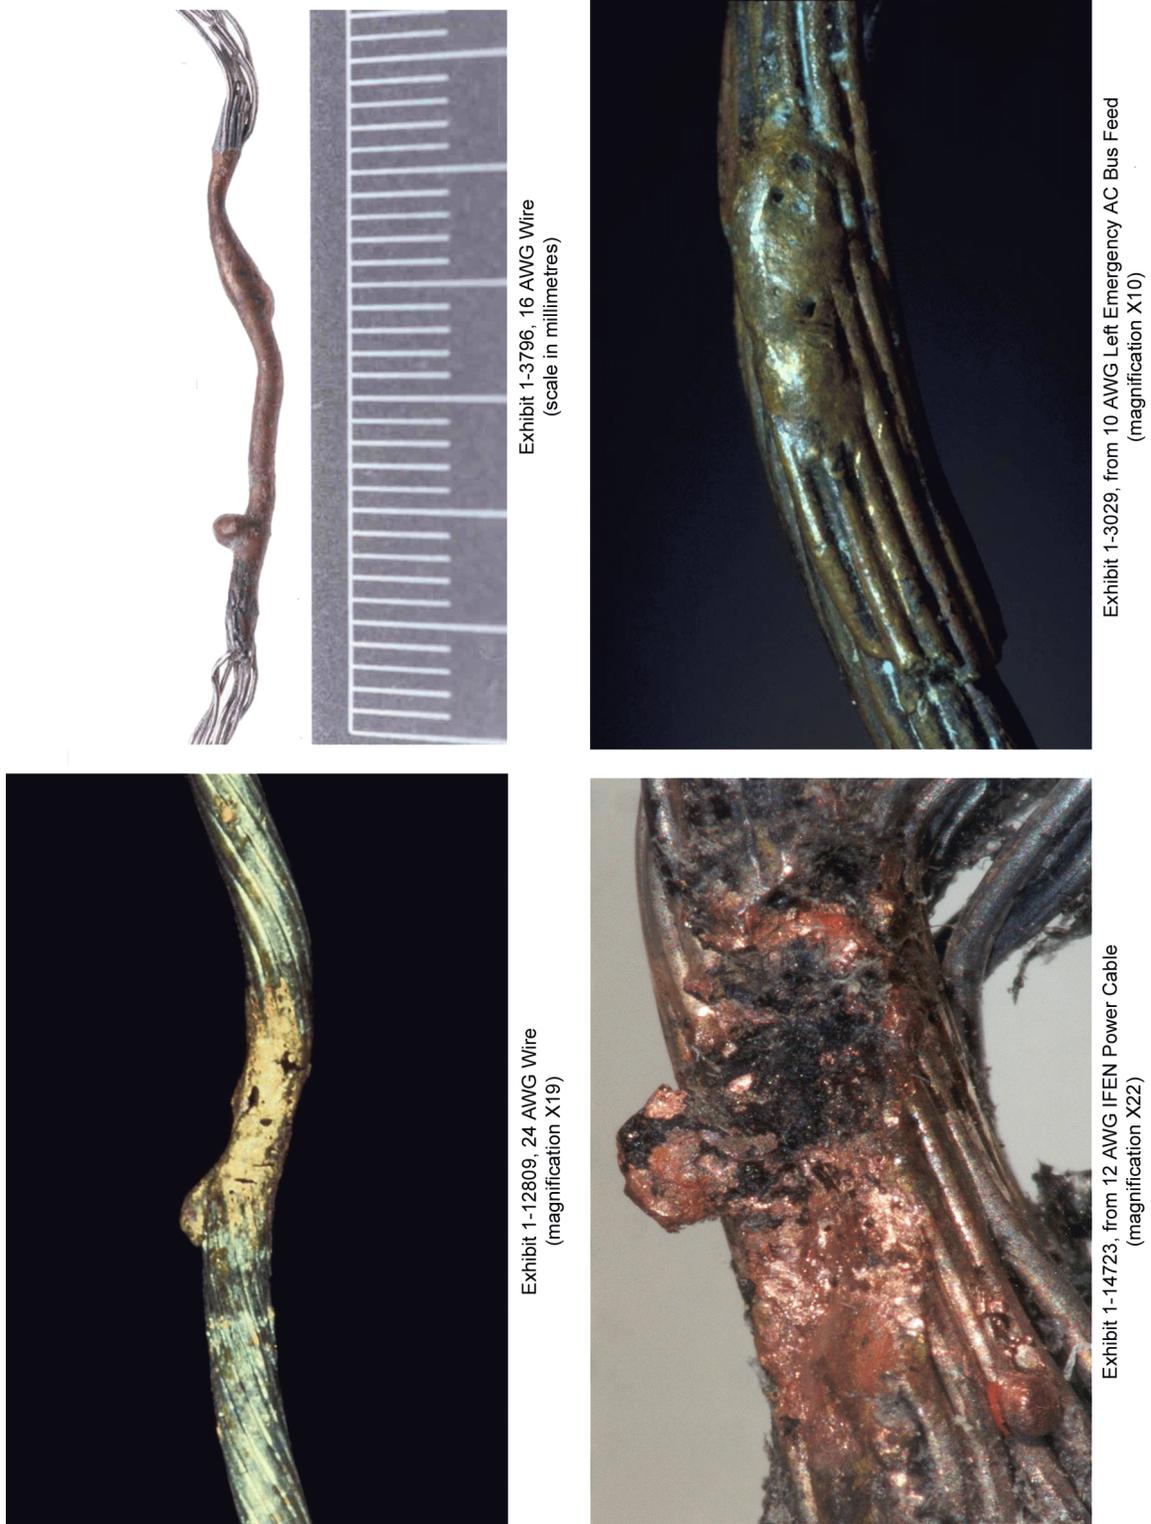
Figure 20: Wire segments with melted copper

All of the recovered wires were examined, primarily to identify any with signs of melted copper. As the fire did not reach temperatures high enough to melt copper,⁵⁰ any areas of melted copper would indicate that an electrical arcing⁵¹ event had occurred.

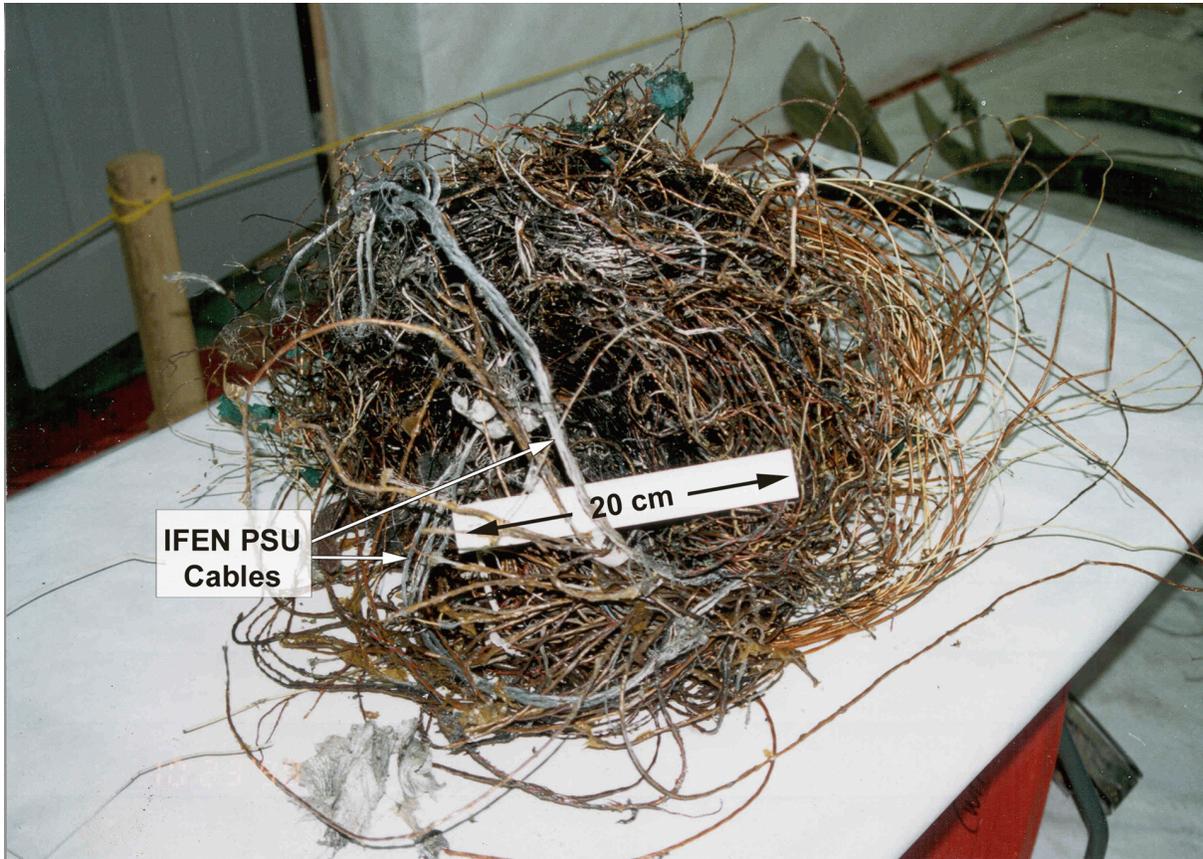
Figure 21: Exhibit 1-4372

Of the nine wire or cable segments with areas of melted copper that were recovered from Exhibit 1-4372, four were positively identified as being segments of the IFEN PSU cables (1-3790, 1-3791, 1-3792, and 1-3793) (see Figure 22). This identification was based on remnants of coloured ETFE insulation remaining attached to the wires. On each of these four segments, one end was heavily matted, or crushed together, and the opposite end was fractured and frayed. Exhibits 1-3790 and 1-3792 both had distinctive regions where the tin coating was missing from the wire strands on all three wires. Exhibits 1-3791 and 1-3793 did not have a similar region of missing tin.

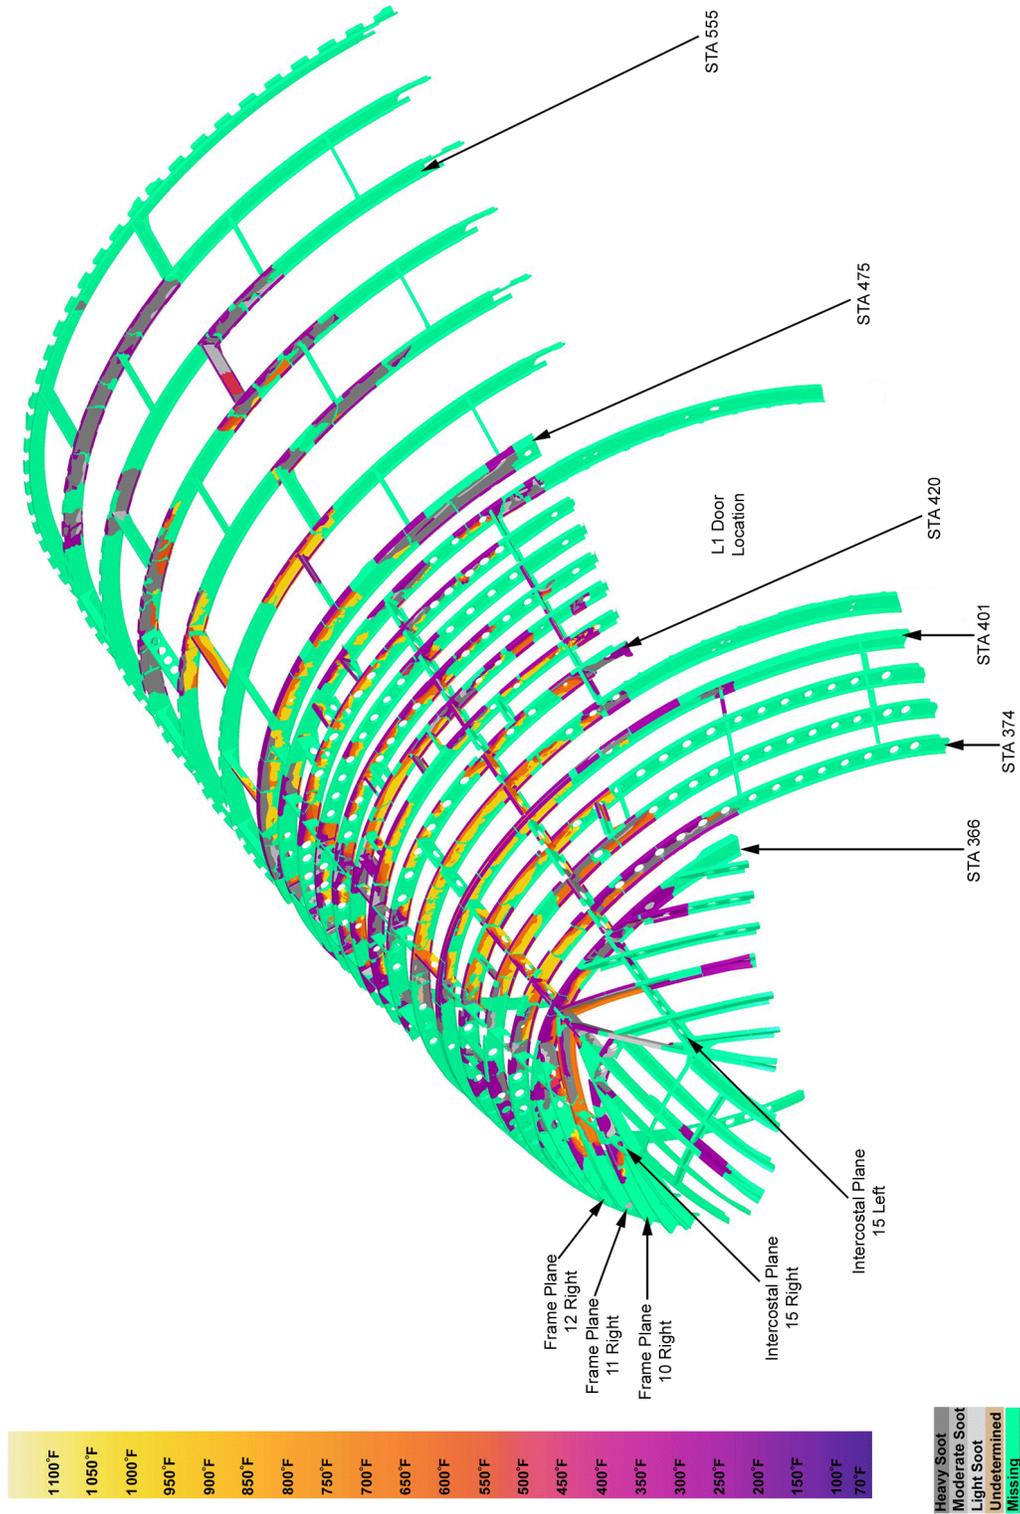
Figure 25: Heat damage – airframe structure

Damage to the riser duct assembly ranged from no heat damage to bare-metal heat damage. The vertical portion of this assembly had no heat damage. The first area of bare-metal damage to the riser duct assembly started at intercostal plane 15 right, where the lower surface had a region of bare-metal heat damage from $X = -30$ inboard to the joint at $X = -20$. This was in the vicinity of the Galley 2 vent end cap. There was bare-metal damage from approximately STA 395 to STA 442 between $X = 25$ and $X = -10$. A section of molded duct was installed in that area from STA 420 to STA 442 between $X = 5$ and $X = 25$. No portions of this molded duct were identified in the wreckage.

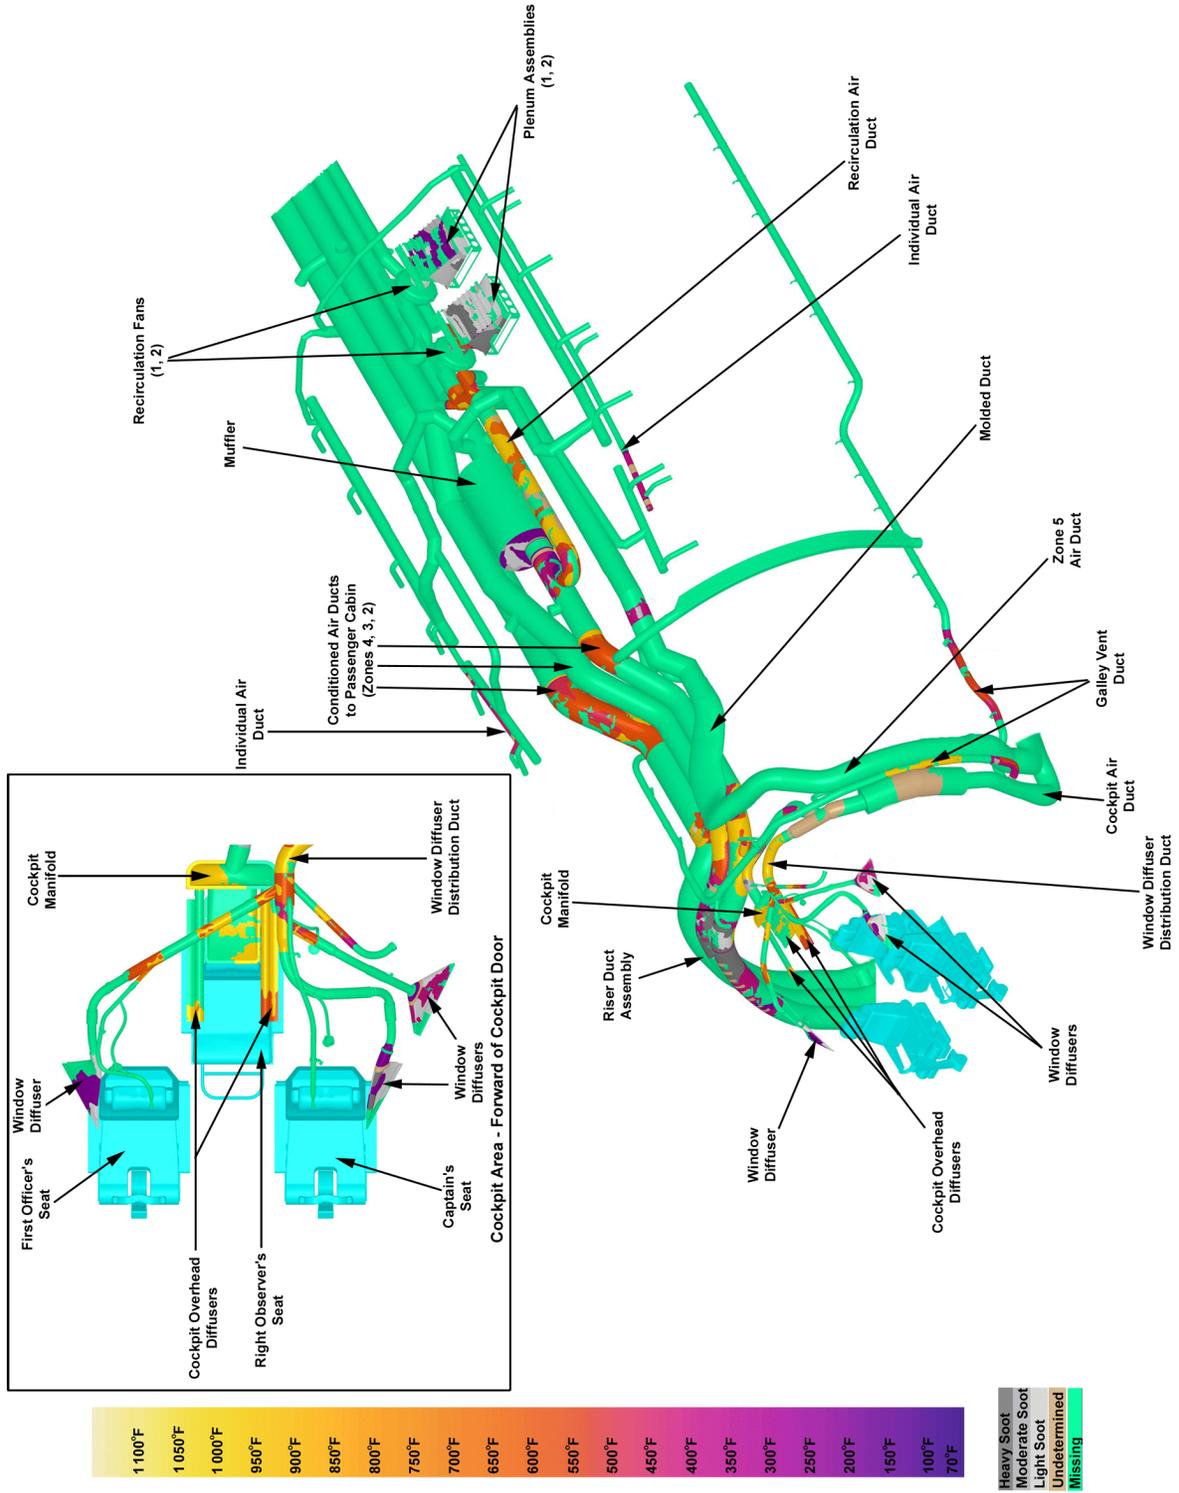
Figure 26: Heat damage – air distribution system

Forward passenger cabin individual air was supplied by a fan and plenum assembly identical to a recirculation air fan and plenum assembly. The fan was located at STA 990 at $X = -24$. The plenum assembly was between $X = -40$ and $X = -65$. The recovered portions of the plenum had no heat damage or soot accumulation. The individual air ducts were uninsulated and ran forward from STA 990 to a "Y" (split) at STA 750 at $Z = 91$, $X = -21$. One branch of the "Y" ran across the crown to the left side of the cabin at $X = 76$, and the other ran to the right side at $X = -76$. The recovered portions of these ducts had moderate to heavy soot accumulations on the exterior, with no heat damage. The aftermost section of individual air duct that was identified was from STA 934 to STA 955 at $X = -22$ and had light soot accumulation on the exterior.

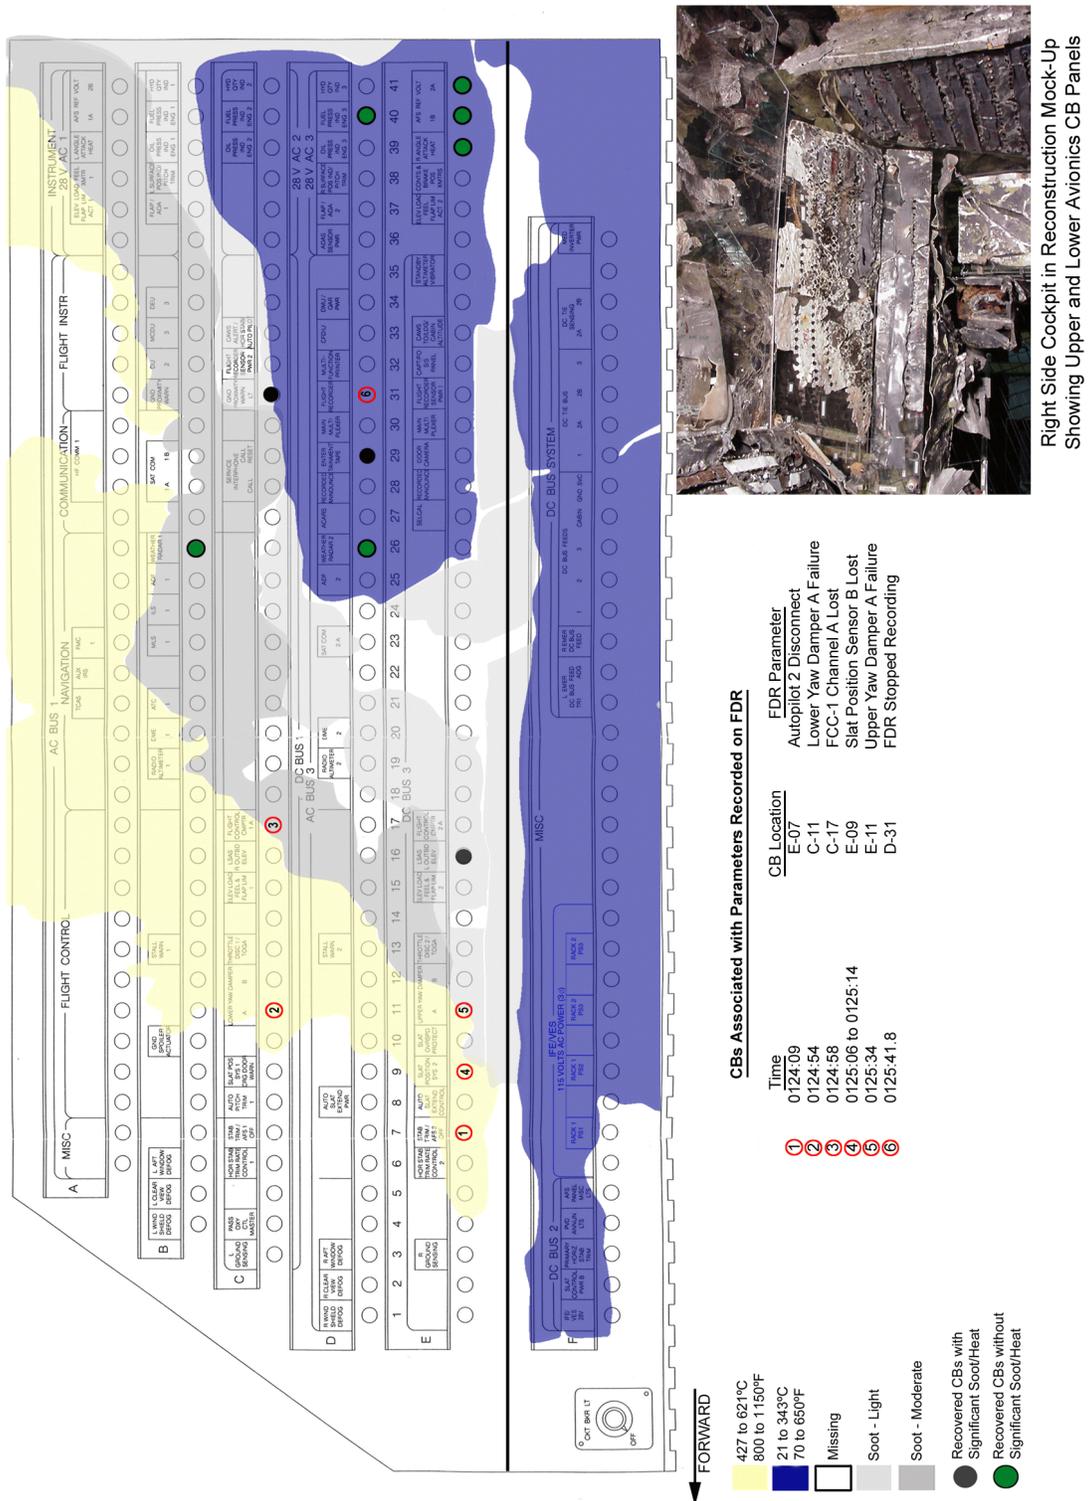
Figure 28: Heat damage – upper and lower avionics CB panels

side, particularly on those pieces near the forward end of the panel where the front side of the panel showed considerably more heat damage than the back side. Individual CBs showed soot on the white indicator ring; soot could only have been deposited if the CB had tripped and subsequently been exposed to combustion by-products. Details concerning the CBs on the avionics CB panel and wiring in the vicinity are included in separate sections of this report.

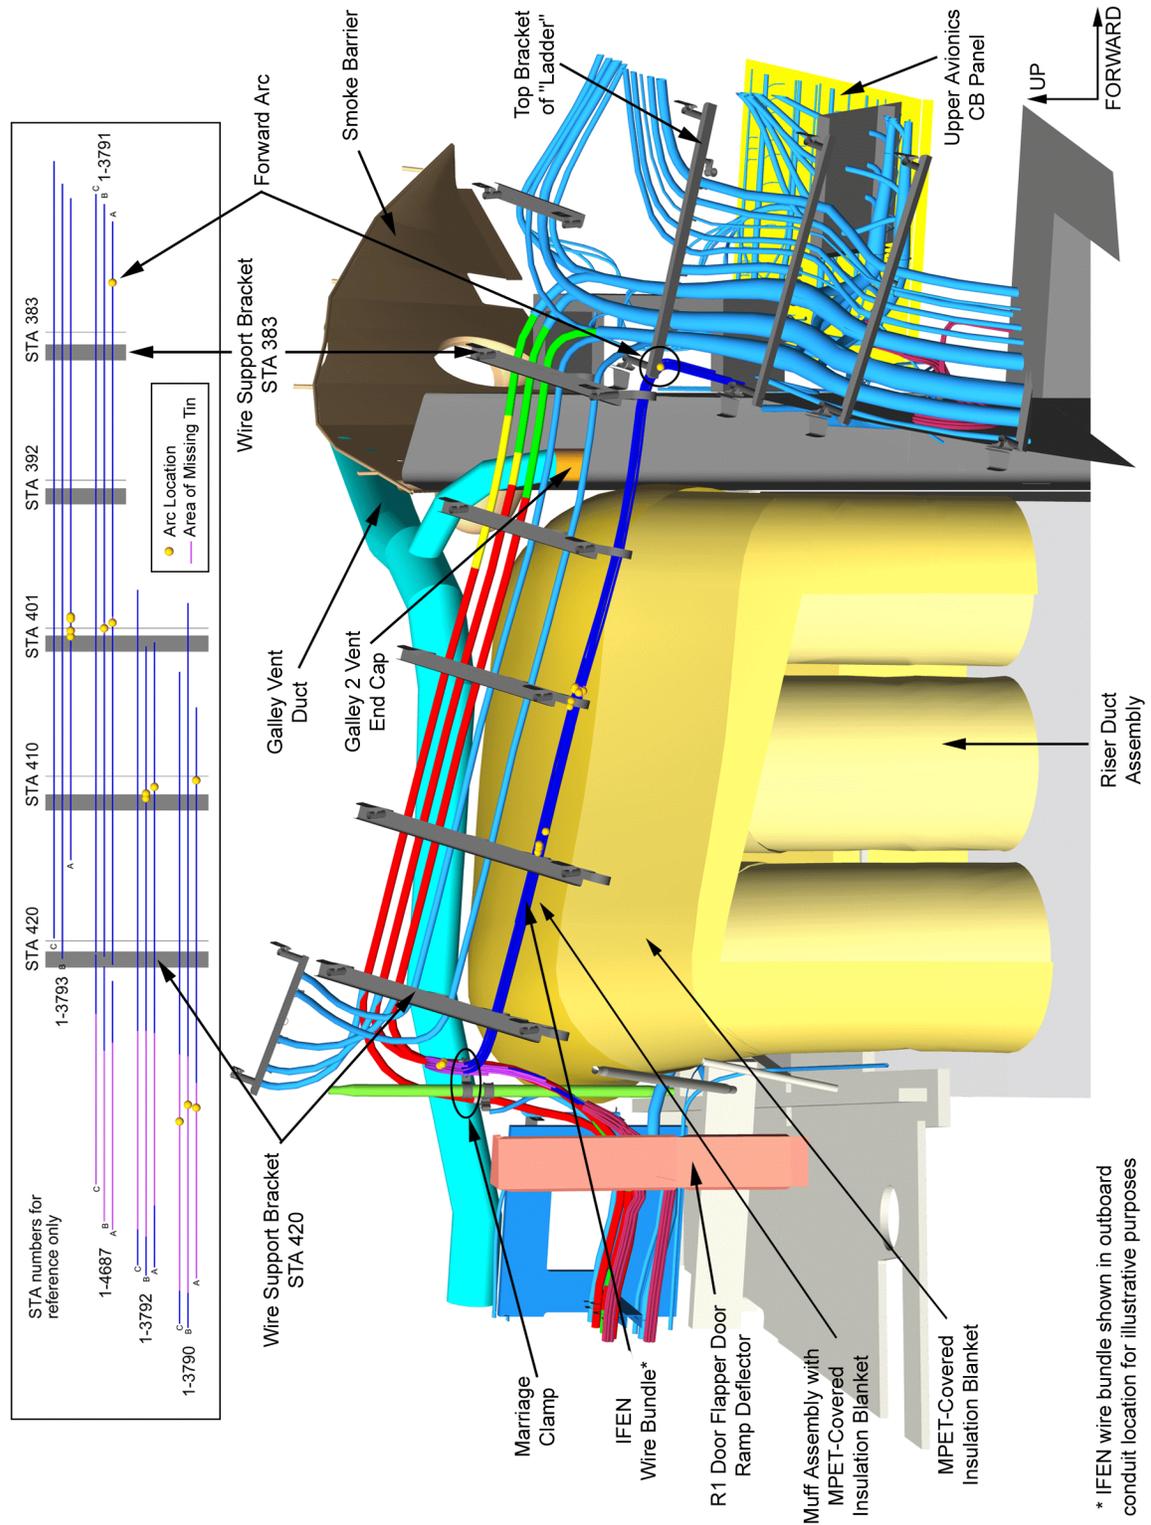
Figure 30: Position of recovered IFEN wires – outboard conduit

As indicated above, based on the layout of the cables and wires, it is possible to assess the direction of fire propagation based on the sequence of the arcing events. The aft arcs on exhibits 1-3790 and 1-3791 would most likely have tripped their associated CBs; therefore, the forward arcs must have occurred first, and not tripped their associated CBs. This strongly suggests that the fire was moving forward to aft.

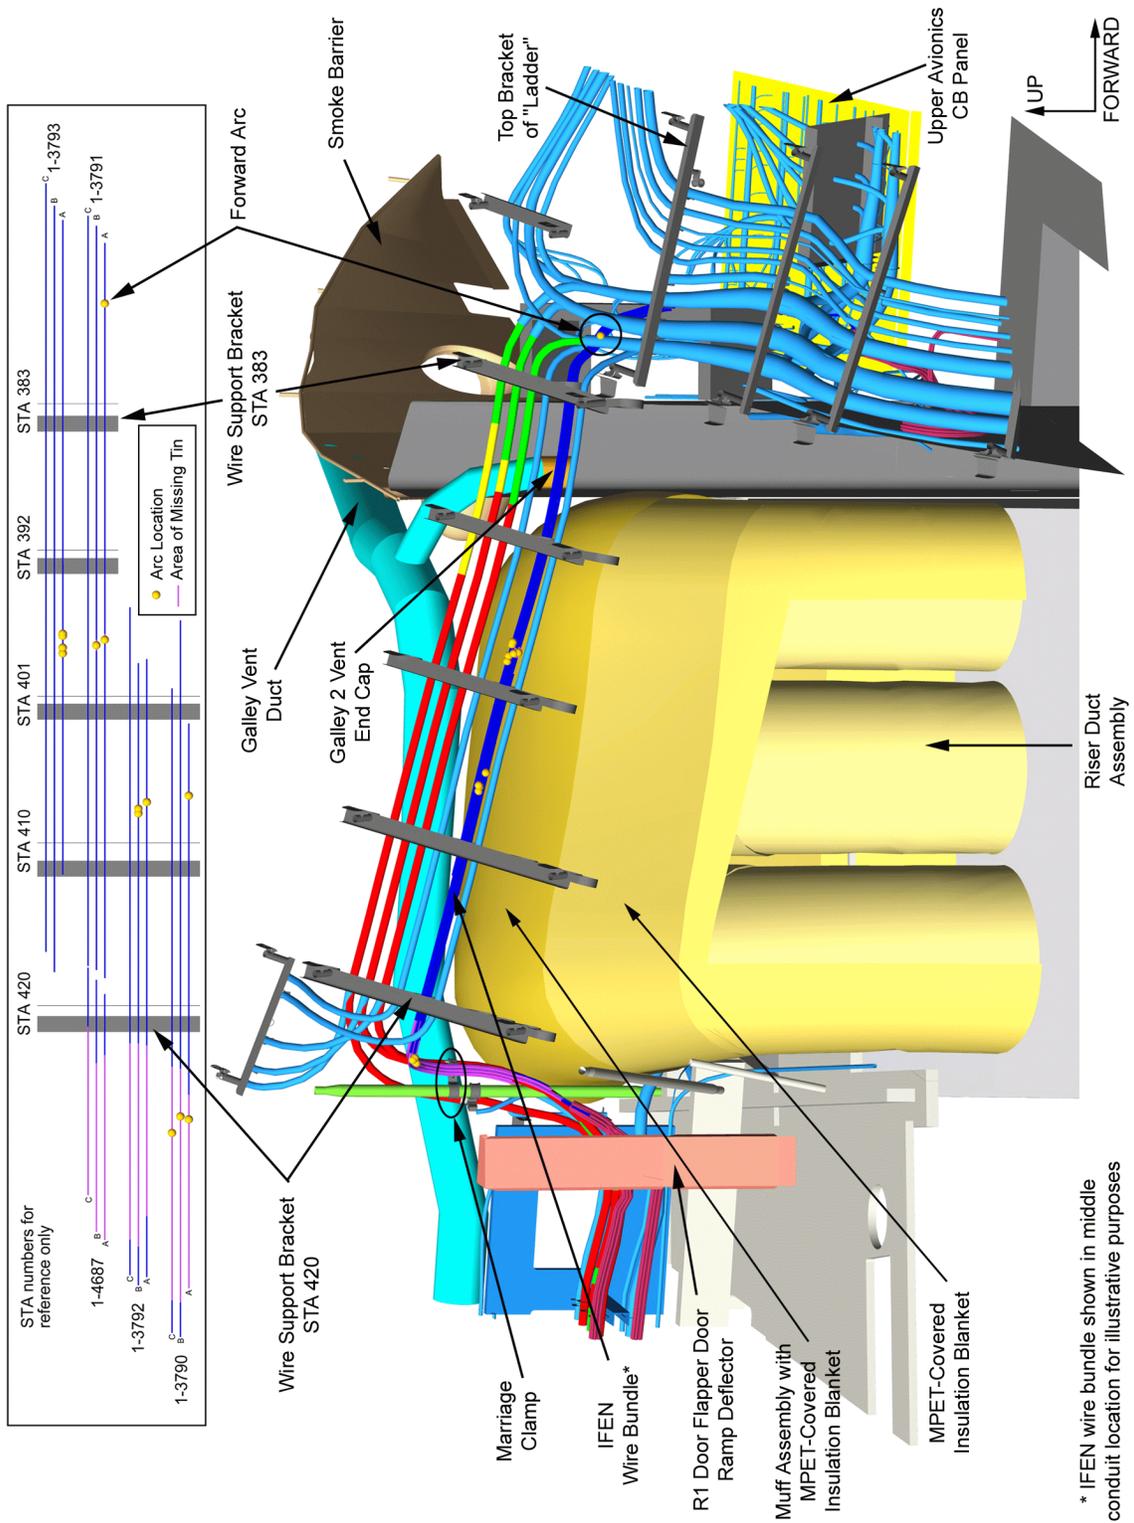
Figure 31: Position of recovered IFEN wires – middle conduit

The region of missing tin represented an area of higher heat. If this had been an earlier event, it is strongly suspected that all three cables would exhibit similar arcing events in the vicinity of 1-3790 outside the aft end of the conduit. With the cables and control wire laid out as described above, all of the regions of melted copper could be attributed to arcing events between phases on the same cable, between the cables and the control wire except for the arc event that took place at the forward end of 1-3791, or both. There was no matching arc damage on cable 1-3793 in this area. However, the continuation of exhibits 1-3790/1-3792 from approximately STA 401, along with the 16 AWG control wire forward, were not identified. Therefore, no determination could be made with respect to exactly what the single wire from 1-3791 had come in contact with at the forward end.
