PB92-917007
NTSB/SIR-92/03

SPECIAL INVESTIGATION REPORT

PIPER AIRCRAFT CORPORATION
PA-46 MALIBU/MIRAGE
ACCIDENTS/INCIDENT
MAY 31, 1989 TO MARCH 17, 1991

Adopted: July 21, 1992
Notation 5803

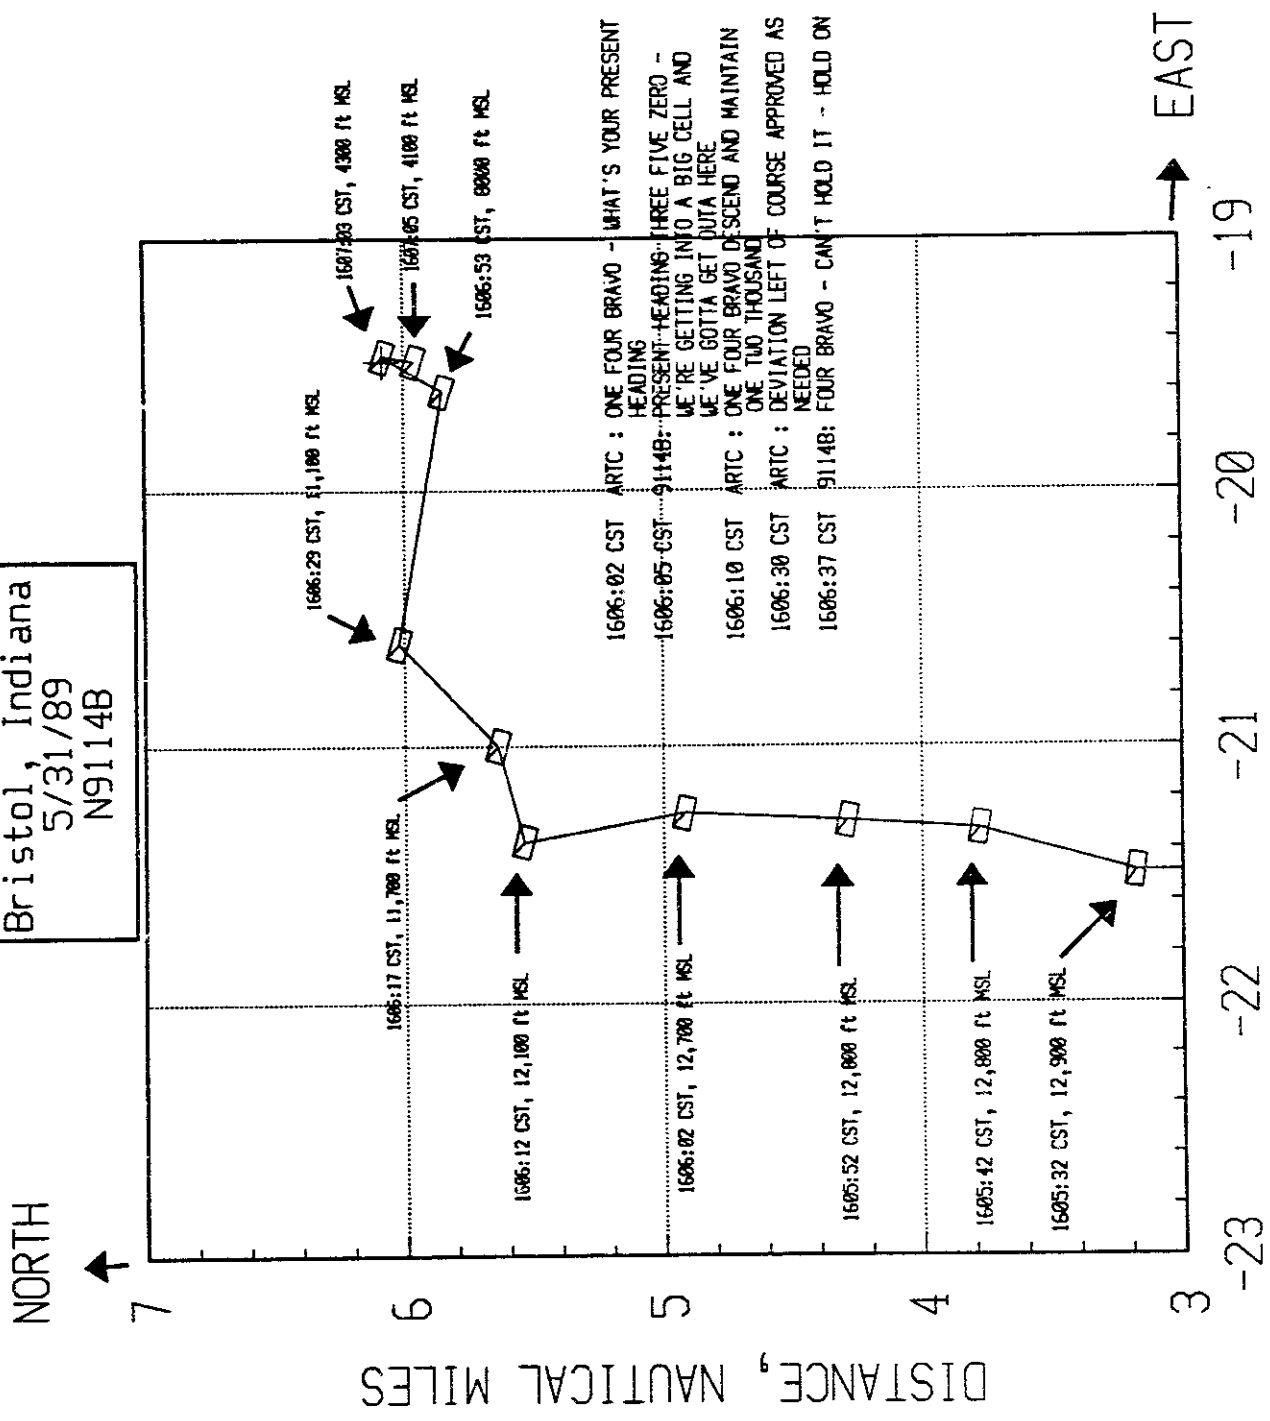
FIGURE 2

A flightpath study of recorded air traffic control (ATC) radar data (See Figures 2 and 3) was conducted for the accident by a Safety Board airplane performance engineer. Airplane performance calculations derived from recorded radar data indicate

that as the airplane descended from 17,000 feet, it was heading north; it then was leveled at 13,000 feet. At that time, the airplane's indicated airspeed was about 190 knots (KIAS). The speed decreased to about 150 KIAS over the next 40 seconds. During the following 60 seconds, the airspeed increased to 180 KIAS and then decreased again to 150 KIAS. A descent from 13,000 feet was then begun and the speed increased to 170 KIAS by the time the pilot reported, "...we're getting into a big cell and we've gotta get outa here." At an altitude of 12,100 feet, the airplane entered a steeply banked turn to the right, its speed increased from about 170 KIAS to more than 200 KIAS as the altitude decreased to 11,100 feet in about 17 seconds, and its heading changed from north to east. From the original northerly ground track, the airplane traveled about 1.5 miles to the east where it broke apart in flight. A trajectory study of various parts of the airplane wreckage disclosed that the breakup occurred above 10,000 feet.

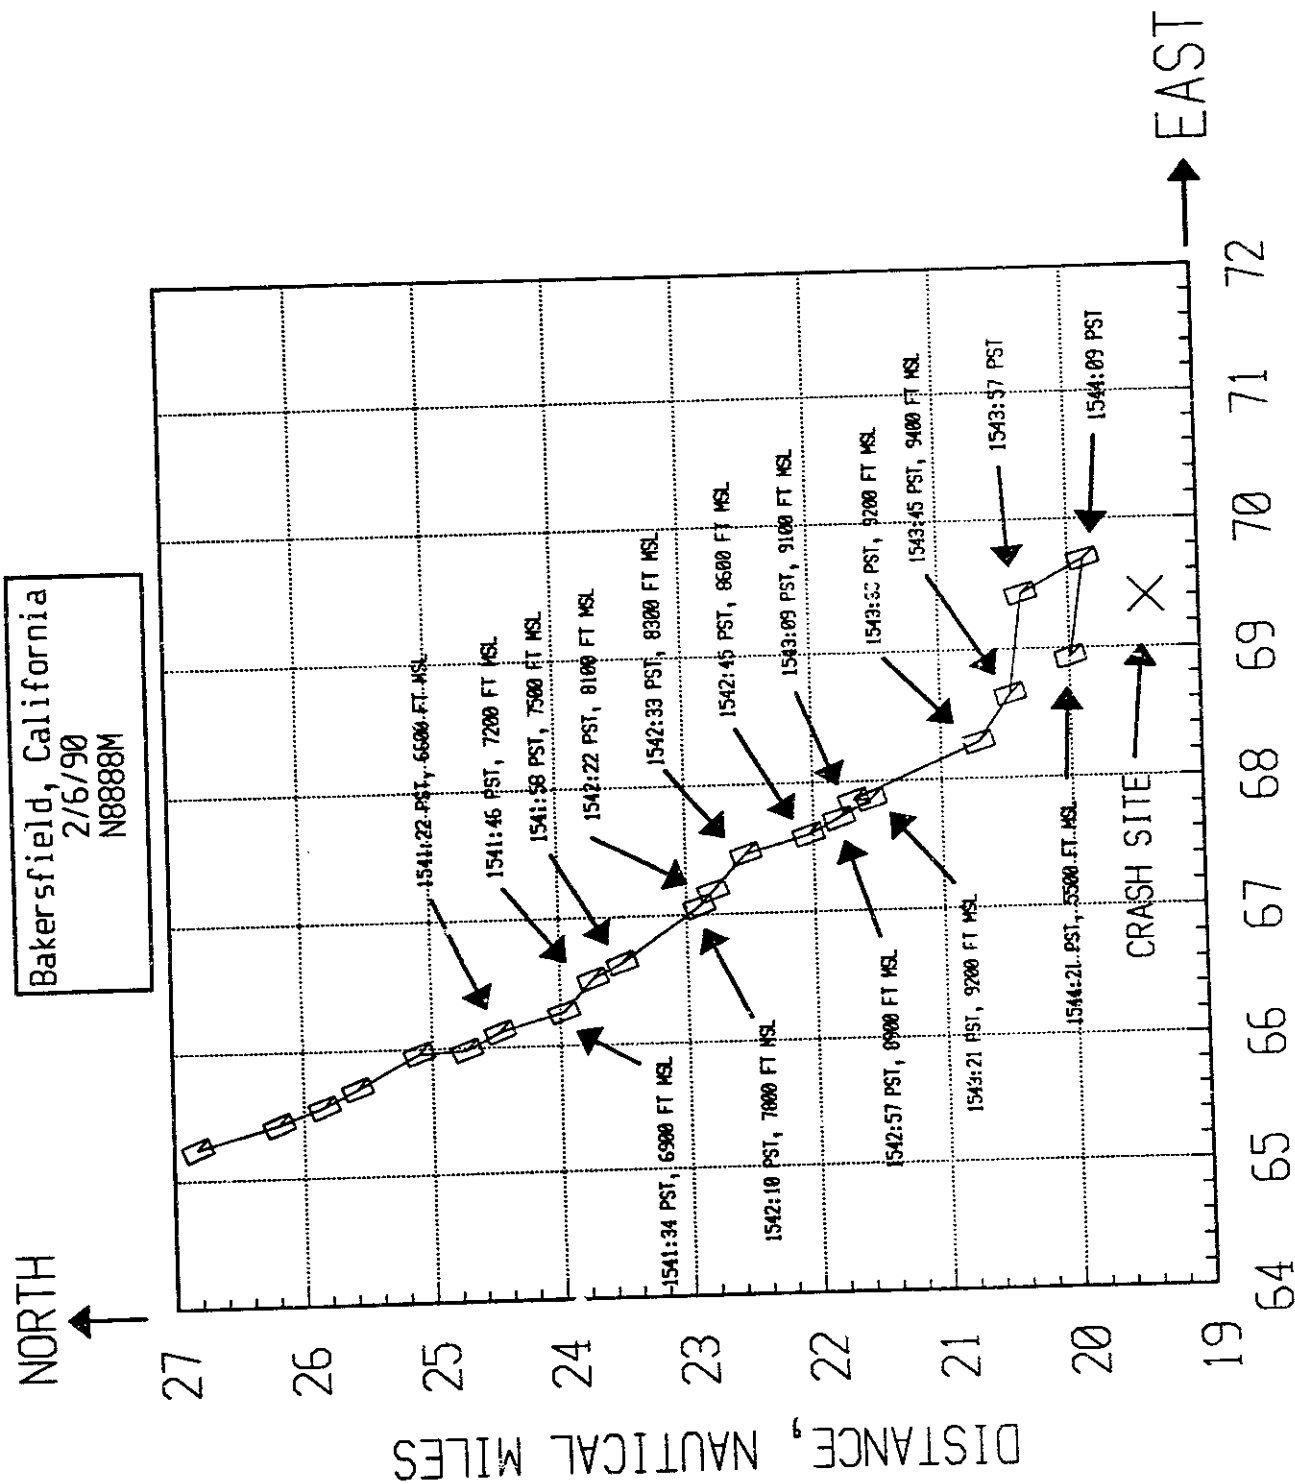
DISTANCE, NAUTICAL MILES
FIGURE 4

A flightpath study was performed for this accident by Safety Board aircraft performance engineers from recorded ATC radar data (See Figures 4 and 5). Airplane performance derived from the data indicate that the airplane initially was ascending at a rate of about 1,500 feet per minute (fpm) at an indicated airspeed of 100 KIAS. Near 8,000 feet, the vertical speed decreased to about 1300 fpm and the airspeed decreased from about 100 KIAS to about 90 KIAS over the next 35 seconds. Near 9000 feet, the vertical speed decreased to near zero while the airspeed was near 100 KIAS. Over the next 25 seconds, the airplane reached 9,200 feet, and the airspeed increased to 135 KIAS. The airplane then started a turn to the left, climbed 200 feet to 9,400 feet in about 15 seconds during the initial part of the left turn, and the airspeed increased to about 140 KIAS. Within the next 20 seconds, the airplane started a turn to the right and descended rapidly with the airspeed increasing to about 190 KIAS. Within the next 10 to 15 seconds, the rate of descent increased, the airspeed increased to over 220 KIAS, and the rate of turn to the right

increased significantly. Trajectory studies of airplane wreckage and the derived flight path are consistent with an in-flight breakup that occurred between 4,500 feet and 6,500 feet while in a descent angle of 50 degrees with an airspeed in excess of 265 KIAS.

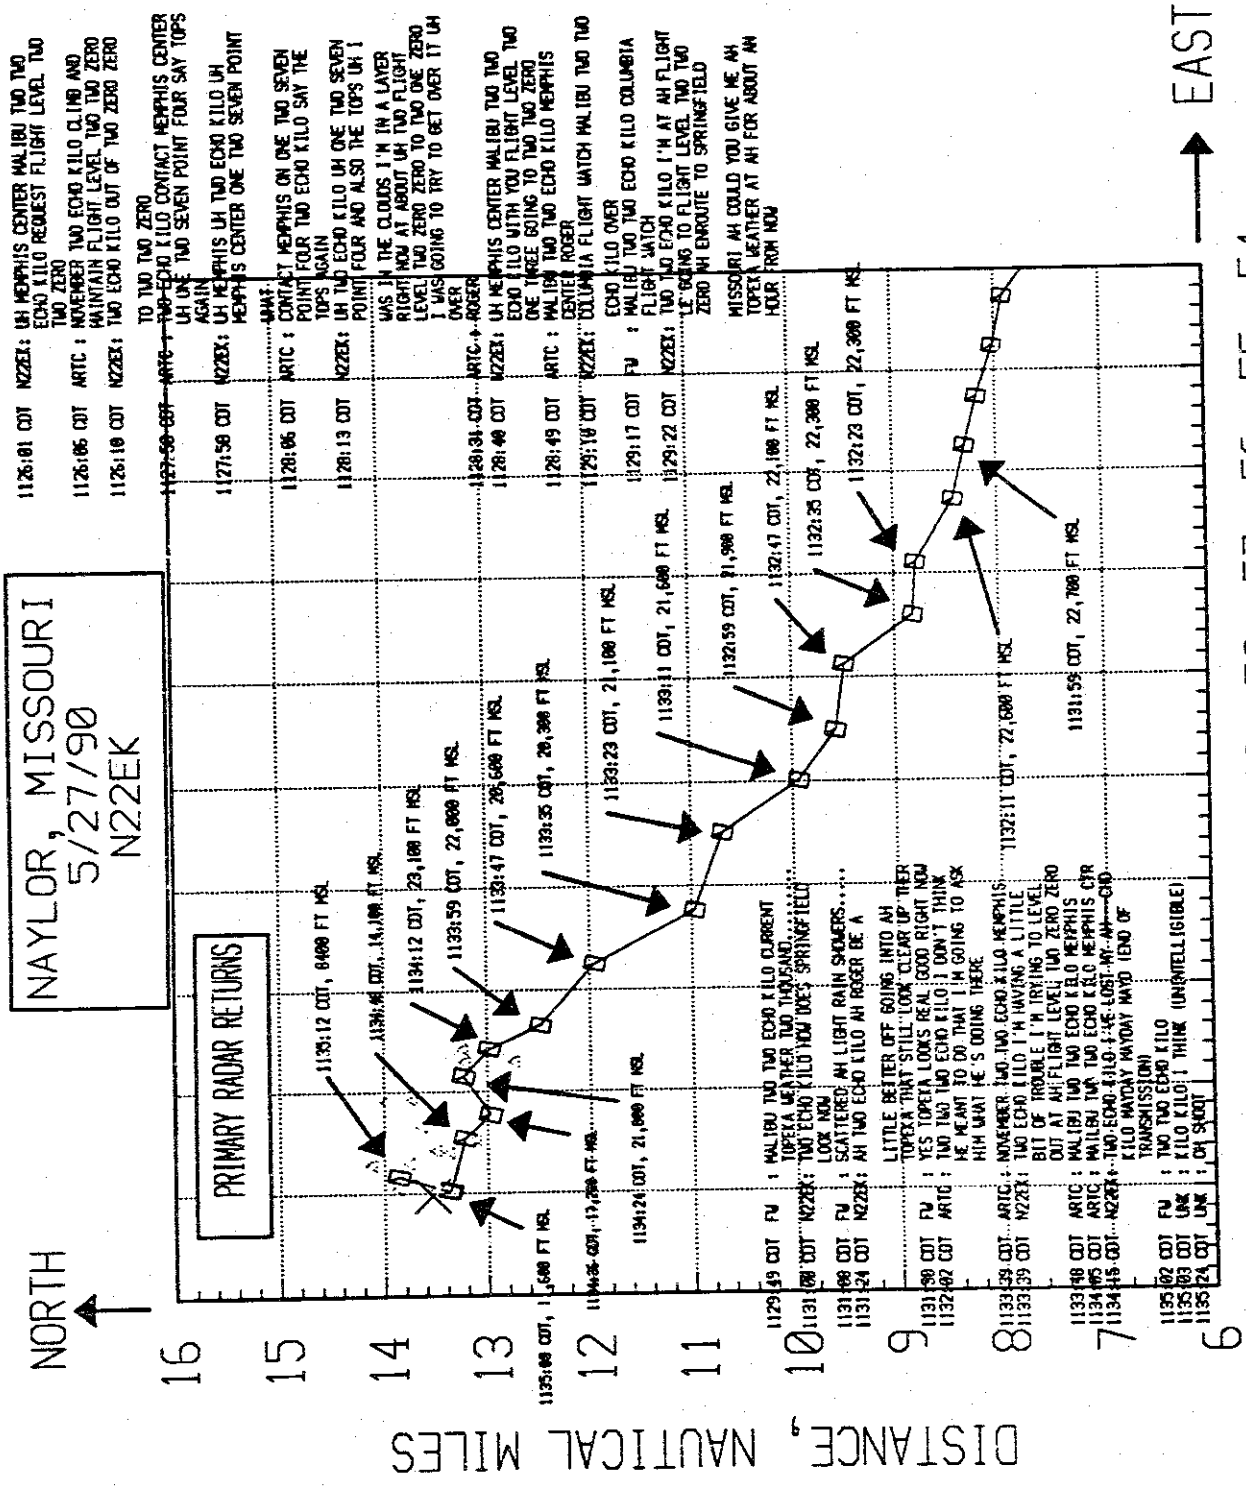
DISTANCE, NAUTICAL MILES
FIGURE 6

The flightpath study conducted from ATC radar data (See Figures 6 and 7) for this accident by Safety Board airplane performance engineers showed that as it ascended from FL200 to FL227, the airplane was climbing at a rate of about 500 feet per minute and was slowing from about 130 KIAS to about 110 KIAS. The airplane stopped ascending about FL227 and then began to descend for 90 seconds. The airplane descended about 2,300 feet to about FL204, reached a vertical speed of about 3,200 feet per minute during the descent, and the airspeed increased from about 110 KIAS to 198 KIAS. The airplane's descent stopped at FL204, and a climb to FL231 feet began. During the ascent to FL231, the airspeed decreased to well within the range of stall while the airplane achieved a climb angle of about 25 degrees.

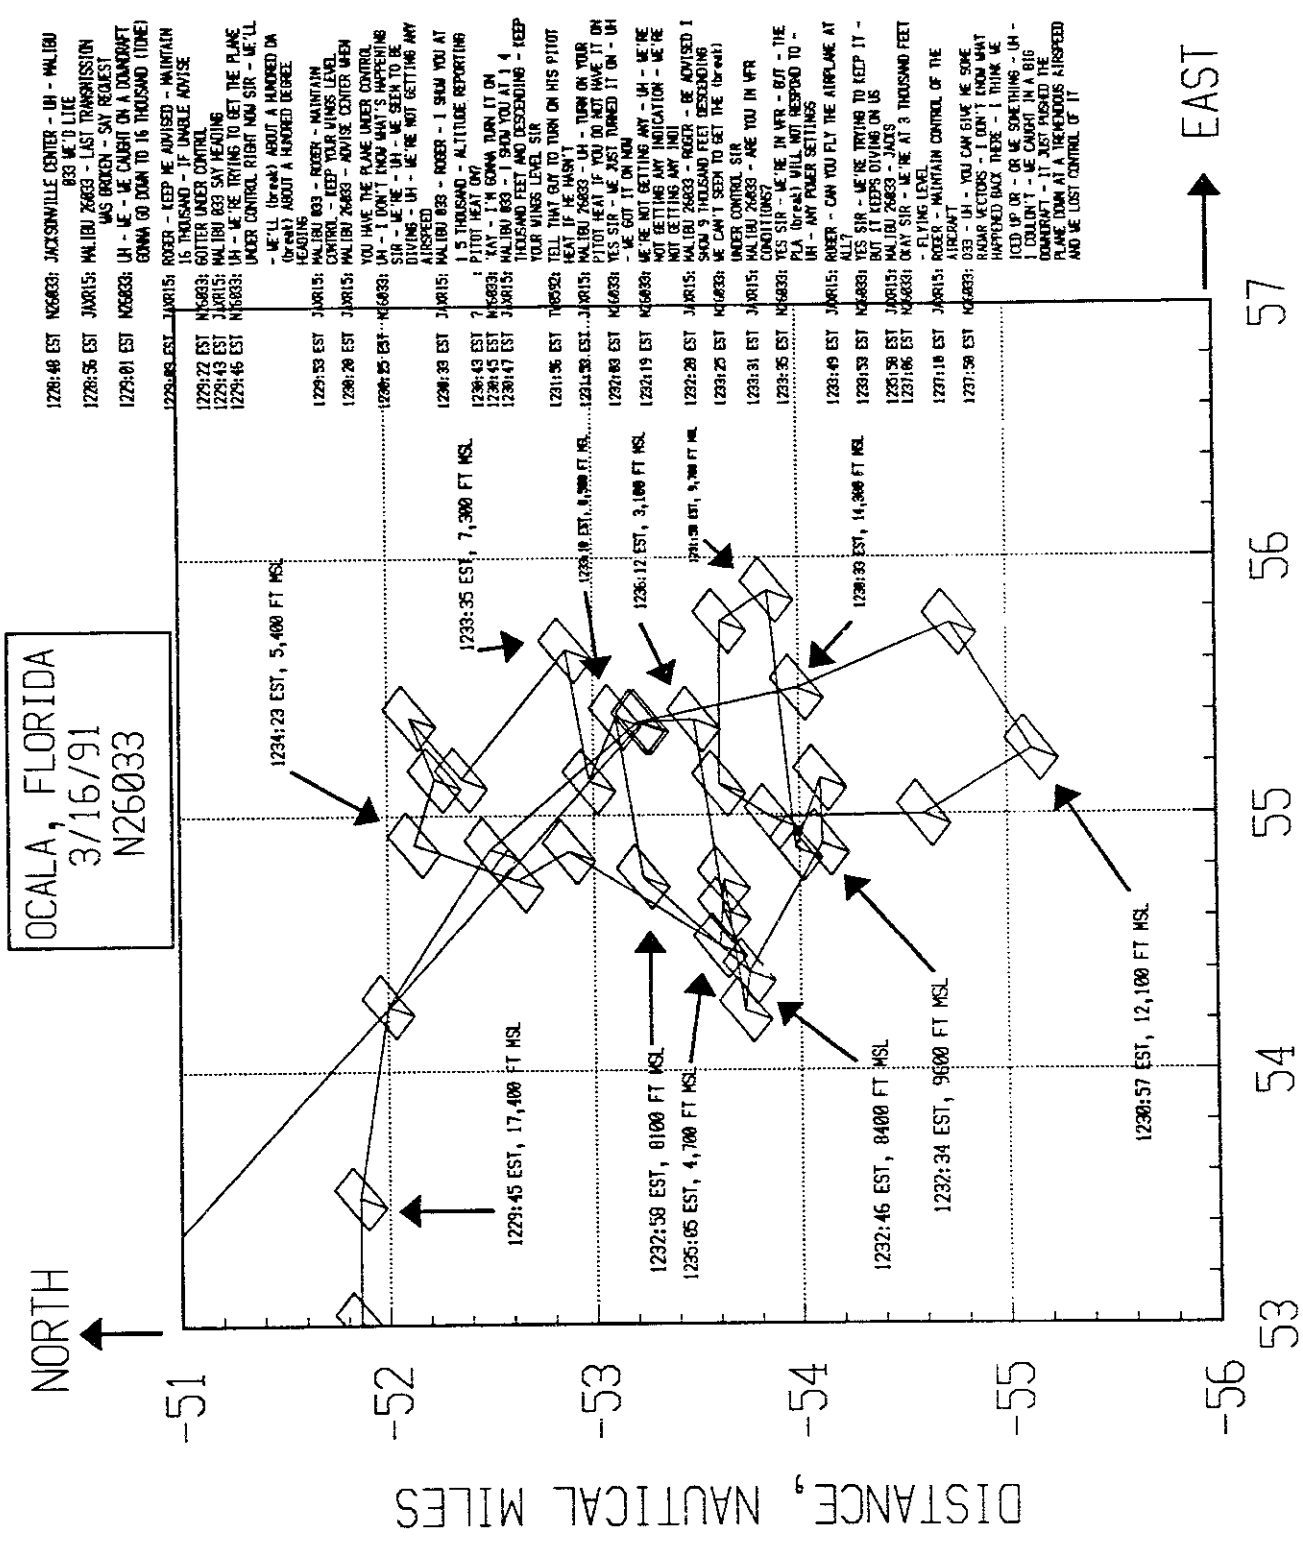
DISTANCE, NAUTICAL MILES
FIGURE 11

Safety Board airplane performance engineers again used ATC recorded radar data (See Figures 11, 12 and 13) to reconstruct the flightpath of the airplane. The flightpath study revealed that before significant flightpath deviations began, the airplane was at FL181 and heading north at approximately 150 KIAS. At 1228:07, while in a turn to the northwest, the airplane began to descend; it descended about 300 feet and then returned to FL180, at 1228:32, while in a sharp right turn that began about 1228:26. While in the right turn, the

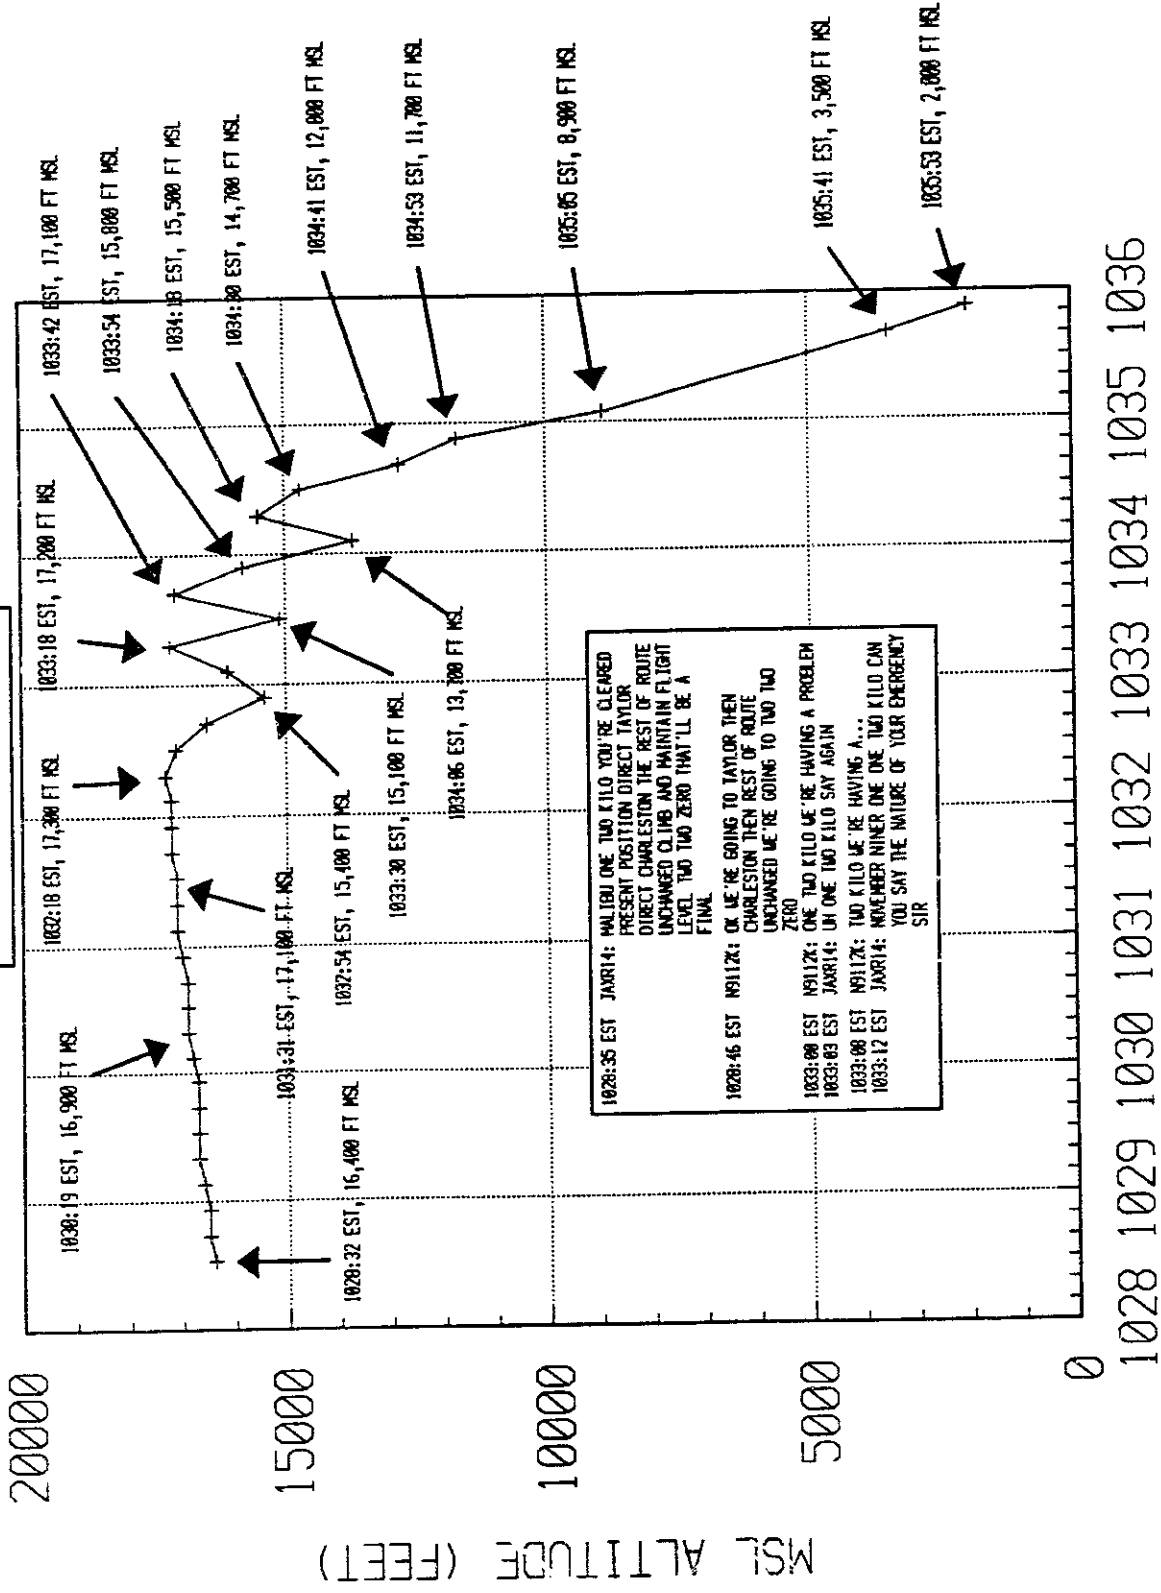
TIME (EASTERN STANDARD)
FIGURE 15

The recorded ATC radar data (See Figures 14 and 15) were used by a Safety Board aircraft performance engineer to reconstruct the flightpath of the airplane and to study the possible time histories of pitch angle, roll angle, indicated airspeed, and G load. The flightpath study revealed that before significant excursions began, the airplane was climbing about 200 fpm on a north-northeast heading and was flying at 150 to 160 KIAS. As the airplane reached about 17,300 feet, it entered a descent followed by an abrupt, steeply banked turn to the right. About 20 seconds elapsed from the start of the descent to the completion of a heading change to the east. The airplane continued in an easterly direction for about 1 minute while further altitude excursions occurred.

The airplane's altitude decreased to 15,400 feet, and it accelerated to more than 230 KIAS while attaining the near easterly heading. The airplane then ascended to about 17,200 feet while losing much of its airspeed in about 20 seconds. The airplane descended and climbed two more times before entering a final descent with a large right bank angle. About 3 minutes elapsed from the first indication of a descent to the final descent. The aircraft crashed about 6 nmi east of its original ground track.
