AIRCRAFT ACCIDENT REPORT

ALLEGHENY AIRLINES, INC.

ALLISON PROP JET CONVAIR 340/440, N5832

JUNE 7, 1971

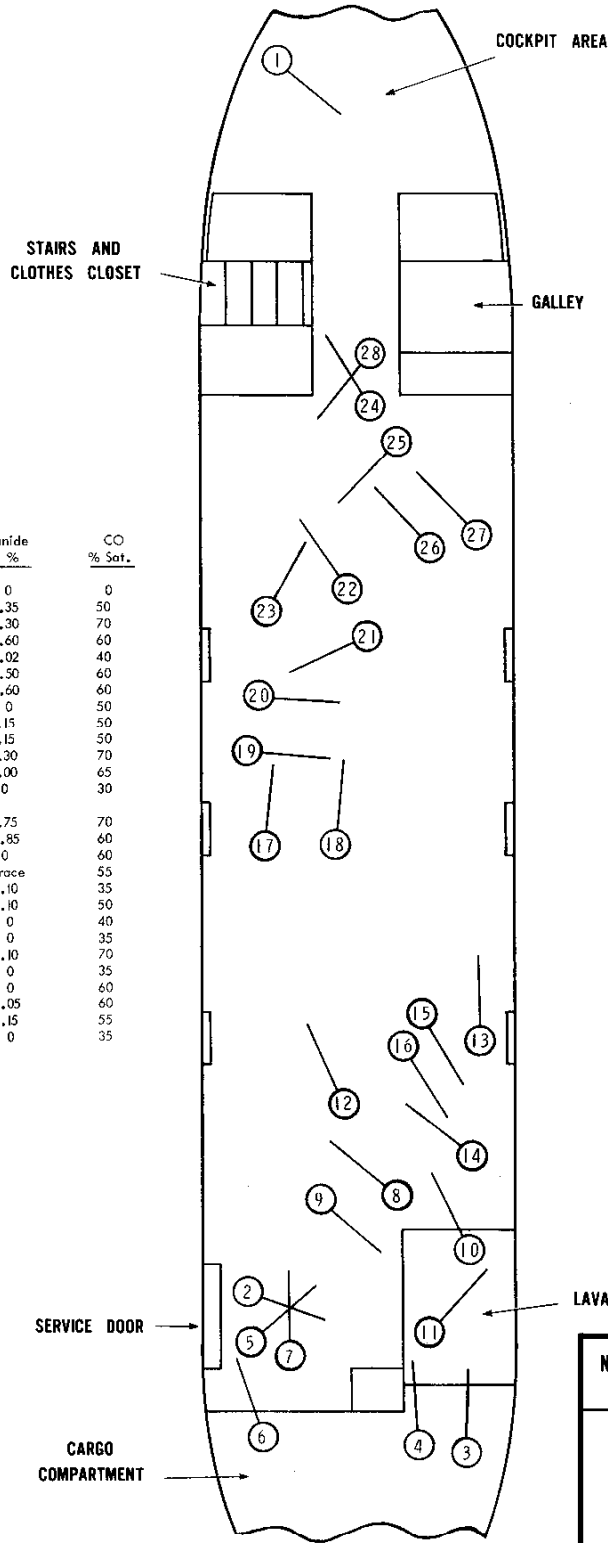
When the fire was extinguished, 15 of the 27 nonsurviving passengers were near the rear service door. The others were found near the center and forward cabin sections. Toxicological studies are available for 26 of the 27 passengers. Autopsy and toxicological studies showed that all had died of chemical asphyxiation and thermal injury or a combination of both. (See Appendix G for location and toxicological findings of fatalities.) The stewardess who was stationed near the rear door also died of chemical asphyxiation and, in addition, had suffered fractures of the upper posterior rib, fracture of the left clavicle and fracture of the third thoracic vertebra. The operation and opening of the rear service door by other than trained personnel requires an ability to see and adhere to the instructions which are affixed near the door handle. The lower portion of the rear exit door was found in the latched (closed) position. Because of extensive fire damage to the remaining emergency exits, a determination could not be made regarding which other emergency exits could have been opened by surviving passengers.

Fatality Location No.	Cyanide mg. %	CO % Sat.
1	0	0
2	0,35	50
3	0,30	70
4	0,60	60
5	0,02	40
6	0,50	60
7	0,60	60
8	0	50
9	,15	50
10	,15	50
11	,30	70
12	1,00	65
13	0	30
14		
15	,75	70
16	0,85	60
17	0	60
18	Trace	55
19	0,10	35
20	0,10	50
21	0	40
22	0	35
23	0,10	70
24	0	35
25	0	60
26	0,05	60
27	0,15	55
28	0	35
