'AIRCRAFT ACCIDENT REPORT'

NATIONAL AIRLINES, INC.

DC-10-10, N60NA

NEAR ALBUQUERQUE, NEW MEXICO

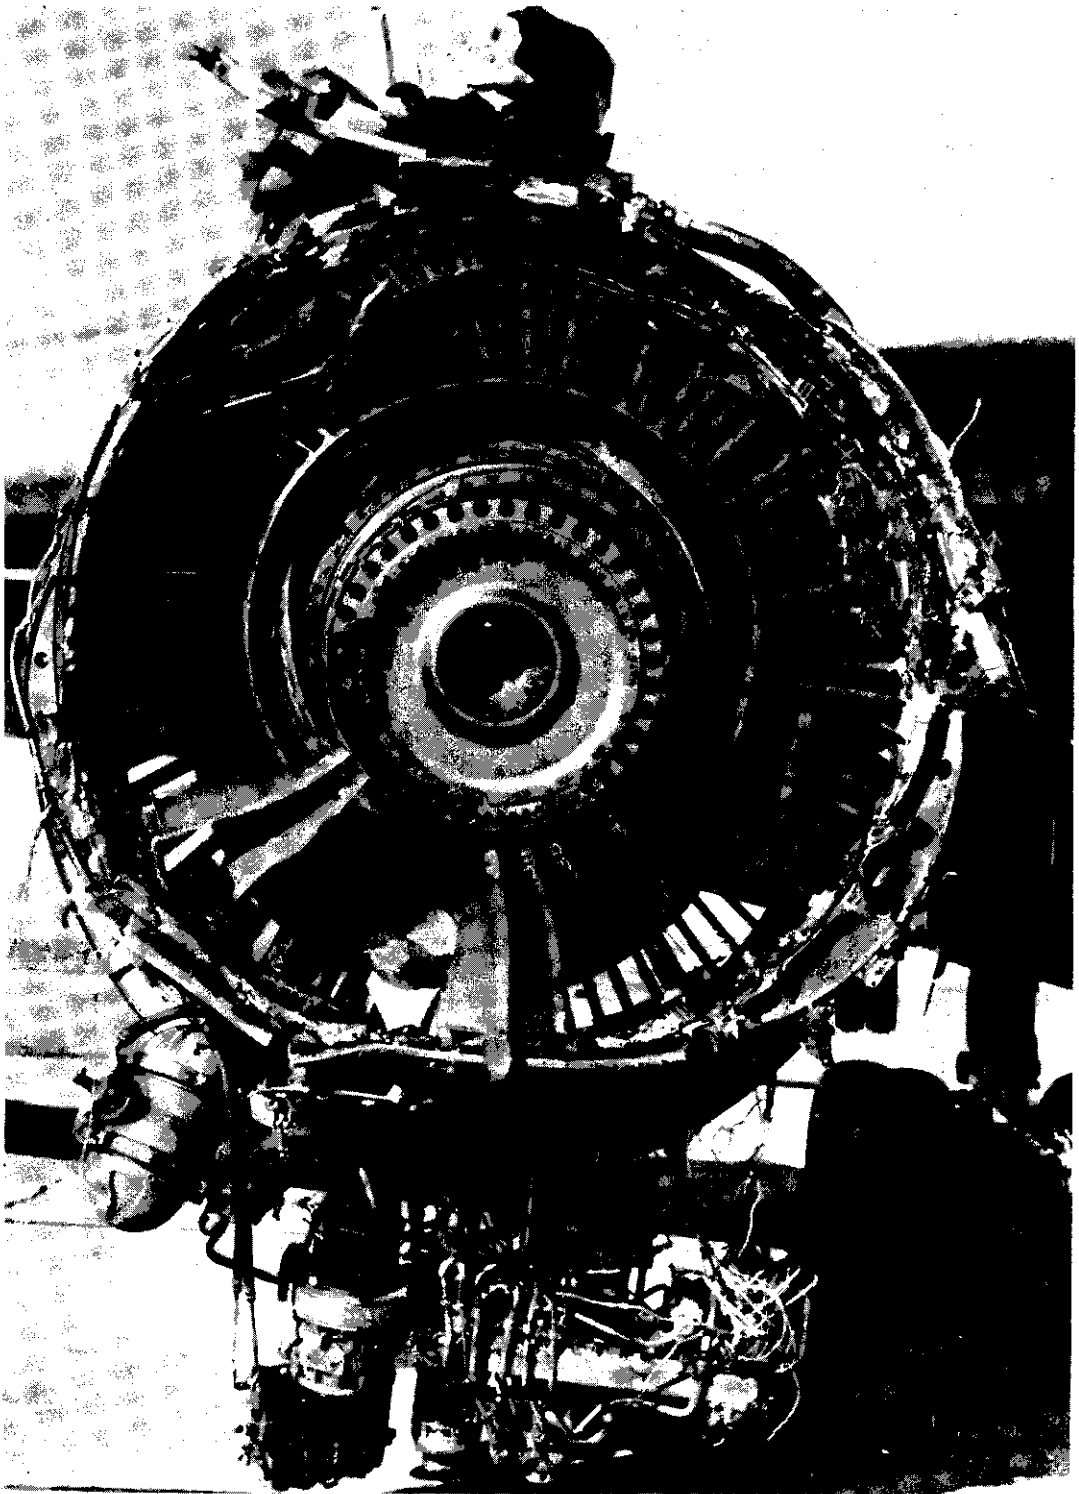
Front View No. 3 Engine

The nose cowl (inlet duct) was intact. It had broken away along the aft attach area, and the aft portion had been crushed on ground impact. Numerous blade fragments had penetrated through the inner barrel of the cowl. The outer barrel was punctured in eight locations.

The porous sheet from the first acoustic panel, extending from 12:00 ^{3/} to 4:00, was missing from the nose cowl. It had been torn lengthwise at 12:30. A piece of this porous skin, about 230 square inches in area, was found resting against the fan outlet guide vanes.

➔ The fan blade containment ring was recovered in an opened-up and twisted configuration. It separated at the 7:00 position, and the entire ring appeared torn and distorted, with considerable abrasion along the inner surface of the ring. Of the 12 bolts that attach the nose cowl to the containment ring, only portions of 5 bolts were recovered. The fracture surfaces of the bolts showed evidence of failure in shear. The 12 attachment bolt holes had deformed in various directions. The predominant forces, however, as shown on both the nose cowl and the containment ring, were in the direction of engine rotation.

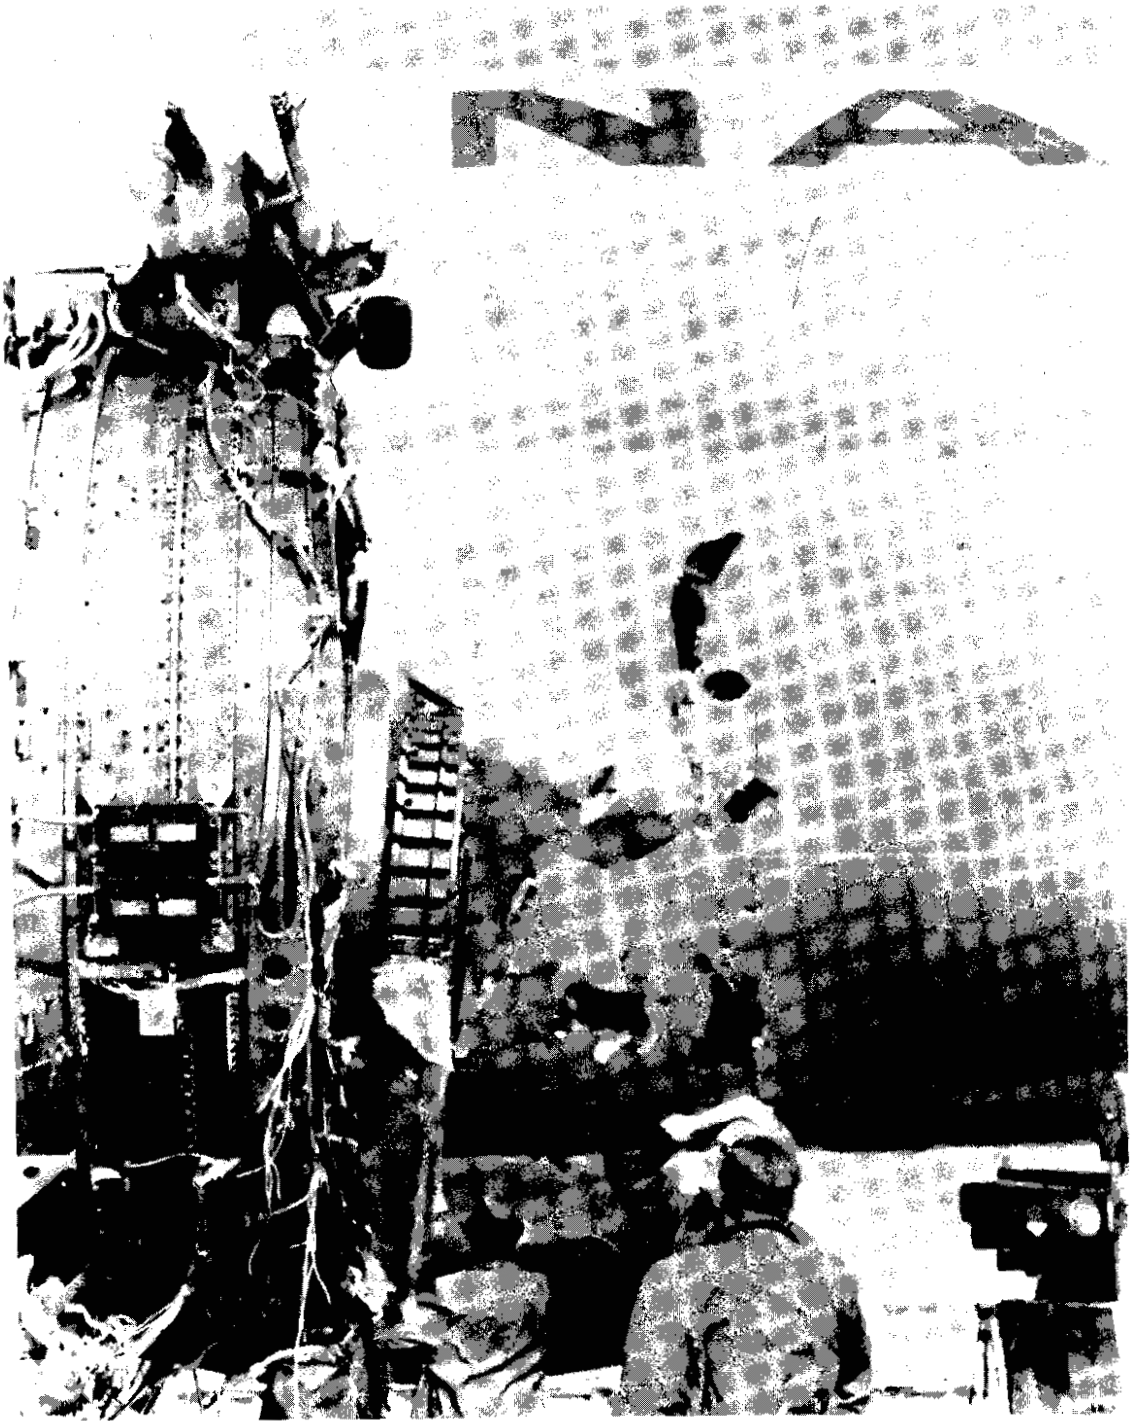
The aircraft structure exhibited numerous punctures and tears in the lower fuselage skin, primarily in the area of the No. 3 engine. The lower fuselage skin had been punctured in six areas, each ranging between 470 and 540 square inches. Other small punctures and skin damage were found in the right wing along the inboard leading edge and the fuselage fillet area. One puncture on the underside of the right wing extended into the inboard fuel tank.

A window panel, located at station 1129, was missing. The outer panel, inner panel, window seal acoustic panel, and seal had separated from the aircraft. The anacoustic seal support was cracked along the forward edge of the window, from above the horizontal centerline to the lower edge vertical centerline. Three of the eight window panel retaining clips, two on the upper forward side, one on the lower forward side,

Right side view shaving damage to No. 3 engine, fragment damage and missing window.
