1. Report No. NTSB-AAR-76-1	2. Government Accession No.	3. Recipient's Catalog No.	
4. Title and Subtitle <b>Aircraft Accident Report - Wien Air Alaska, Inc.</b> Fairchild F-27B, N4904 Gambell, St. Lawrence Island, Alaska		5. Report Date January 7, 1976	6. Performing Organization Code

AIRCRAFT ACCIDENT REPORT

WIEN AIR ALASKA, INC.  
FAIRCHILD F-27B, N4904  
GAMBELL, ST. LAWRENCE ISLAND, ALASKA  
AUGUST 30, 1975

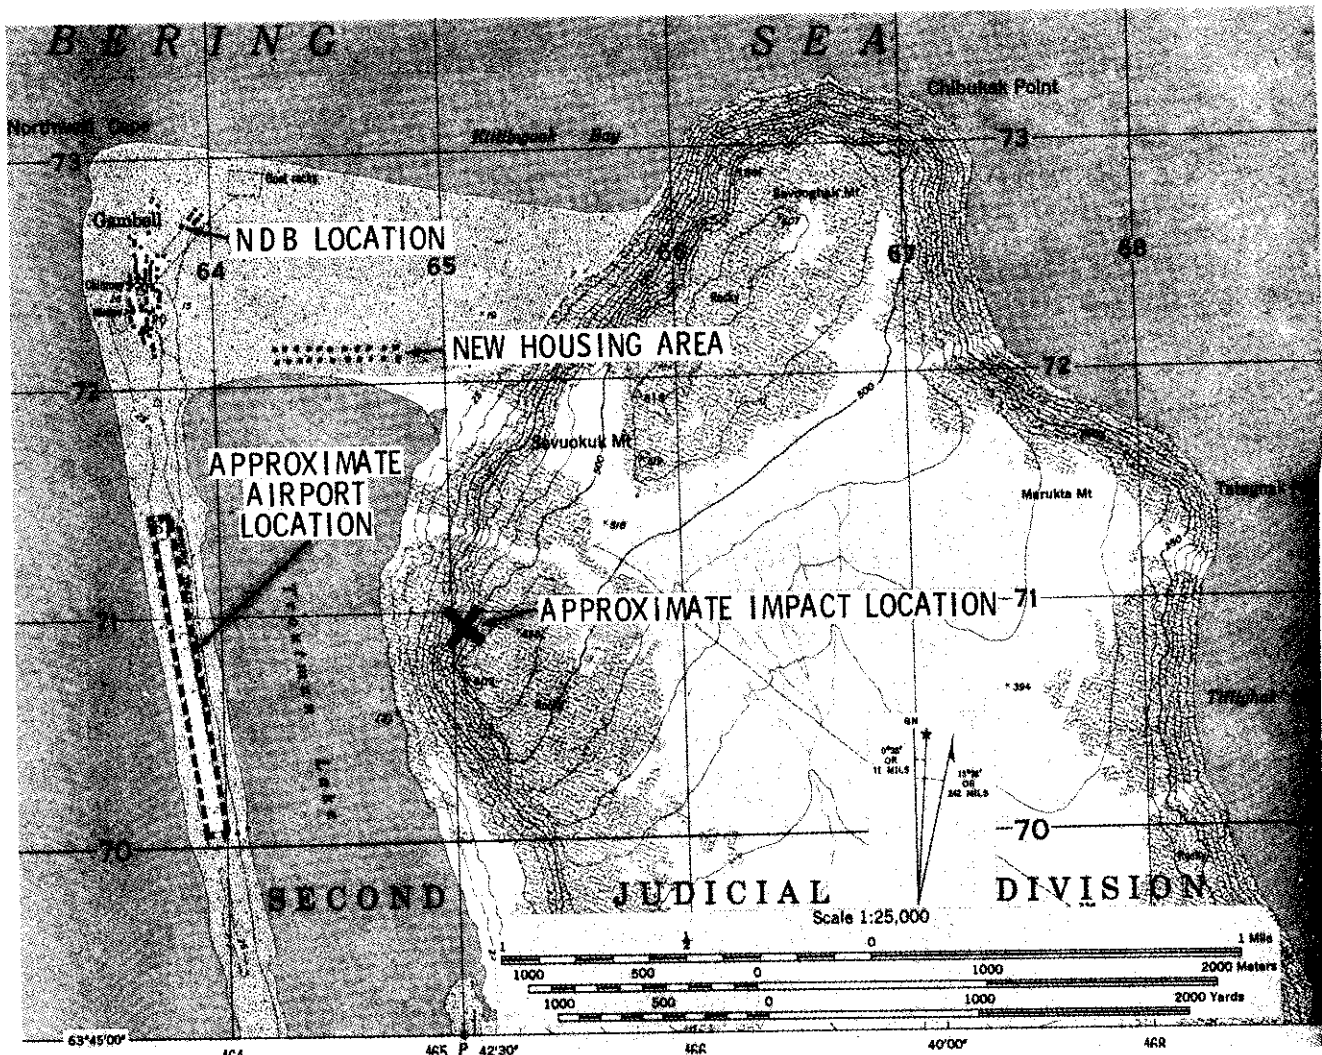
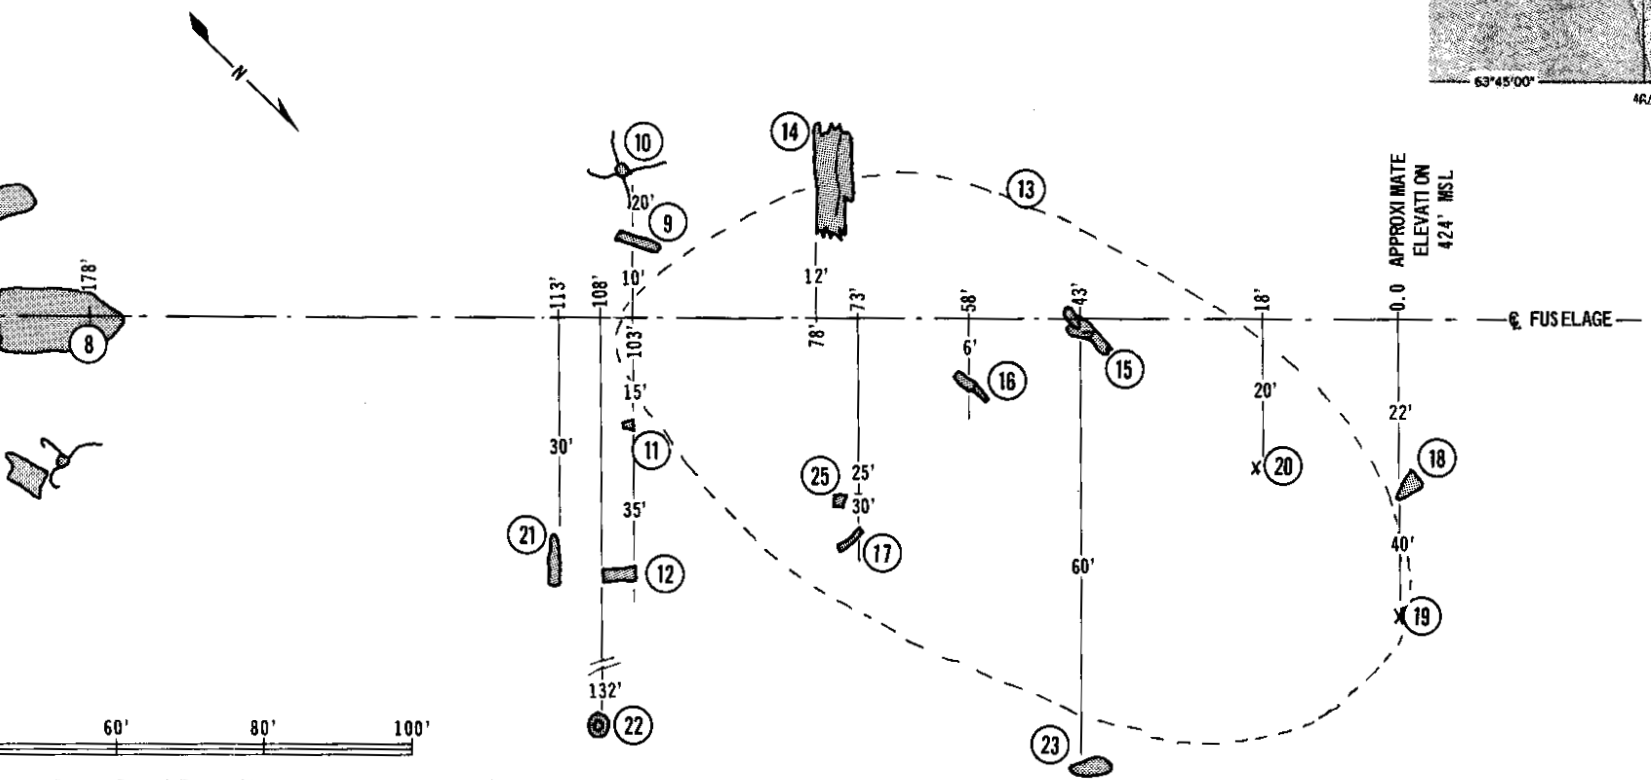
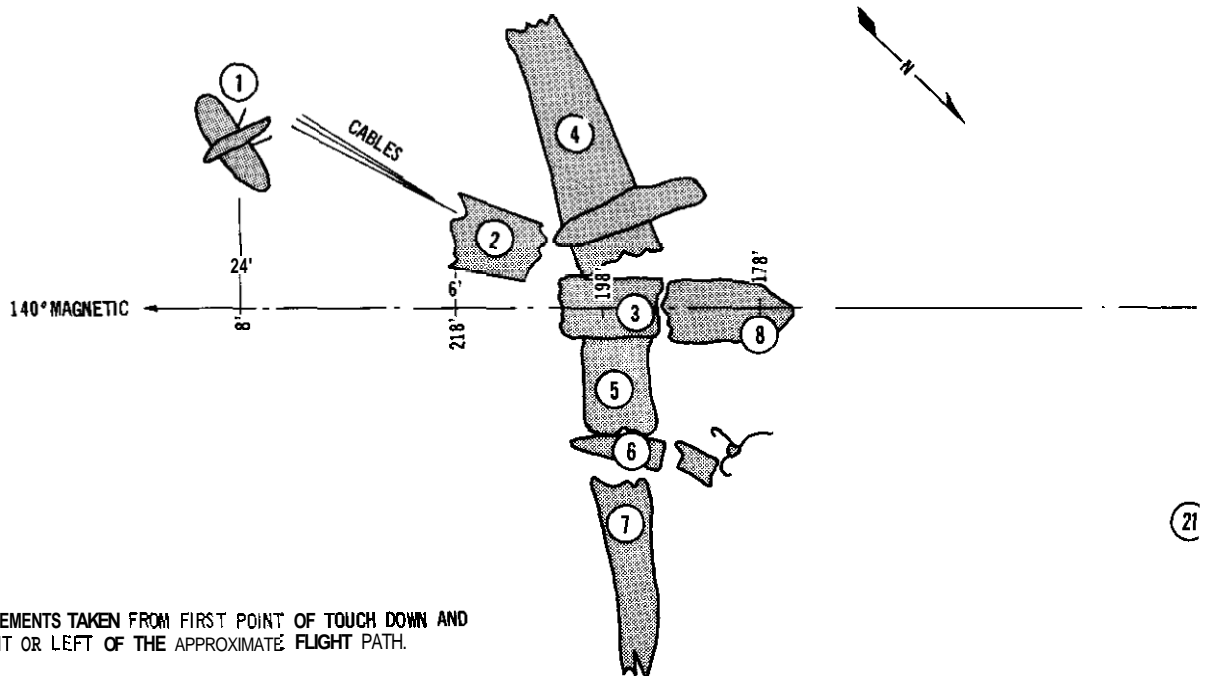
**WRECKAGE DISTRIBUTION CHART  
WIEN AIR ALASKA, INC.  
FAIRCHILD F-27B, N4904  
GAMBELL, ALASKA  
AUGUST 30, 1975**

The aircraft crashed into the northwest slope of Sevuokuk Mountain at an altitude of 424 feet. The first impact mark was found 134 feet below a 558-foot ridge. The aircraft overturned during the crash and came to rest inverted and heading opposite the direction of flight. The wreckage was distributed on a magnetic heading of 140°. Except for a part of the left and right main landing gears, the wreckage was confined to an area 248 ft. long and 80 ft. wide. (See Appendix D.)

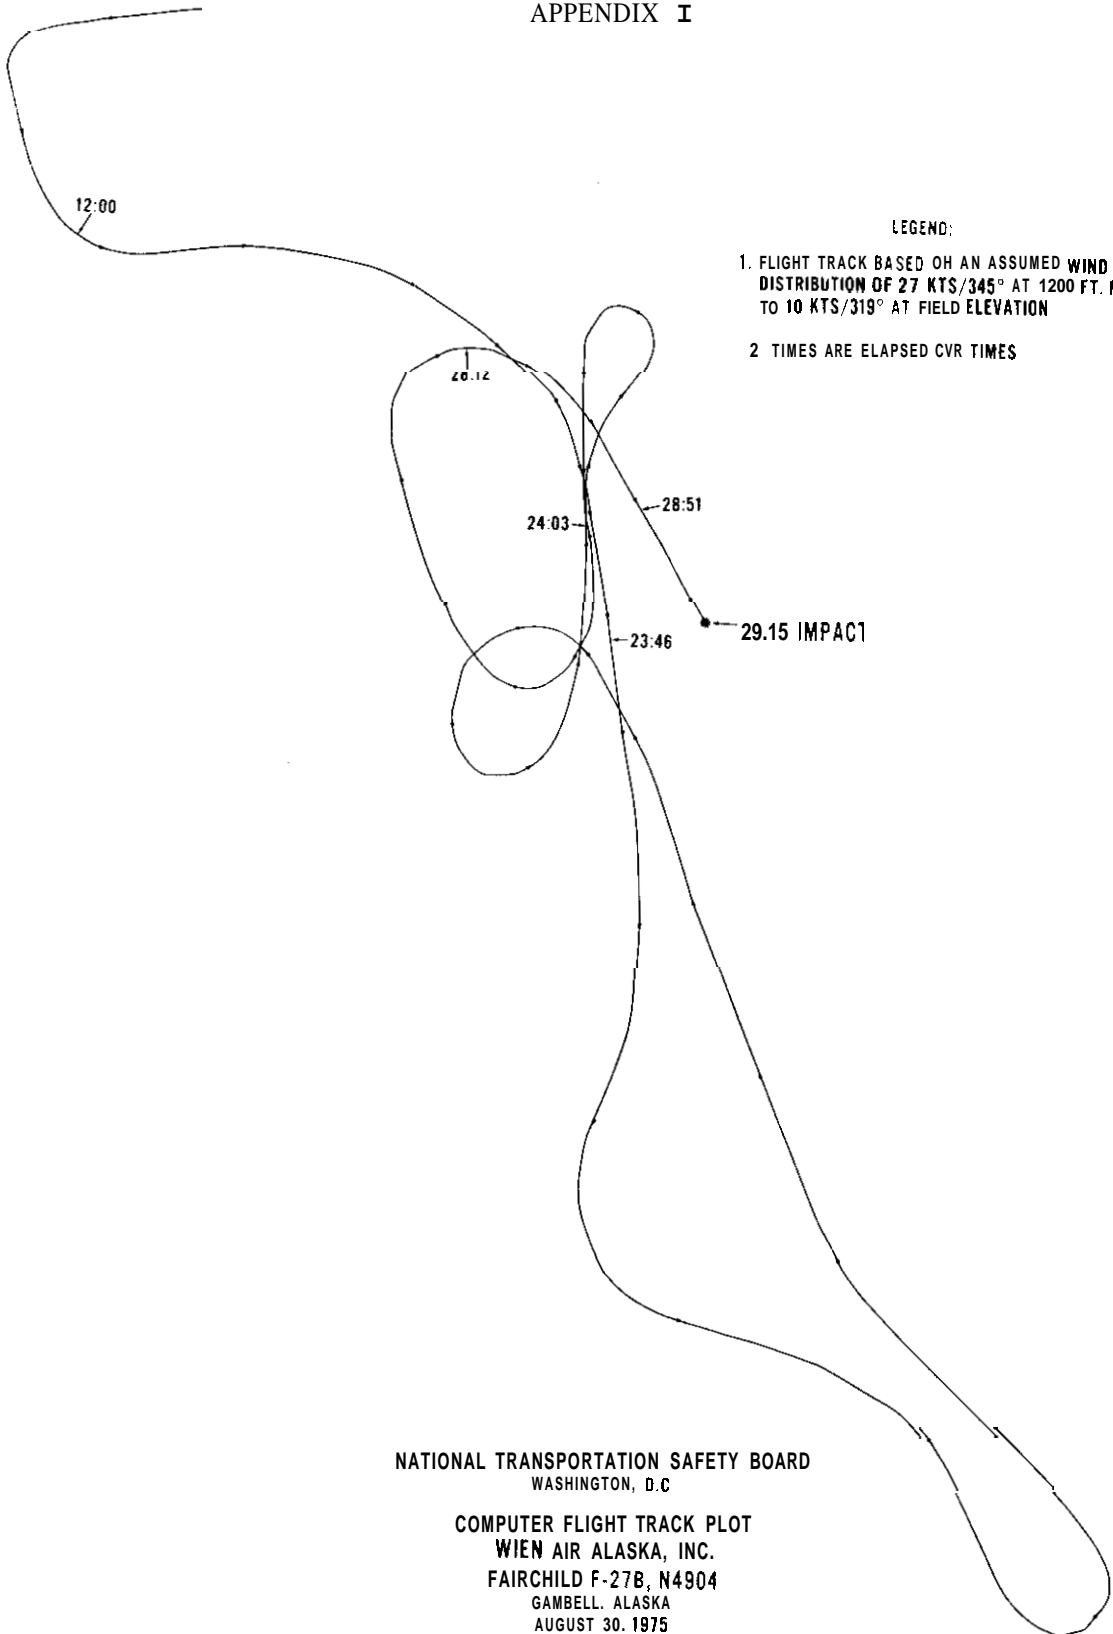
COMPUTER FLIGHT TRACK PLOT  
WIEN AIR ALASKA, INC.  
FAIRCHILD F-27B, N4904  
GAMBELL, ALASKA  
AUGUST 30, 1975

A heading of 140° was maintained for about 28 seconds until the aircraft struck Sevuokuk Mountain at an altitude of 424 feet. Several of the passengers could see the ground and were aware of their position relative to the village of Gambell. Some of them realized that the aircraft was going to hit the mountain and braced themselves.
