1. Report No. NTSB-AAR-78-10		2. Government Accession No.		3. Recipient's Catalog No.	
4. Title and Subtitle Aircraft Accident Report - National Jet Services, Inc., Douglas DC-3, N51071 Evansville Dress Regional Airport, Indiana, December 13, 1977				5. Report Date August 17, 1978

AIRCRAFT ACCIDENT REPORT

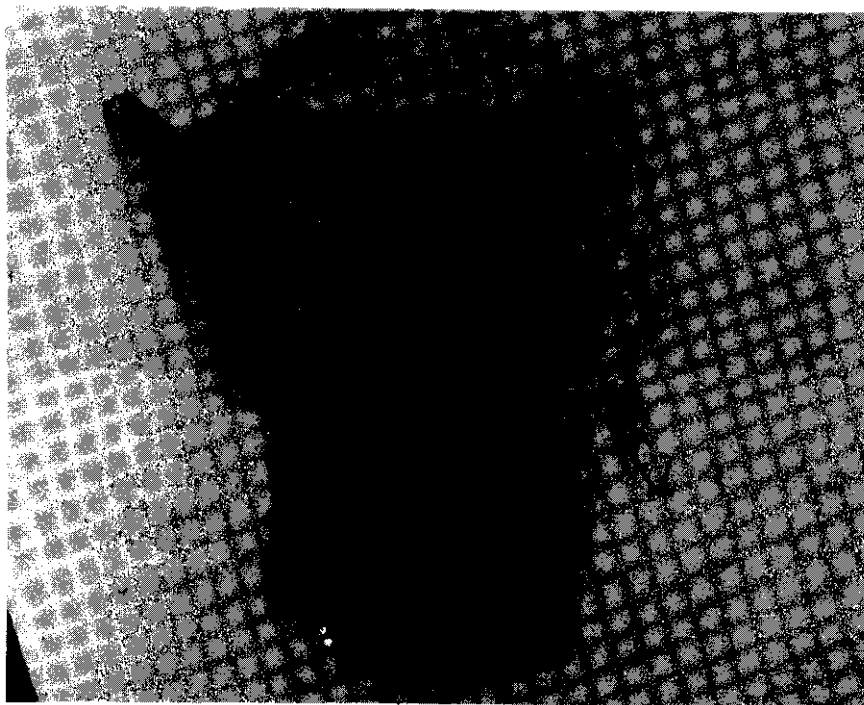
Figure 1. Upper side of the rudder control lock showing horizontal and vertical members. The forward end of the control lock is at the top of the picture.

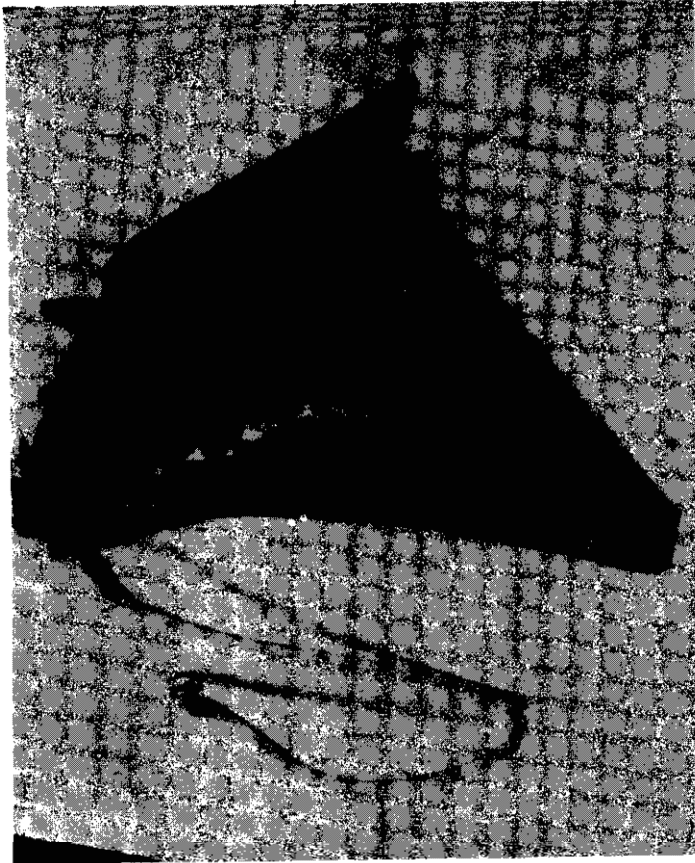
Figure 3. Left (inboard) side of the right aileron control lock showing the inboard side of the vertical member, and the upper horizontal member which holds the wing structure. There is no lower horizontal member to permit operation of the flaps with the lock installed.

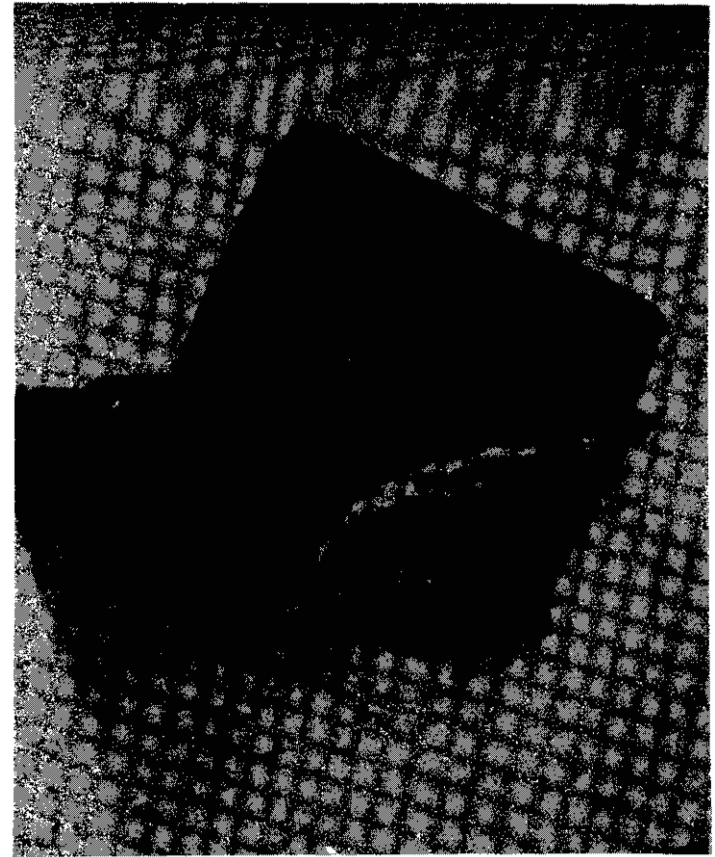
Figure 4. The right (outboard) side of the right aileron control lock showing the vertical member of the lock and the upper and lower horizontal members which hold the inboard end of the aileron.

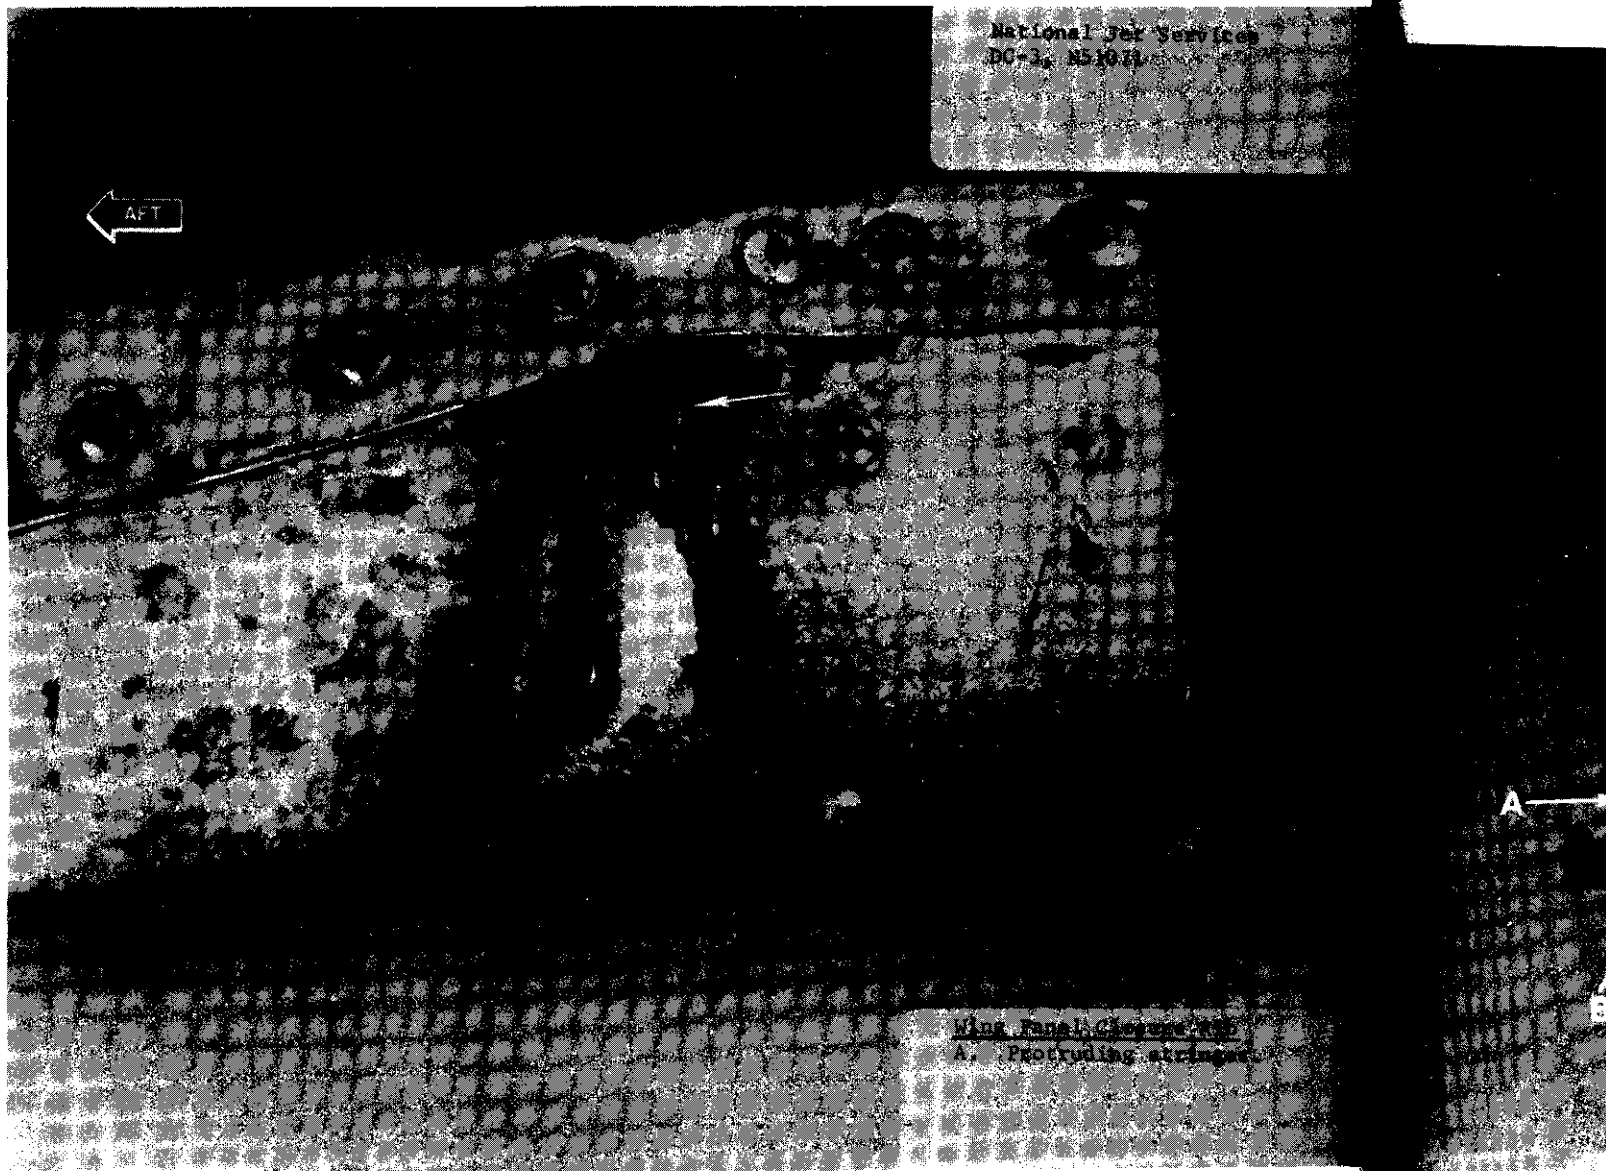
A. Downward bend of upper skin.

B. Downward bend of lower skin.

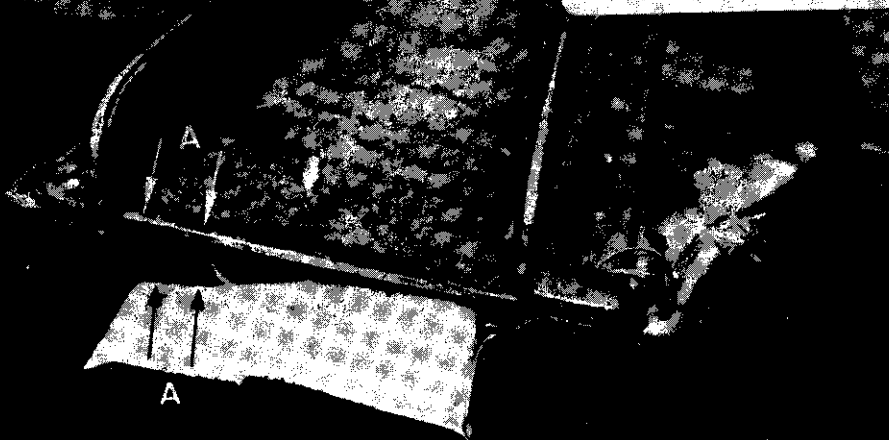
Rudder Control Lock and Stinger
Assembly

A. Matching tear with end of
lock.

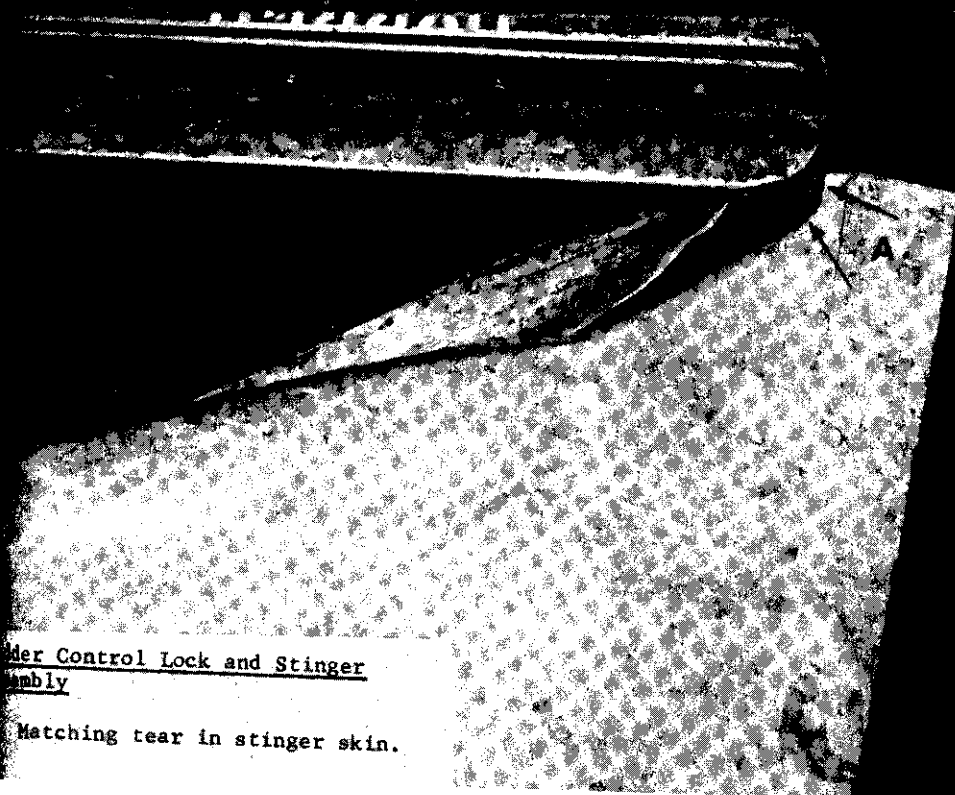
Fig. 11

Rudder Control Lock and Stinger
Assembly

Matching tear in stinger skin.
