AIRCRAFT ACCIDENT REPORT

NATIONAL AIRLINES, INC.,
BOEING 727-235, N4744NA
ESCAMBIA BAY
PENSACOLA, FLORIDA

MAY 8, 1978
AAR-78-13
at

REVISIONS ADOPTED
APRIL 10, 1981

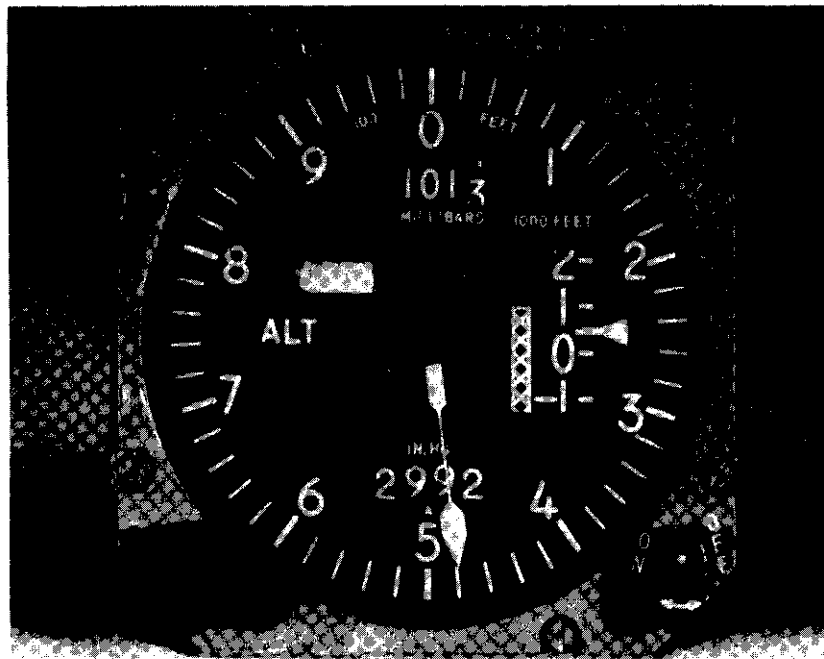
Figure 1. Kollsman Drum Pointer Altimeter

The captain's and first officer's instrument panels were equipped with Kollsman P/NA-41869-10.21 drum-pointer type barometric altimeters. (See figure 1.) This altimeter has a range from +50,000 ft to -1,500 ft. Hundreds of feet are indicated by a radial pointer, and thousands of feet are indicated on a rotating drum visible through a slot on the face of the instrument. A white crosshatch is painted on the left side of the drum adjacent to the numbers from +1,000 ft to -1,500 ft to increase the conspicuity of the lower altitude values.

The captain and first officer testified that they misread their barometric altimeters during the latter stages of the descent after they were cleared to descend from 1,700 ft.

The captain said that he misread his altimeter at 500 ft and believed he saw 1,500 ft. He stated that "When that figure got on my mind as I ran my scan after that, I was seeing 400 and 300 and they were 14 and 13 in my mind. I was looking at the needle instead of looking at the 1,000-foot marker in it. I didn't actually look at the thousand-foot pointer at that time. I just glanced down at the hundred-foot pointer."
