NATIONAL TRANSPORTATION SAFETY BOARD

AIRCRAFT ACCIDENT REPORT

**DOWNEAST AIRLINES, INC.
D-HAVILLAND DHC-6-200, N68DE
ROCKLAND, MAINE
MAY 30, 1979**

NTSB-AAR-80-5

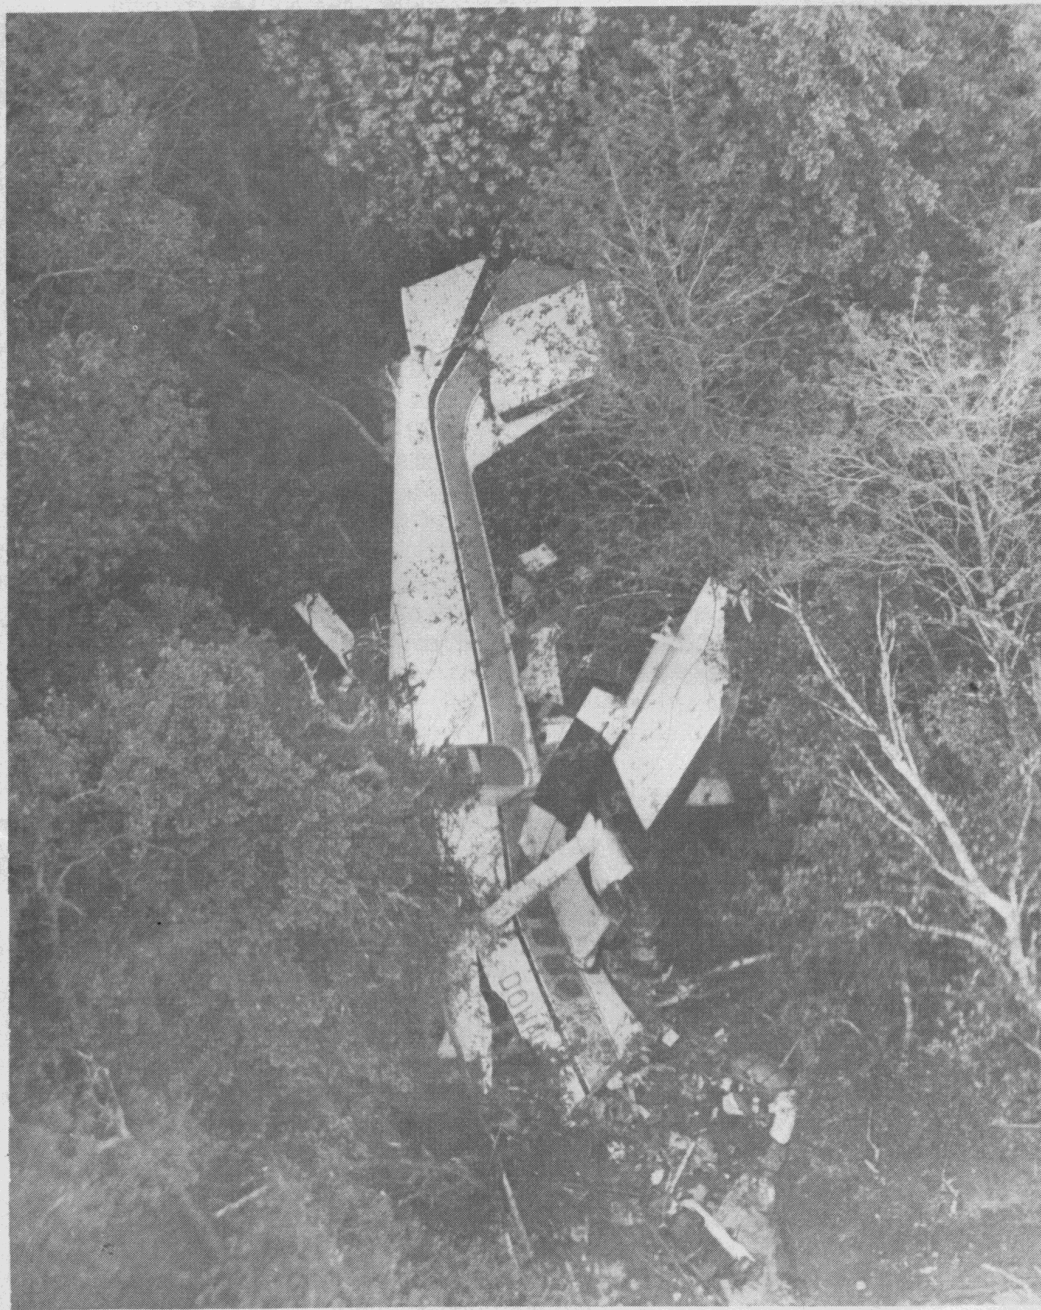
Figure 2.—Aerial view of accident aircraft.

The aircraft continued along a general heading of 010° striking several more trees, breaking some and uprooting others. Various wing and flap parts were torn from the aircraft. About 30 ft before the main wreckage area, large components of the aircraft were found to the left of the crash path including an 8-ft outboard section of the right wing and a 15-ft section of the right aileron. The right engine and the aircraft nose struck the ground about 22 ft and 17 ft, respectively, from where the main wreckage came to rest.

The aircraft fuselage came to rest on its left side about 340 ft from the initial tree strikes in a near-vertical position supported by trees. (See figure 2.) The fuselage was oriented on a heading of about 195° with the empennage, still attached to the fuselage, canted in the direction of the airport. The crushed, twisted, and fragmented cockpit area was found in a near upright position next to the forward section of the fuselage and oriented on a heading of about 095°.

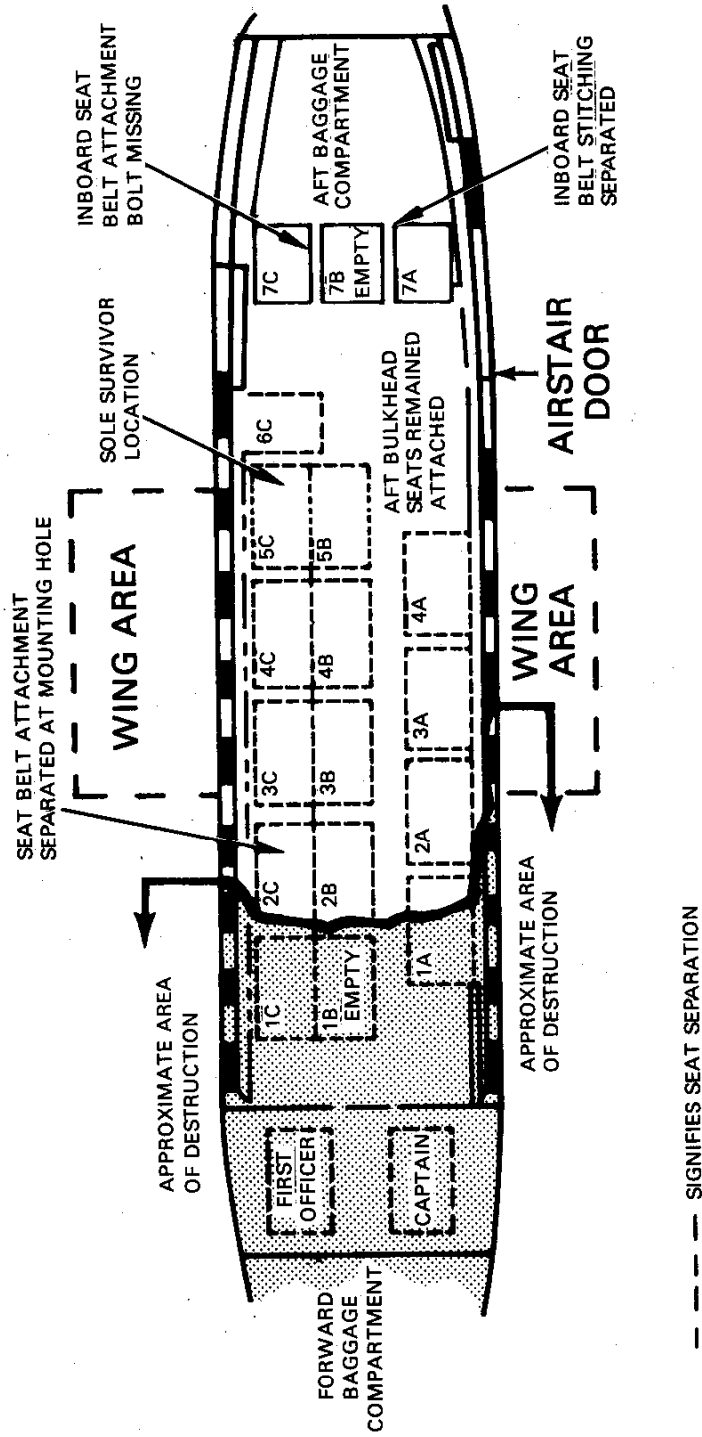
Figure 3.—Cockpit and cabin configuration.

The forward fuselage and flight deck were destroyed. Except for seat failures, there was relatively little damage to the cabin interior aft of the leading edge of the wings. The passenger cabin was 18 ft long; about 5 ft of the forward cabin was destroyed.

Seats in the destroyed area (rows 1 and 2) exhibited massive impact damage on their forward sides and had separated in the aft direction. Seat damage in rows 3 through 5 generally showed separation failures of the seat track tiedown fittings in the forward direction. Three of the four double-unit seats (located on the right side of the aircraft) also exhibited counterclockwise rotational damage. This damage is compatible with inboard lateral movement and the rotation of the seat pans after the primary impact had caused a separation of the anchor pins from the sidewall tracks. The only side-facing unit (6C) separated from its wall tiedown structure. The seats mounted on the aft bulkhead (row 7) were the only seats that did not fail. The bulkhead attachment fittings of these seats were undamaged. Large, fixed, metal ashtrays were attached to some of the seatbacks.

There were three seatbelt failures. The outboard metal belt-end attachment fitting of seat 2C fractured adjacent to its anchor bolt hole. No reason for this material failure could be found. The bolt had been attached to a seat which was located in an area of the forward fuselage which was destroyed.

The stitching had separated completely in the webbing around the inboard belt attachment fitting on seat 7A. Each belt was certificated in accordance with 14 CFR 37 (TSO C-22) which requires a strength of 1,500 lbs. The seat was reportedly occupied by a 160-lb man. The estimated impact loads of 20 g (average) and 40 g (peak) would have resulted in forces of 3,200 lbs and 6,400 lbs, respectively, on this belt; these forces exceed the maximum required 3,000-lb loop strength of the seatbelts under current regulations.

The webbing, buckles, and attachment fittings of the seatbelt on seat 7C were intact. The bolt and nut securing the inboard belt attachment fitting on this seat were missing and not recovered. The mounting hole in both the seat structure and fitting of the seatbelt showed no evidence of elongation or damage. The 200-lb occupant in seat 7C would have generated forces beyond the required strength of the belt. The lack of damage to the mounting hole suggests the possibility that the nut or bolt or both were either defective, improperly installed, or were not installed. No data to conclusively support any of these possibilities were found.
