NATIONAL TRANSPORTATION SAFETY BOARD

AIRCRAFT ACCIDENT REPORT

TRANS WORLD AIRLINES, INC.,
BOEING 727-31, N840TW
NEAR SAGINAW, MICHIGAN
APRIL 4, 1979

NTSB-AAR-81-8

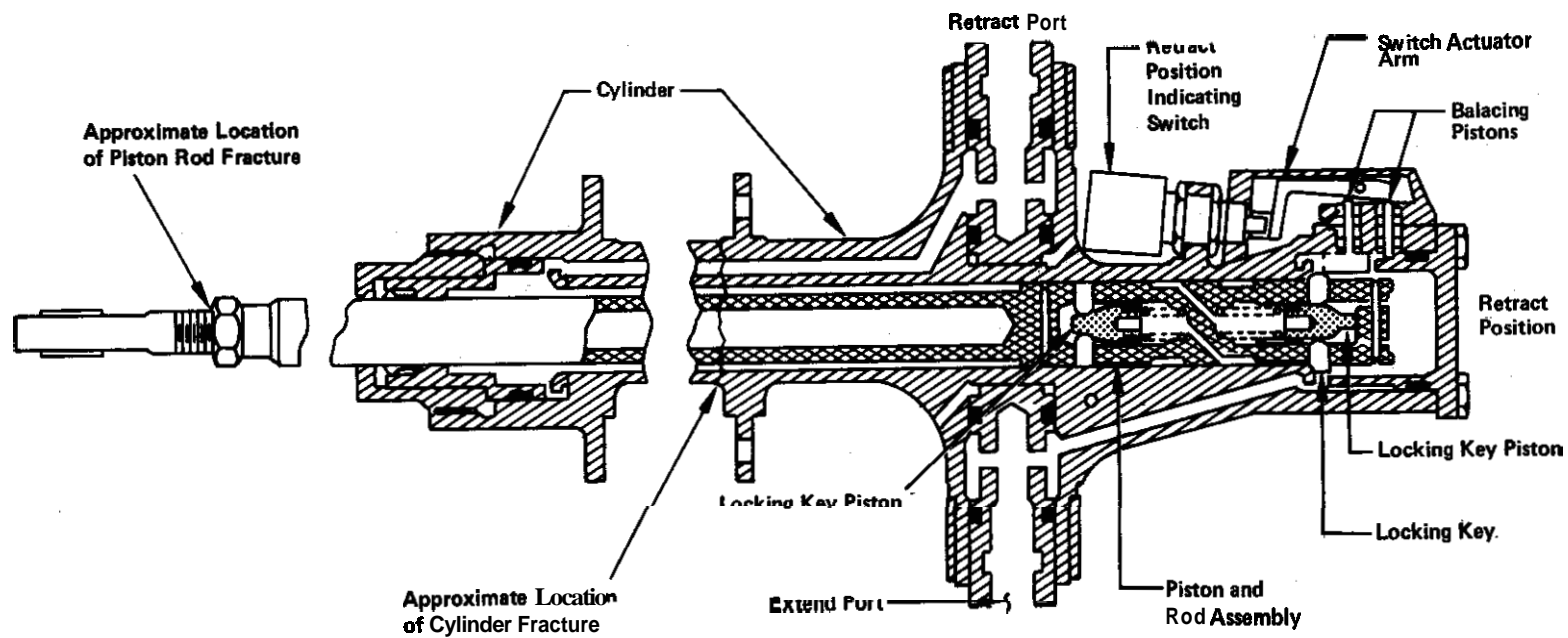
Figure 3.--Leading edge slat' actuator.

A fault analysis of the B-727 leading edge slat actuating system indicates that, except for a separation of the piston rod from the actuator piston or a fracture of the piston, at least two failures involving the slat actuator must precede an unscheduled extension of a slat. This is because when the leading edge slat is in the retracted position, the slat actuator piston is held continuously in the locked position by 3,000 psi of "A" system hydraulic pressure and by a mechanical locking device. Therefore, to nullify these features, hydraulic pressure must be lost and the mechanical locking device must fail. There is no evidence that "A" system hydraulic pressure was lost before the slat extended--in fact, the flightcrew statements indicate that it was not lost before the slat extended. Moreover, the landing gear uplocks and the landing gear, which operate off "A" system pressure, retracted and extended respectively, about 72 seconds after the buzzing began. Therefore, any loss or significant reduction of retraction pressure would have had to have involved either a main piston seal failure or a locking piston seal failure. A main piston seal failure would have permitted fluid to flow past the seal to the extend side of the piston, out the return ports, and back into the "A" system reservoir. If the return ports were plugged, the pressure on both sides of the piston could equalize but the locking keys would remain in place from friction and spring pressure. If the locking piston seal also failed, the piston would still maintain its position by friction and spring pressure. Therefore, even a massive leak across either or both piston seals would not have released the mechanical lock.

A locking device failure would have had to involve excessive friction in the switch actuator pin guide while the actuator piston was out of the retract position, thereby freezing the pin in the unlocked position. This condition would have prevented the lock keys from being forced into the lock detent when the actuator piston moved into the retracted position. This condition alone would not have affected slat extension or retraction; however, the amber "in transit" lights on the cockpit displays would have remained illuminated following slat retraction. Therefore, the two concurrent prerequisites for nullification of the hydraulic and mechanical extension restraints would had to have involved a loss of "A" system pressure in conjunction with the freezing of the switch actuator pin in the unlocked position. Both events would have caused warning lights to illuminate in the cockpit.

The forward two-thirds of the actuator cylinder, the actuator piston, the piston rod, the locking pistons, and the locking pins were missing; therefore, the condition of the piston, its seals, and the piston rod could not be verified. However, as described above, it is not likely that even a massive failure of either or both piston seals would have nullified the mechanical lock.

A transverse fracture of the actuator piston would have permitted a maximum differential hydraulic force of about 780 pounds to act on the fractured face of the forward portion of the piston. This force could have extended the No. 7 slat since it was slightly greater than the force produced by air loads on the slat during Flight 841's cruise conditions. However, calculations related to such a fracture in the area of the main piston seal indicate that under normal operational loads, which are predominantly axial, a 11,300 percent margin of safety existed at minimum material strength with regard to internal stress levels that could have produced a fracture in that area. Also, under design limit load conditions, a 3,200 percent margin of safety existed. Further, because of locking piston seal frictional forces, 70 or more g's would have been required to unlock the aft portion of such a fractured piston. Calculations for margins of safety regarding a transverse fracture of the main piston in the area of the retract locking keys, establish that since the cross sectional area of the piston in that location is 59 percent of the main seal cross sectional area, operational and design limit safety margins would have been 6,667 and 1,888 percent, respectively. Also, when in the retracted position, there were no forces acting on the piston that would have tended to produce a transverse fracture in the area of the locking keys. Finally, in 16 years of service history and over 36-million flight hours, such fractures of a slat actuator piston have never occurred. Therefore, the Safety Board concludes that a transverse fracture of the actuator piston was highly improbable.

The only reasonable single failure within the slat actuator that would have freed the slat to move in opposition to airloads on the slat was a separation of the piston rod from the actuator piston. Separation of the rod from the piston would have permitted the hydraulic pressure within the cylinder to act on the end of the piston rod with 1,545 pounds of force, which could have forced an unscheduled extension of the slat since the aerodynamic loads on the slat produced less than 1,545 pounds of compressive force on the bearing end of the rod. However, the evidence indicates that the piston rod did not separate from the piston, but rather that the bearing end of the rod fractured in overload and remained attached to the slat. The actuator cylinder was fractured and the retained portion of the cylinder bore was distorted to the extent that the actuator piston could not have been in the retracted position when the cylinder broke; otherwise, the piston would have remained in the retained portion of the cylinder. Therefore, the Safety Board concludes that the piston rod was attached to the piston when the slat extended and when the slat was broken from the aircraft.

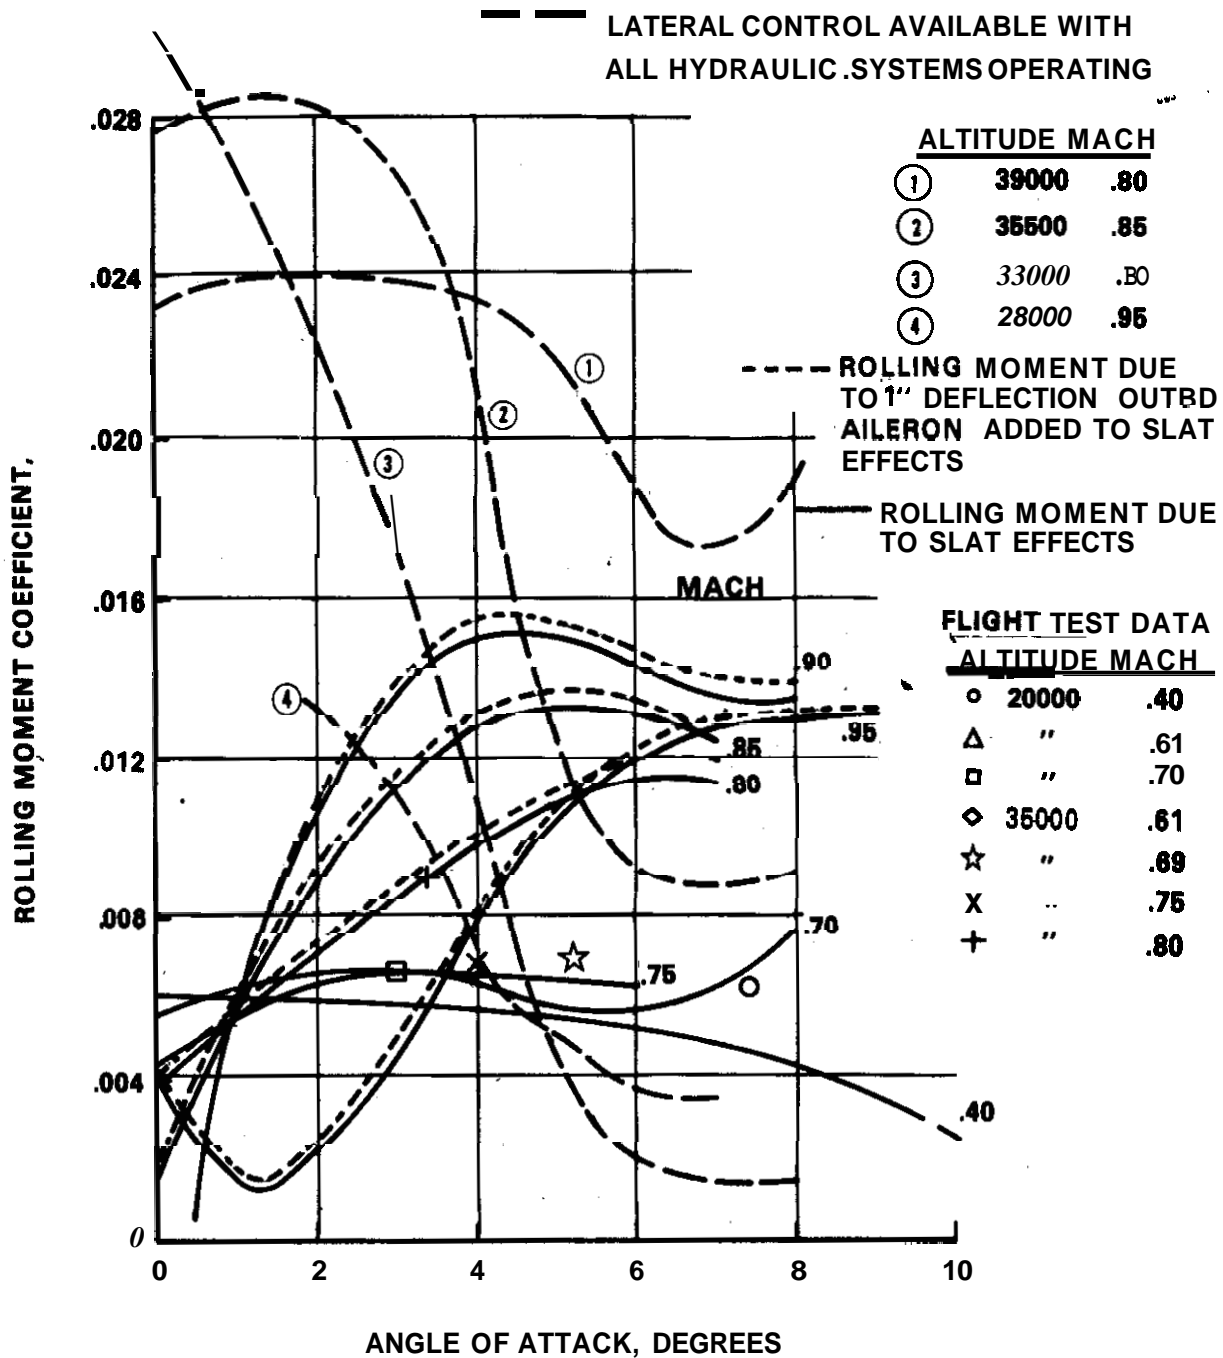
Figure 4.—Rolling moments from extended No. 7 leading edge slat -- adjusted to flight test data points.

The rolling moment coefficients caused by the extension of the No. 7 leading edge slat were supplied by the aircraft manufacturer from wind tunnel and flight test data developed in 1975. These coefficients were compared to the lateral rolling moments available from aileron and spoiler controls at various mach numbers and altitudes as a function of wing angle of attack. The comparison showed that at Flight 841's cruise altitude of 39,000 feet and at a cruise angle of attack of 4°, the rolling moment available from lateral controls at mach 0.80 exceeded the rolling moment caused by the extended slat by a factor of about 2. At 37,000 feet, mach 0.85, and an angle of attack of 5°, the rolling moments were approximately equal. Further increases in the angle of attack or

The manufacturer later provided data to define the critical lateral control margins of the accident aircraft based on assumptions that the right outboard aileron hinge fitting bolt was broken (allowing the aileron to float at its zero hinge moment position) and that the No. 7 leading edge slat extended suddenly to its most adverse position, including the possibilities of deflected and cocked positions. The data were based on the rolling moment coefficient obtained from a flight test data point (at mach 0.80), rather than a wind tunnel test data point.

These data showed that the adverse incremental rolling moment coefficients produced by a floating right outboard aileron were essentially negligible. Also, the data showed that at angles of attack of less than 5° the most adverse position of the slat was its normal extended position. However, the use of the flight test data point (see figure 4) showed that at mach 0.80 and an angle of attack of 4° , the rolling moment coefficient available from lateral controls exceeded the rolling moment coefficient caused by the extended slat by a factor of 1.26, and, that at mach 0.85 at 35,500 feet, the rolling moment coefficients were approximately equal at an angle of attack of 4.8° . Also, by interpolation, at mach 0.83 and an angle of attack of 6° , the moments were approximately equal. Any further increases in either the mach number or angle of attack caused the rolling moment coefficient produced by the extended slat and a floating aileron to exceed the coefficient available from the lateral controls. From the time histories of Flight 841's mach number and angle of attack, it was determined that the rolling moment equalization point occurred 34.5 seconds after the first oscillation of Flight 841's g-trace, or about 2148:07 e.s.t.

Using the adjusted rolling moment data, a dynamic analysis of Flight 841's maneuver was performed. This analysis showed that 12.5 seconds after development of the roll to the right caused by the extended No. 7 slat, the simulated aircraft reached an attitude such that lateral control could not be regained by full deflection of lateral and yaw controls.

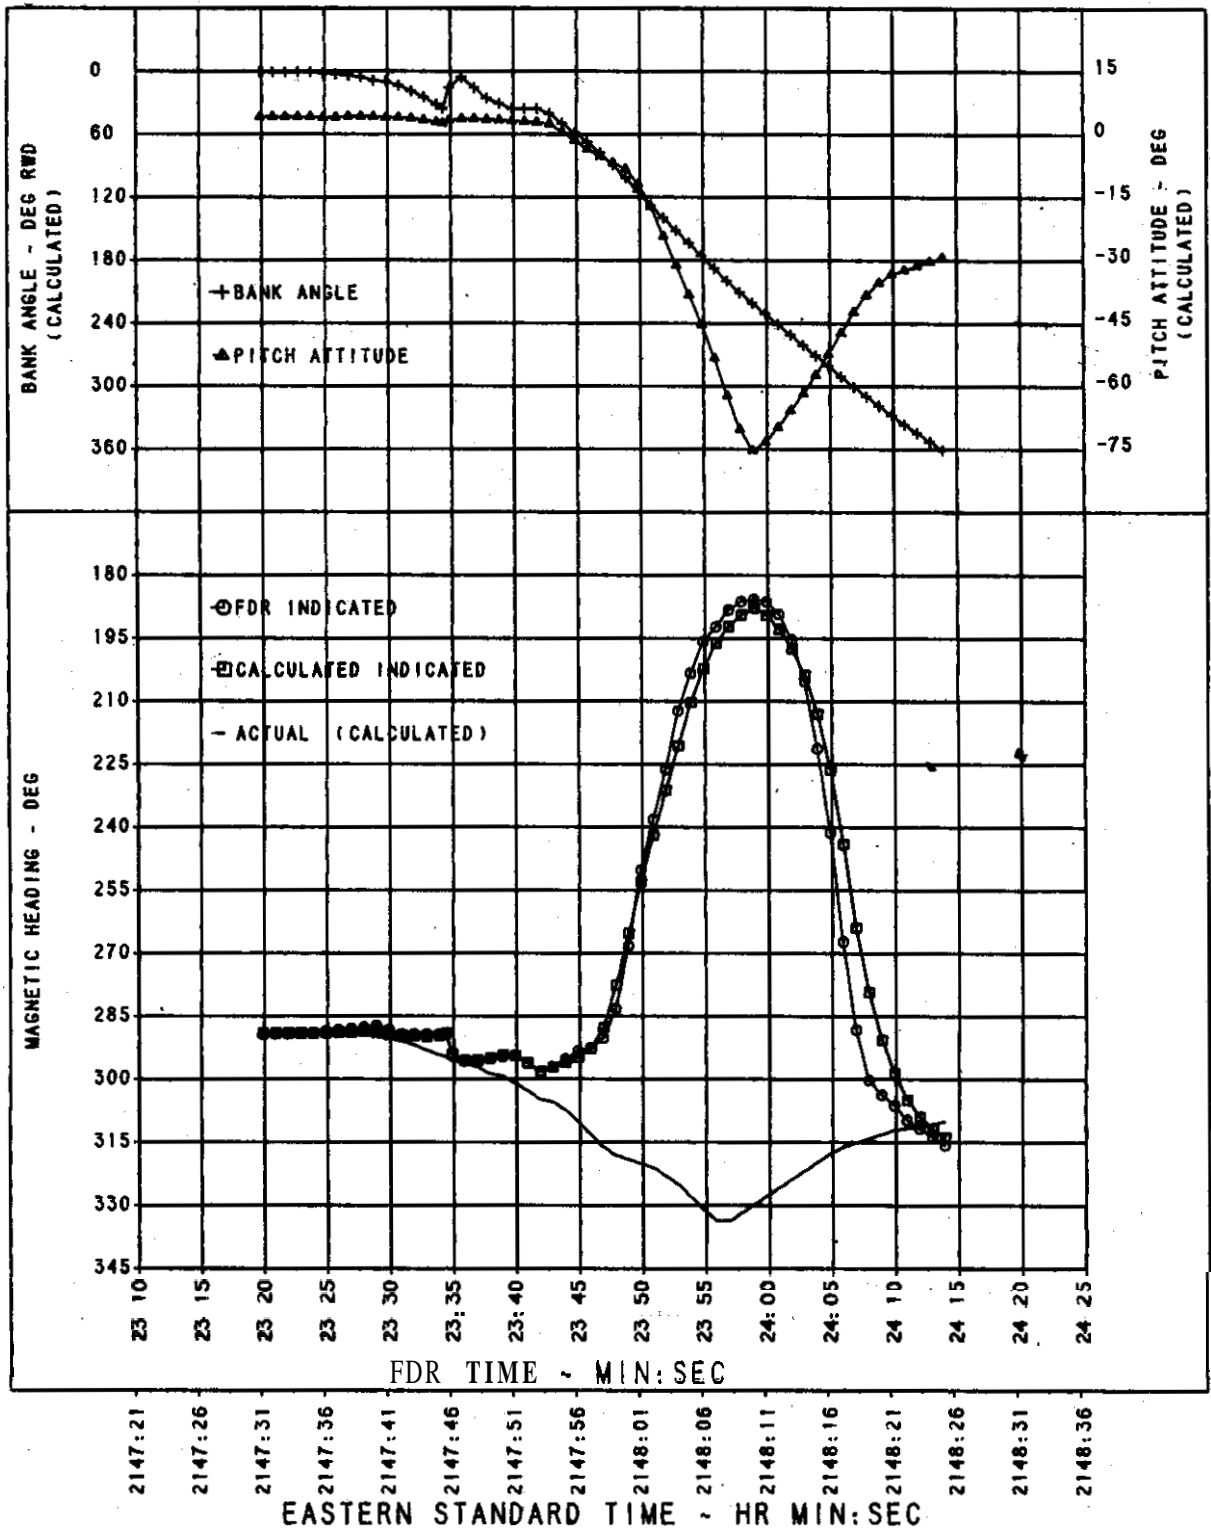
Figure 5.—Comparison of calculated and FDR headings.

As shown in figure 5, the calculated indicated heading trace for these heading, pitch, and bank angles compares almost exactly with the accident aircraft's FDR heading trace with the time shift removed. Beginning about 2147:34, the aircraft began to roll slowly to the right, and about 6 seconds later, the rate of roll began to increase. At 2147:45, the aircraft was in a right bank of about 35° , after which it was rolled rapidly to the left to near a wings-level attitude. About 2147:47, the aircraft began to roll again to the right, and the roll was arrested briefly at 2147:51 near 3° of right bank. At 2147:53, the aircraft resumed its roll to the right and about 2148:07, the aircraft was inverted with a pitch attitude about 45° below the horizontal. As shown in figure 5, the aircraft's actual heading (calculated) changed comparatively little during the 30° of roll.

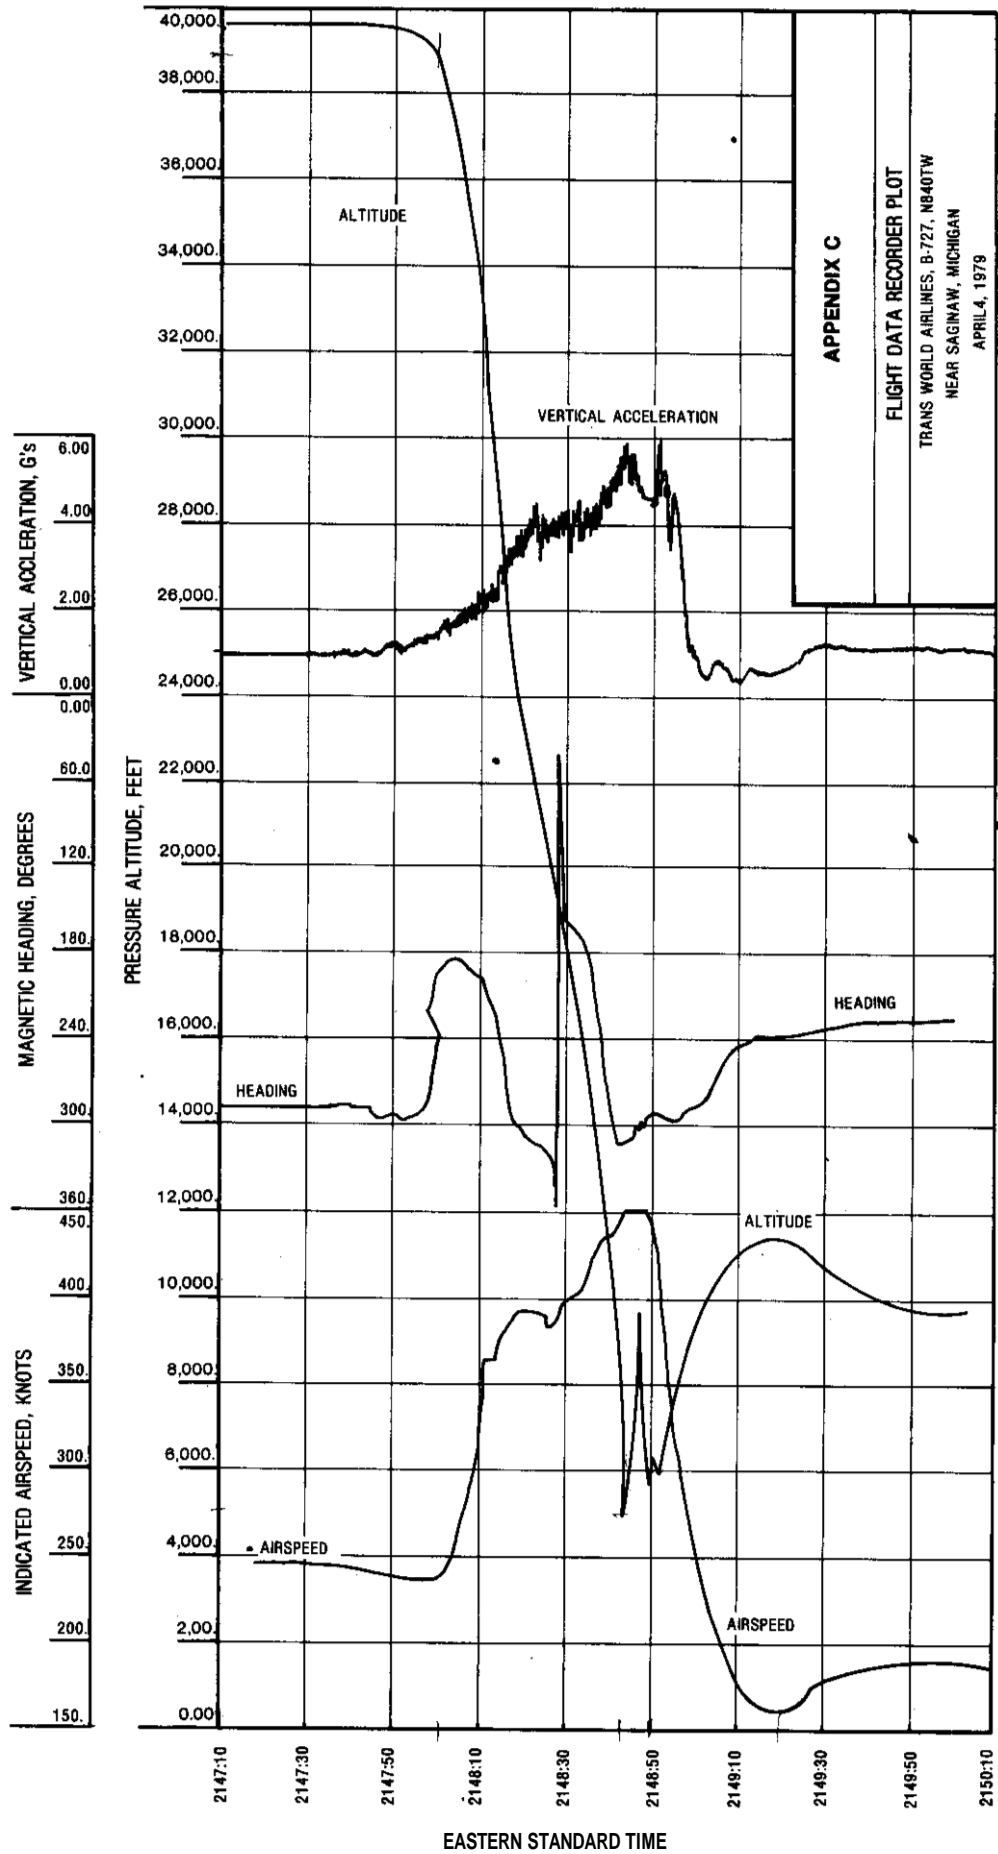
APPENDIX C
FLIGHT DATA RECORDER PLOT
TRANS WORLD AIRLINES, B-727, N840TW
NEAR SAGINAW, MICHIGAN
APRIL 4, 1978

The aircraft was equipped with a Lockheed Aircraft Services Model 109-D flight data recorder (FDR), serial No. 219. The recording foil was not damaged and all four flight parameters were clear and active. (See appendix C.) There was no evidence of malfunction except at one point in the heading trace where the heading stylus moved in a direction opposite to normal movement of the recording foil while the aircraft was in a turn and was being subjected to high vertical acceleration forces. Further examination of the heading trace disclosed that this abnormality occurred again when the aircraft was turning off the runway at Detroit. A detailed examination of the recorder heading trace mechanism disclosed no explanation for these abnormalities. However, according to the manufacturer, the backward movement of the heading stylus (apparent time shifts) were caused by worn mechanisms in the FDR.
