PB89-910406
NTSB/AAR-89/04

AIRCRAFT ACCIDENT REPORT

DELTA AIR LINES, INC.
BOEING 727-232, N473DA
DALLAS-FORT WORTH INTERNATIONAL
AIRPORT, TEXAS
AUGUST 31, 1988

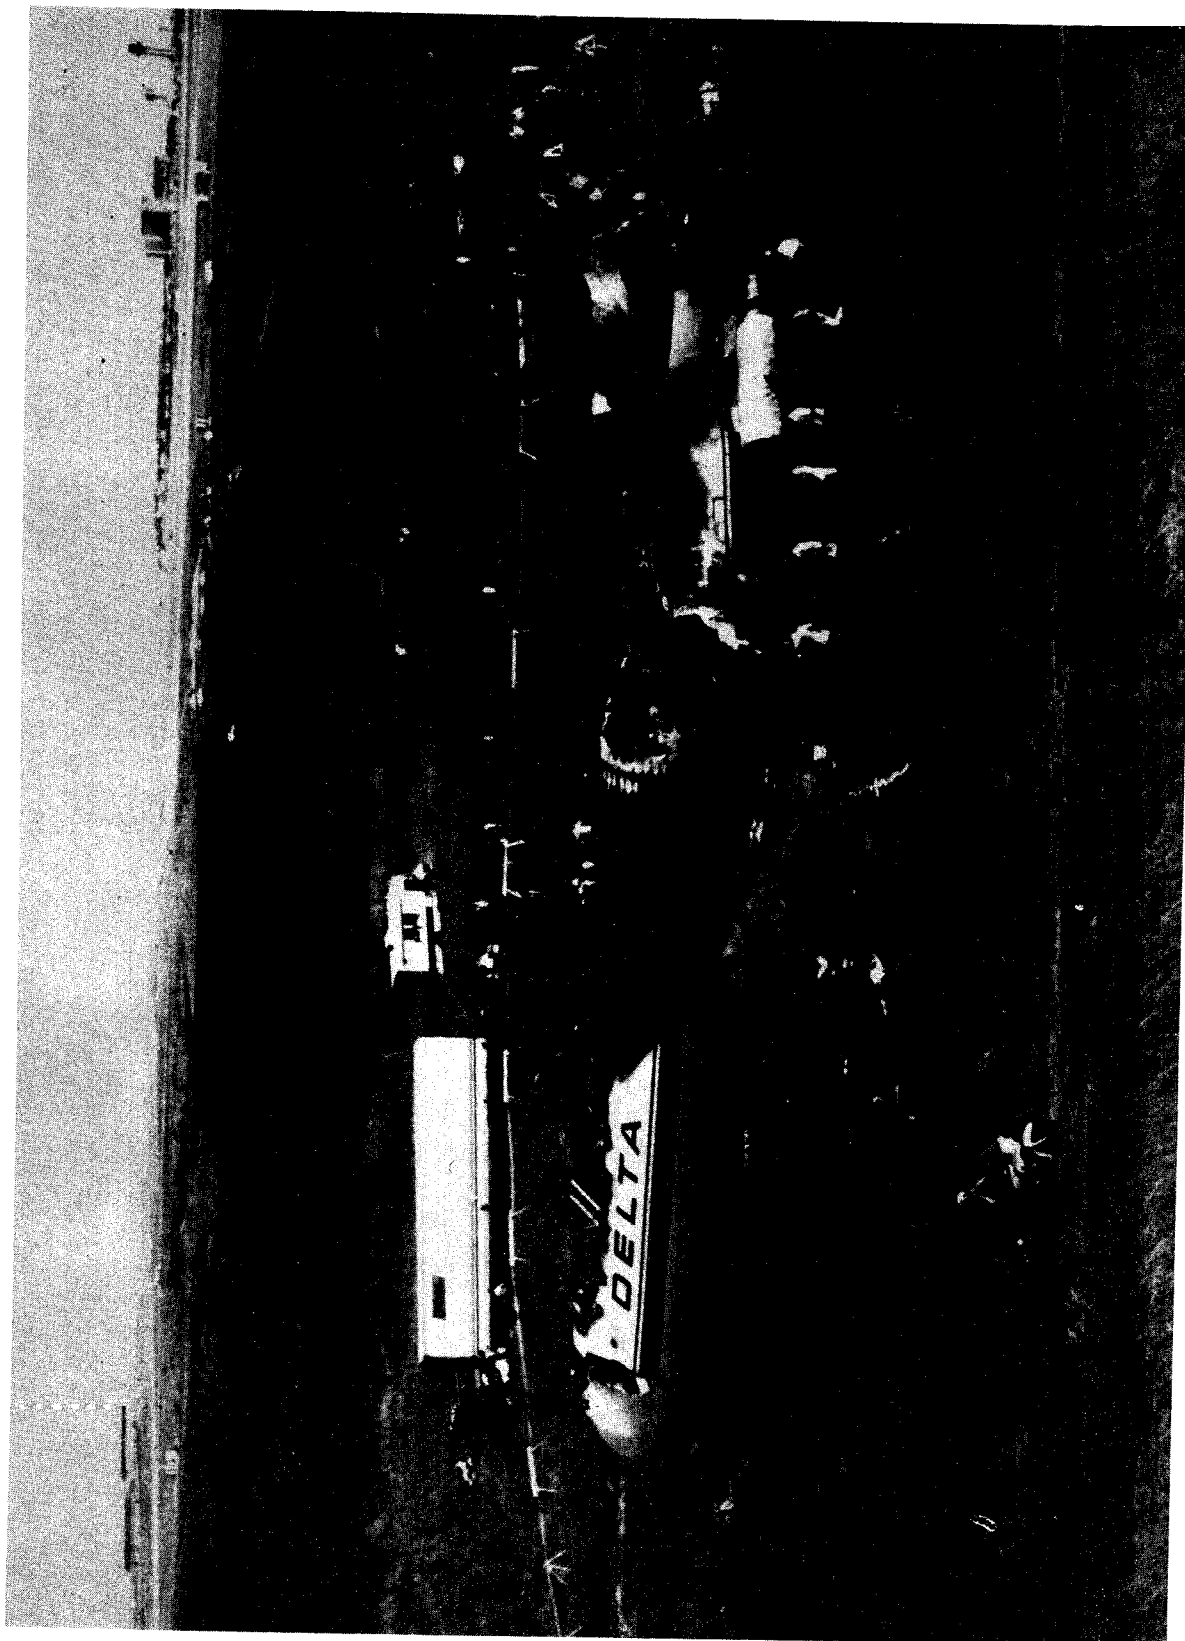
Figure 2.--General aerial view of left side of main aircraft wreckage, wreckage path, and the departure end of runway 18L looking north.

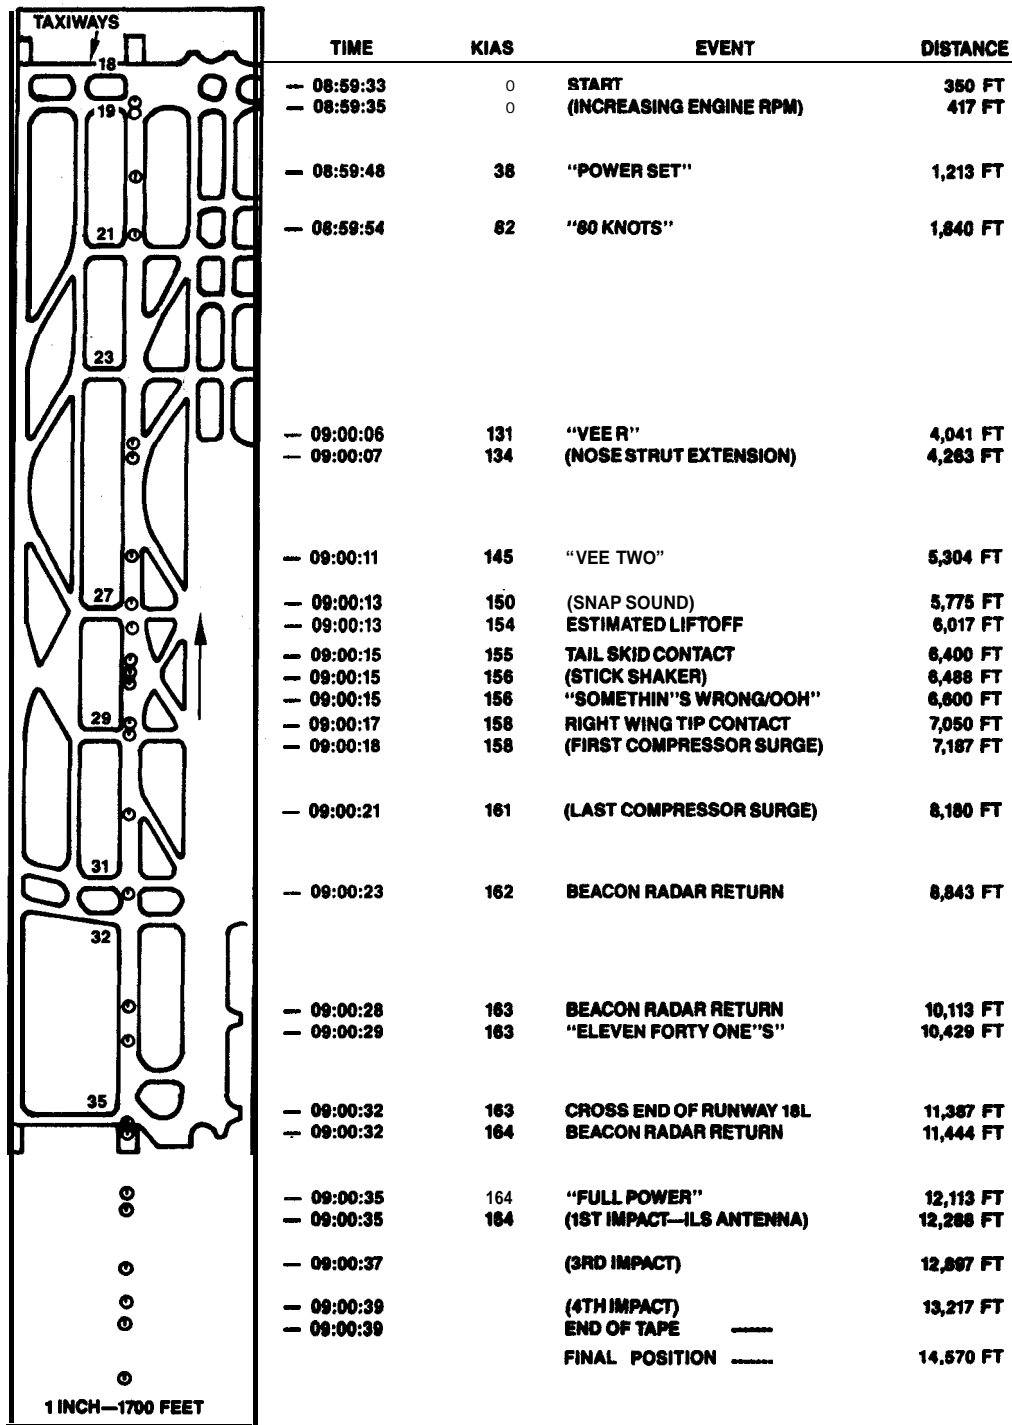
Figure 5.-- Flight 1141 takeoff events.

The first impact mark was made by the tail skid contacting the runway centerline and a runway centerline light between taxiways 27 and 29, at a distance of approximately 4,990 feet prior to the departure end of runway 18L (see figure 5). About 650 feet from this point, the right wing tip struck the right side of the runway near taxiway 29, approximately 4,340 feet prior to the departure end of runway 18L. The taxiway markers for taxiways 31 and 32 were found knocked over, but they did not exhibit any impact damage. Additionally, the grass was found to be scorched between the end of the runway and the ILS antenna. Approximately 5,300 feet from the point of the right wing tip runway contact, and approximately 900 feet beyond the departure end of runway 18L, the airplane impacted and destroyed the ILS localizer antenna. From this point and beyond, airplane components such as the right wing tip and portions of the right inboard and outboard ailerons began separating from the airplane.

After first impacting the antenna installation, the airplane remained airborne for an additional 400 feet, then struck the ground with the main landing gear wheels which produced a 350-foot linear ground depression. The airplane then traversed a ground depression that was approximately 150 feet wide and 16 feet deep. As the airplane crossed the depression, it impacted the ground on the far side. The airplane track then began to gradually swerve to the right of the extended runway centerline. This portion of the wreckage track was approximately 800 feet long.

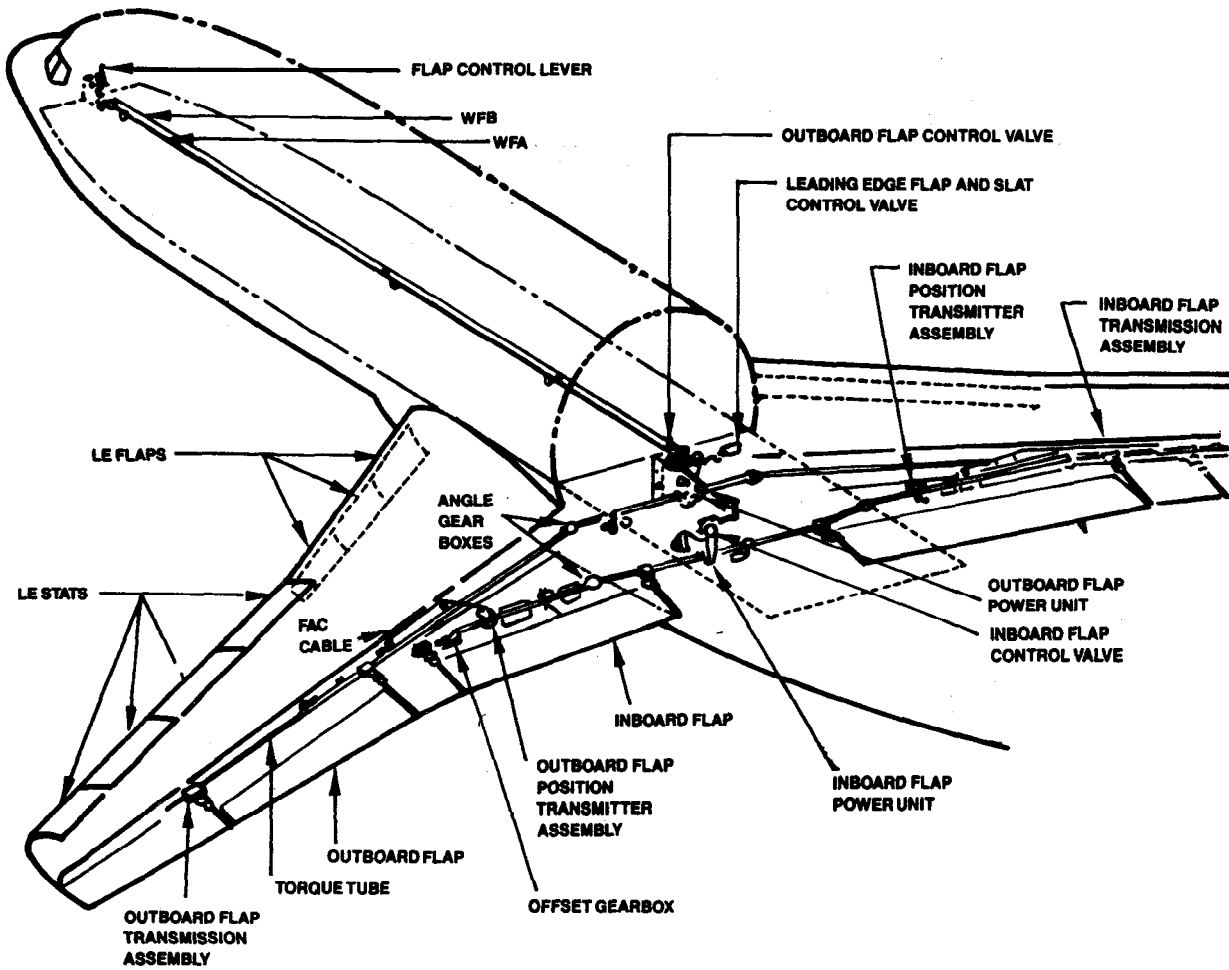
Figure 7.--Trailing edge flap system.

Trailing Edge Flap System. -- The flap control mechanism in the cockpit area was found in the flap up position. (See figure 7.) The mechanism was intact and functional. The flap handle spring tension was normal. The flap control cables were attached, and continuity was established to the forward fuselage break. From the fuselage break, further continuity of the cables was established to the outboard flap control valve

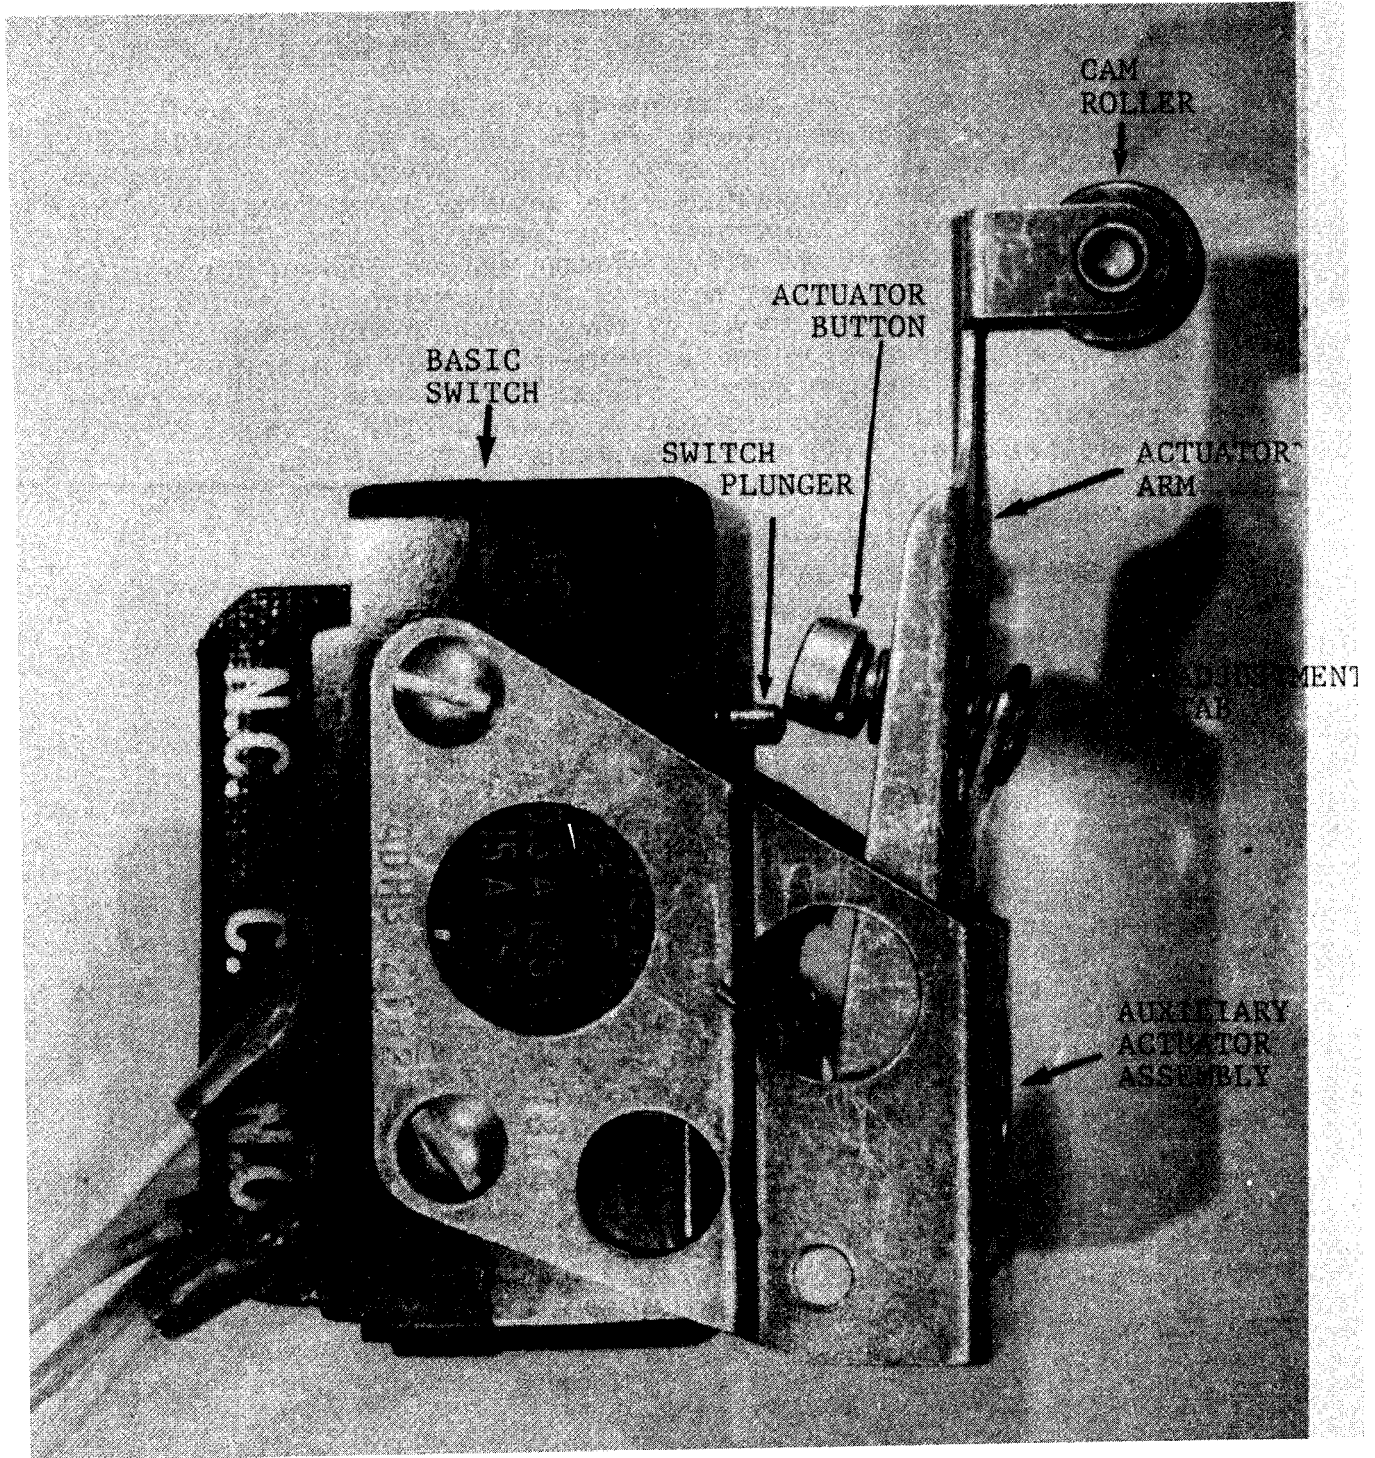
Figure 9. -- Photo of throttle switch.

Switch activation movement, with the switch assembly still installed in the clutch pack assembly, was observed through a microscopic TV camera and recorded. The outer bottom edge of the actuator button would initially contact the top center of the switch plunger and would remain in this position as the plunger was being depressed and the switch tripped. As the switch tripped, the exposed portion of the switch plunger would slide slightly inward toward the bottom of the actuator button and become perpendicular to the switch casing. Approximately 10 switch activations were observed, and each time the switch properly tripped.

The cables that were still attached to the clutch pack assembly containing the switch assembly were then removed to free the jammed cam which moves the switch actuator mounted on the clutch pack assembly structure. Proper orientation of the cam to the switch, as it would relate to thrust lever position, was then established. During this procedure, numerous switch activation sounds were heard. Other switches are installed in the clutch

pack assembly. It is not known if the takeoff warning switch activated each time the outermost surface of the cam made contact with the switch actuator.
