# NATIONAL TRANSPORTATION SAFETY BOARD

## AIRCRAFT ACCIDENT REPORT

AIR TRANSPORT INTERNATIONAL, INC., FLIGHT 805  
DOUGLAS DC-8-63, N794AL  
LOSS OF CONTROL AND CRASH  
SWANTON, OHIO  
FEBRUARY 15, 1992

**Abstract:** This report explains the loss of control and crash of Air Transport International, Inc., flight 805, a Douglas DC-8-63, near Toledo Express Airport, Ohio, after executing a second missed approach to runway 7, on February 15, 1992. The safety issues discussed in the report include unusual attitude recovery training for flightcrews, crew fatigue, and cockpit resource management.

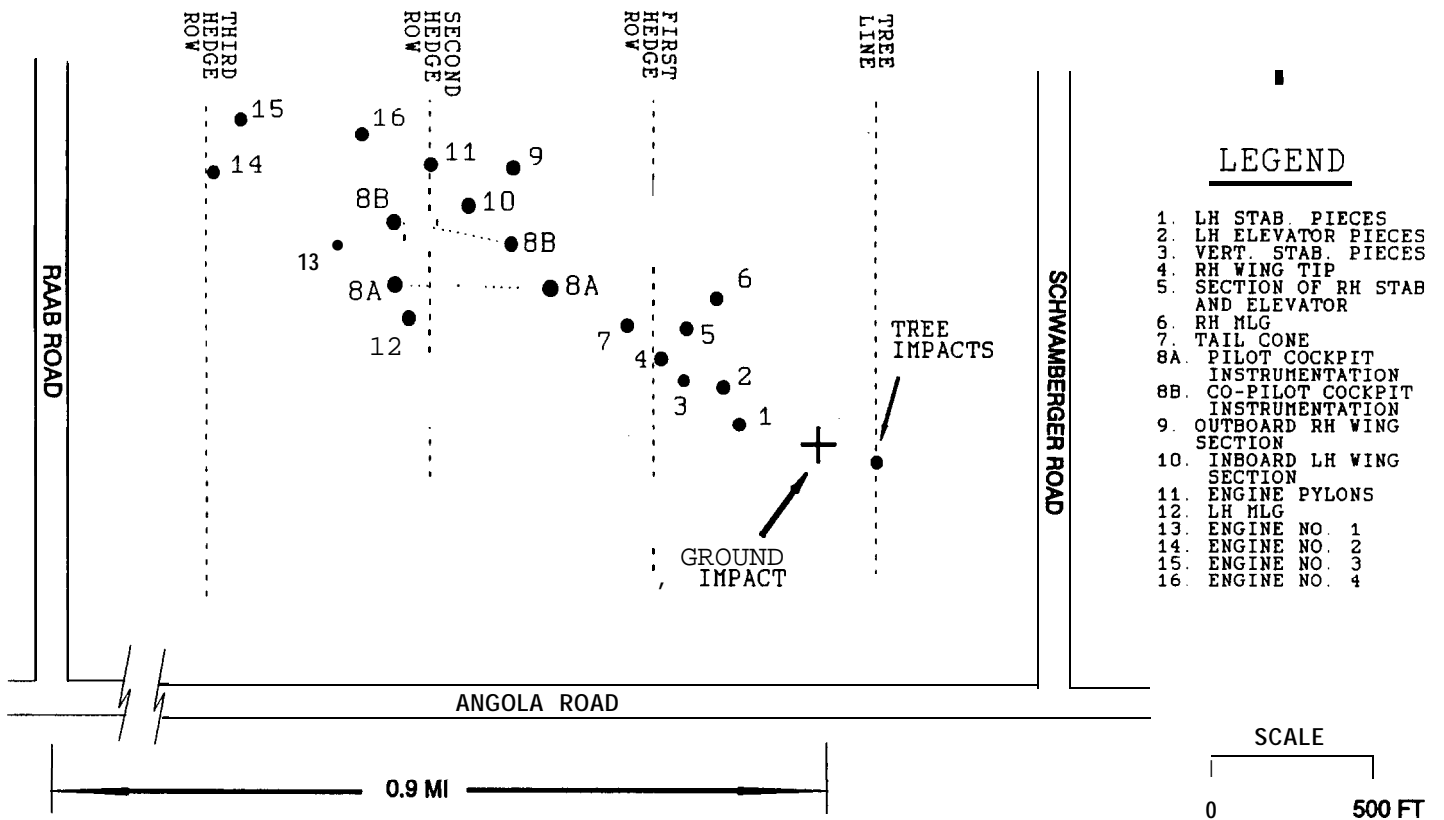
Figure 3.--Wreckage distribution diagram.

Several tree' strikes were documented near the location of the initial ground impact site. In the area of the tree impacts, only a few small pieces of wing skin and engine cowling were found. A piece of one of the trees measuring 2 feet in length was found toward the west end of the debris field and was imbedded with several pieces of thick wing skin.

At the initial ground impact site, several ground scars were observed that were consistent with the size and spacing of the left wing tip, No. 1 engine, No. 2 engine, fuselage, No. 3 engine, and No. 4 engine. No initial ground scars were observed outboard of the No. 4 engine indentation. Based on the tree strikes, ground scars, and airplane dimensions, the flightpath angle was estimated at 17 degrees down, and the airplane roll was approximately 15 degrees left wing down.

The right wing tip was substantially damaged. An outboard section of the right wing contained several penetrations and tears in the leading edge. The left wing tip was not found.

The tail cone was found approximately 600 feet from the initial ground impact site. The bottom was not crushed and the tail light and lens, which are located on the bottom of the tail cone, were intact.

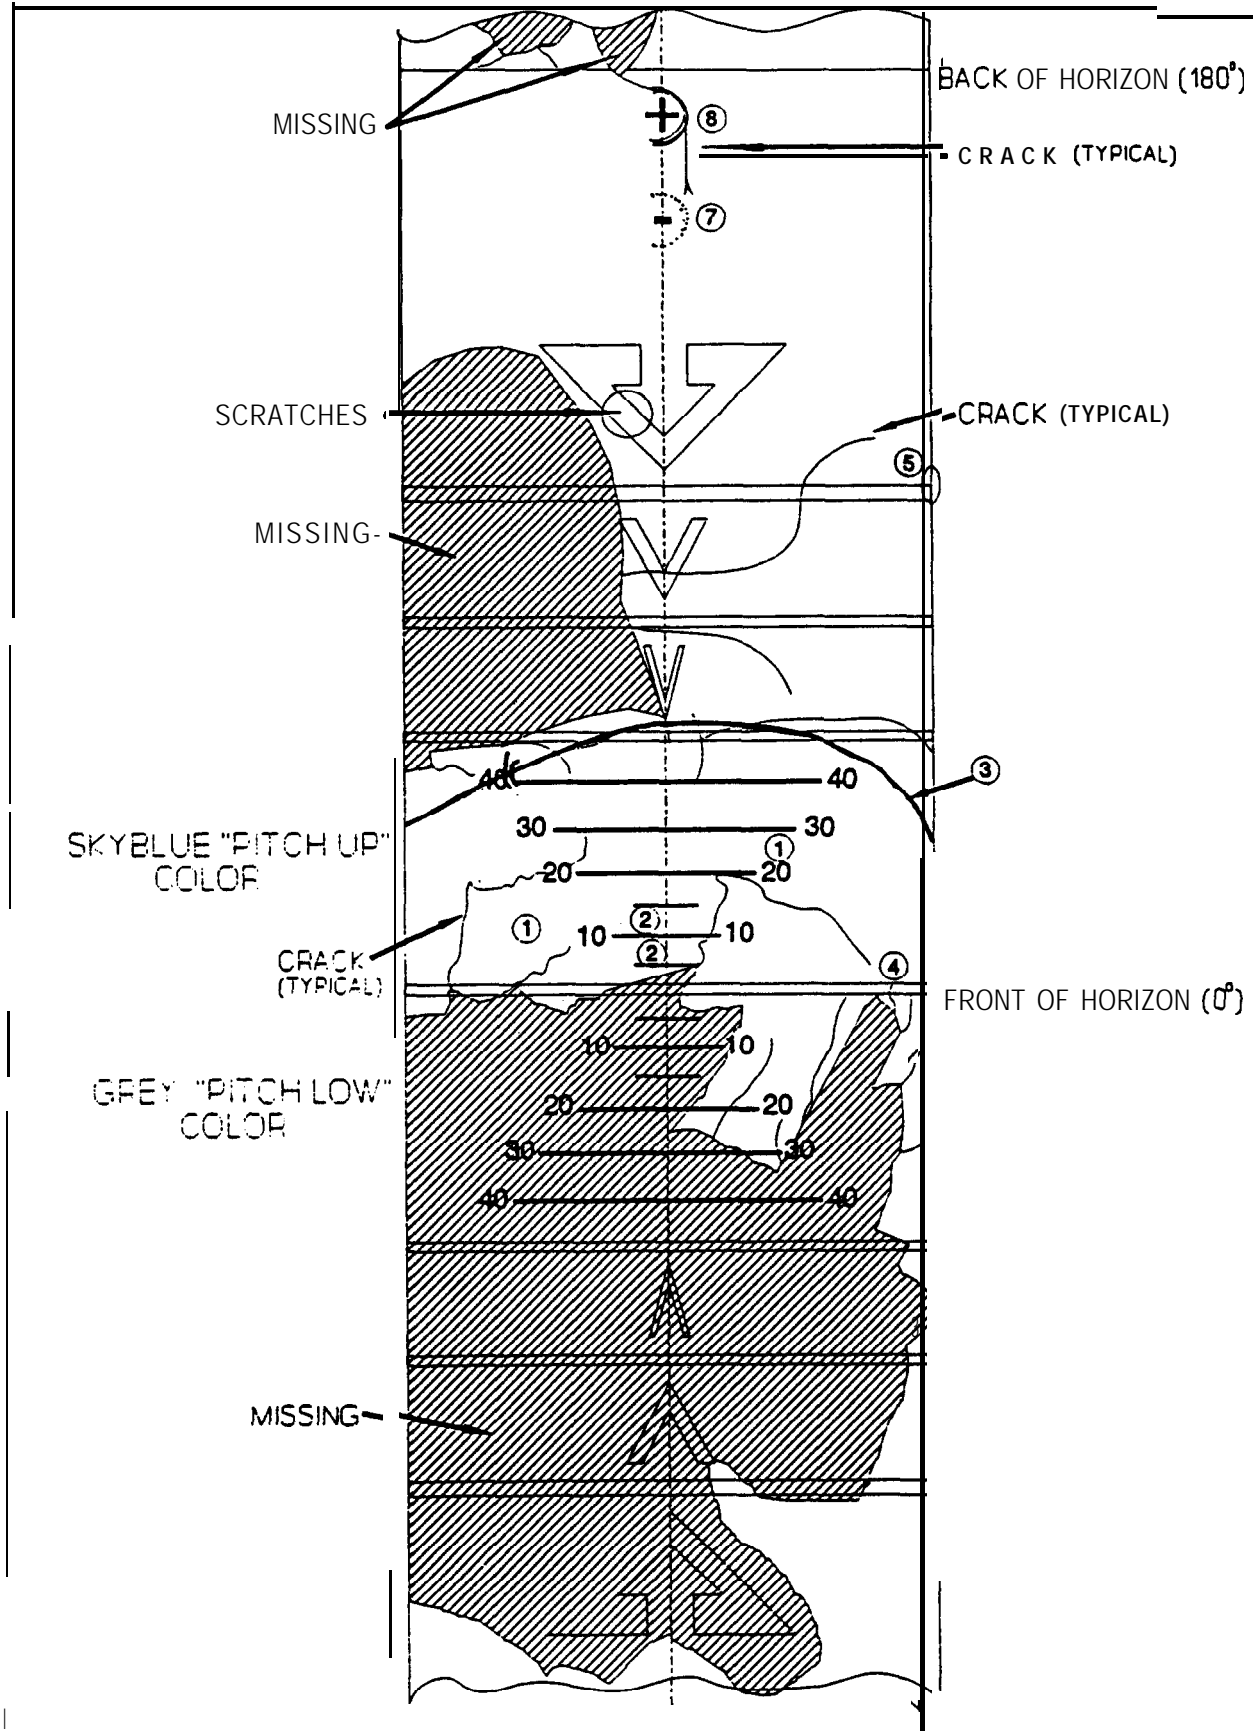
**ADI HORIZON BALL MARKINGS AND DAMAGE**  
 (AS UNWRAPPED FROM BALL SURFACE)

12. (Not shown in illustrations) Douglas documents show that the airplane uses internal resolvers within each AD1 to compare pitch data. The March 4, 1992, group recorded the resolver position as seized at 53 degrees, 29 minutes A.N.D., which was noted by that group as placing the resolver 90 degrees out of phase with a 36 degree 71 minute A.N.D. electrical position. At the September 9, 1992 meeting, Honeywell personnel stated that in subsequent review, it was realized that the measurement should have been described by the inverse phase, therefore, an indication of 26 degrees, 31 minutes A.N.D. was given as the correct measurement.

Note: Two remaining instrument light filaments were fused to the glass and exhibited massive stretching of individual coils and of the general coil.
